Atwood Eagle

Dropped Stand of 2-3/8" Drill Pipe

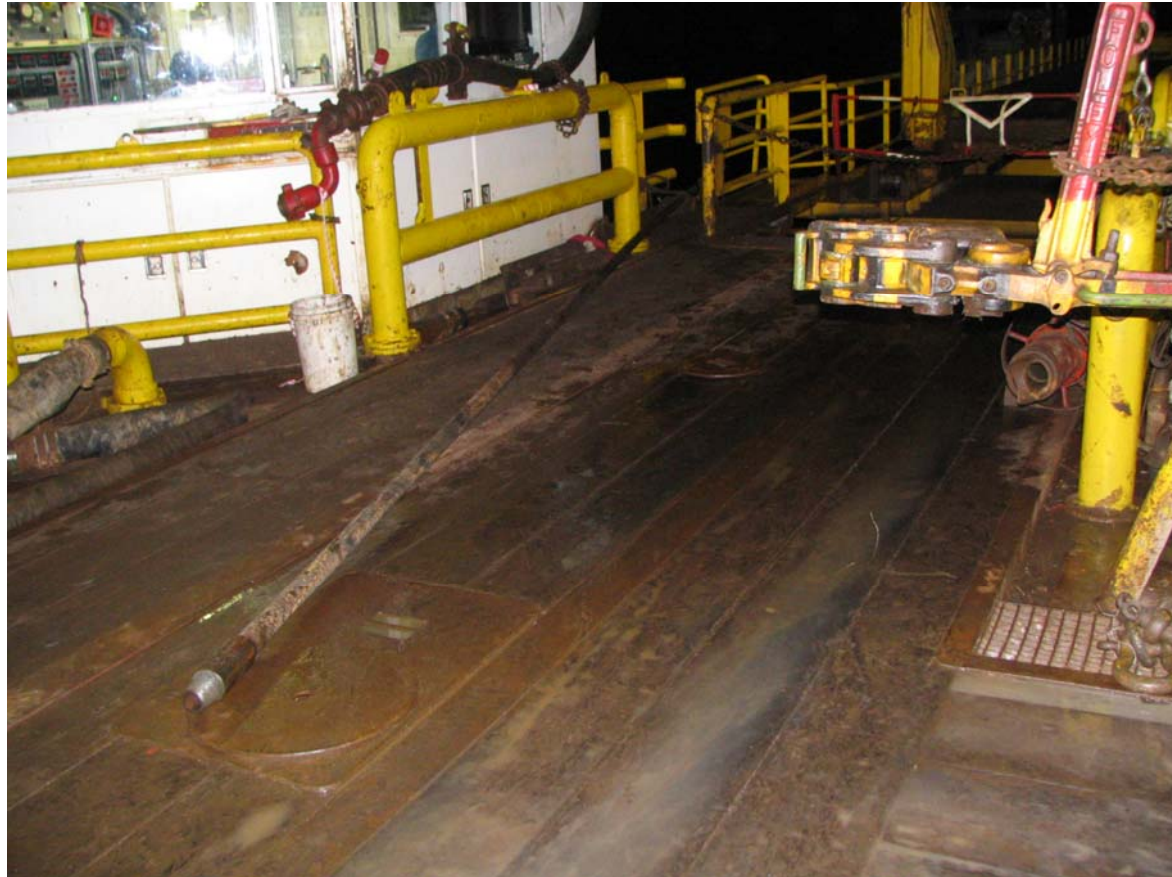
- The lower end of the stand remained on the drill floor

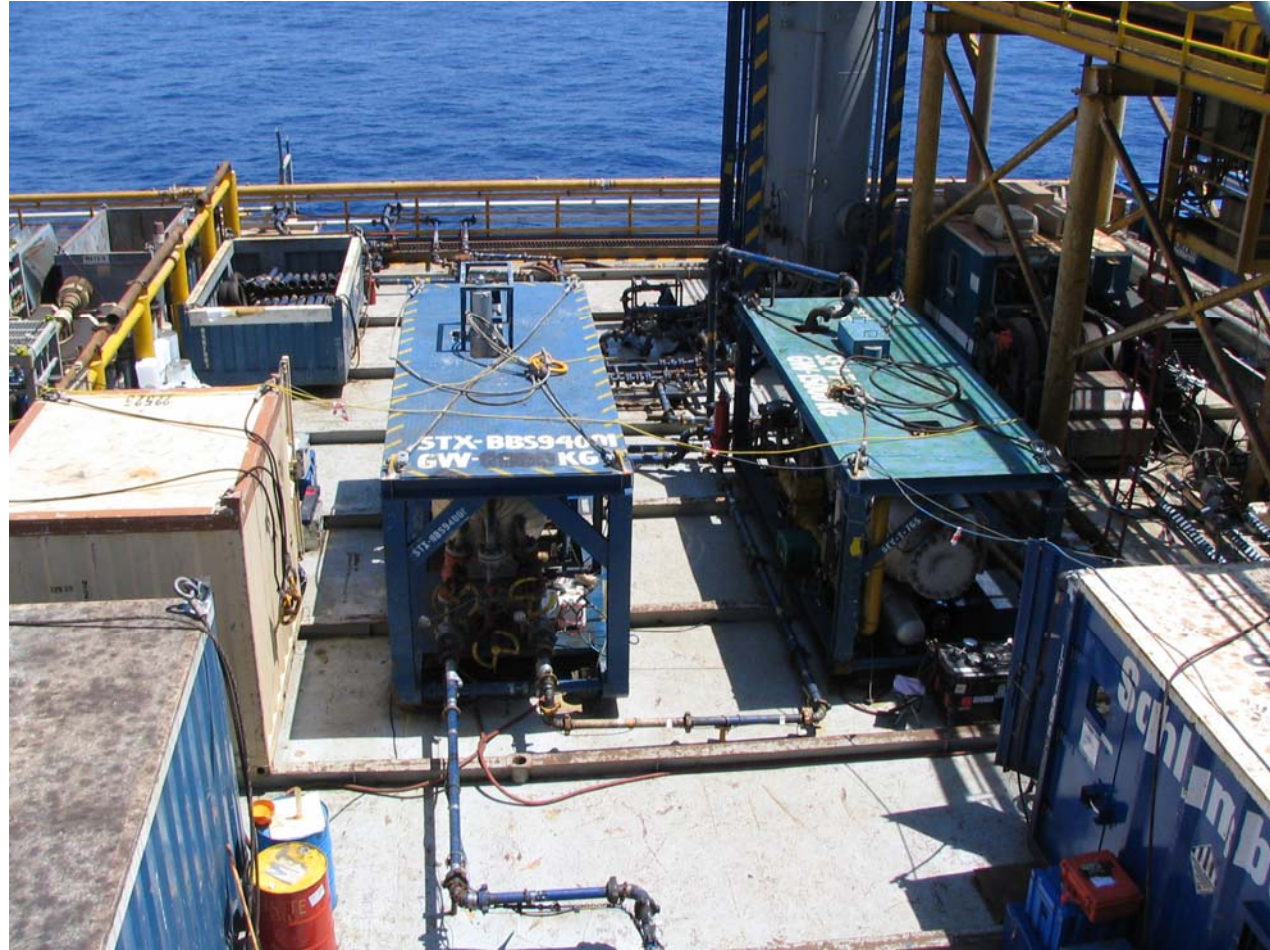
- The top end of the stand fell across the aft pipe deck onto the well testing equipment below

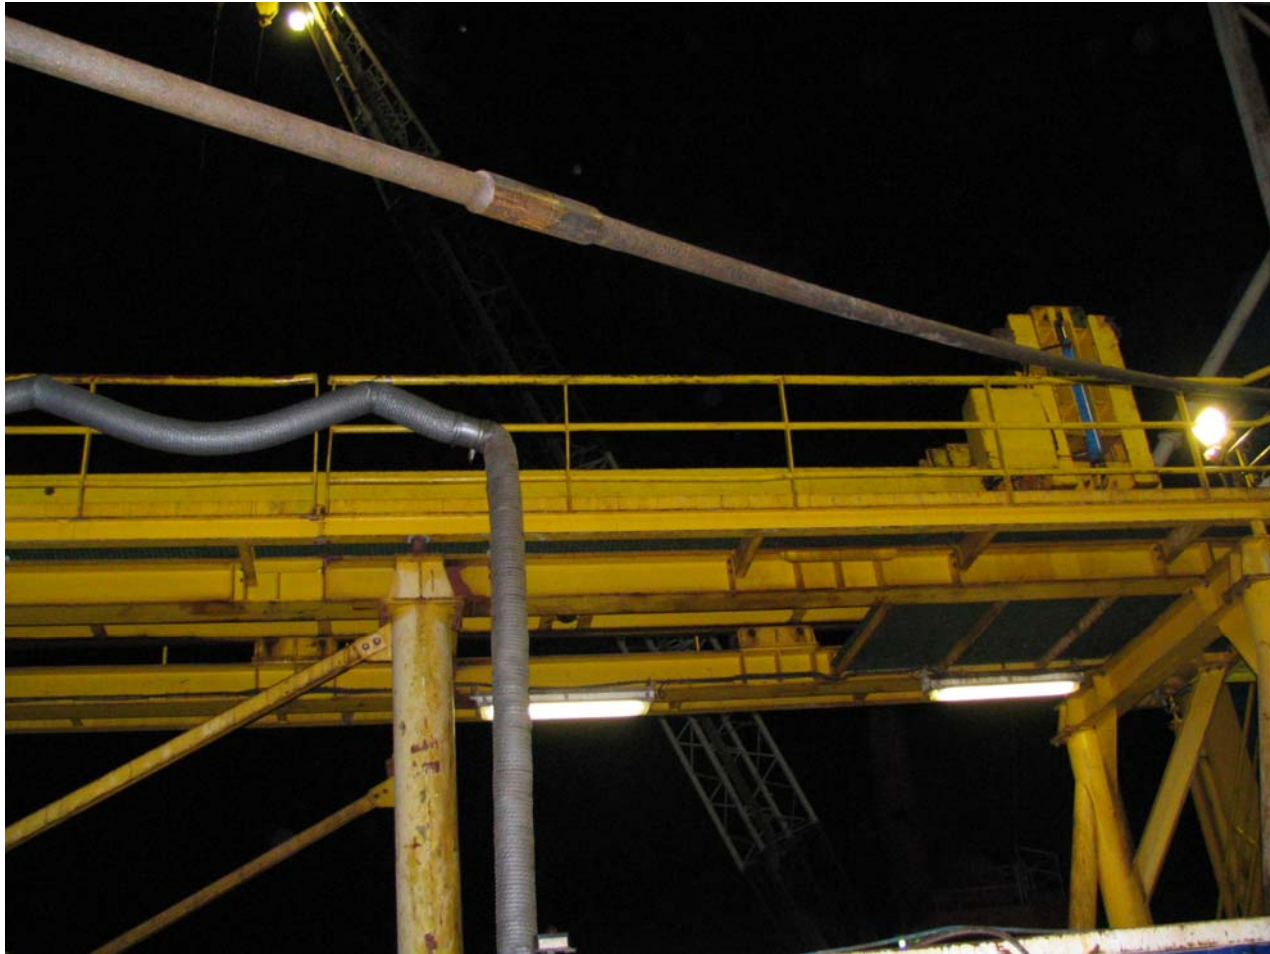
Stand of DP mid section final resting place – Looking up towards Drill Floor

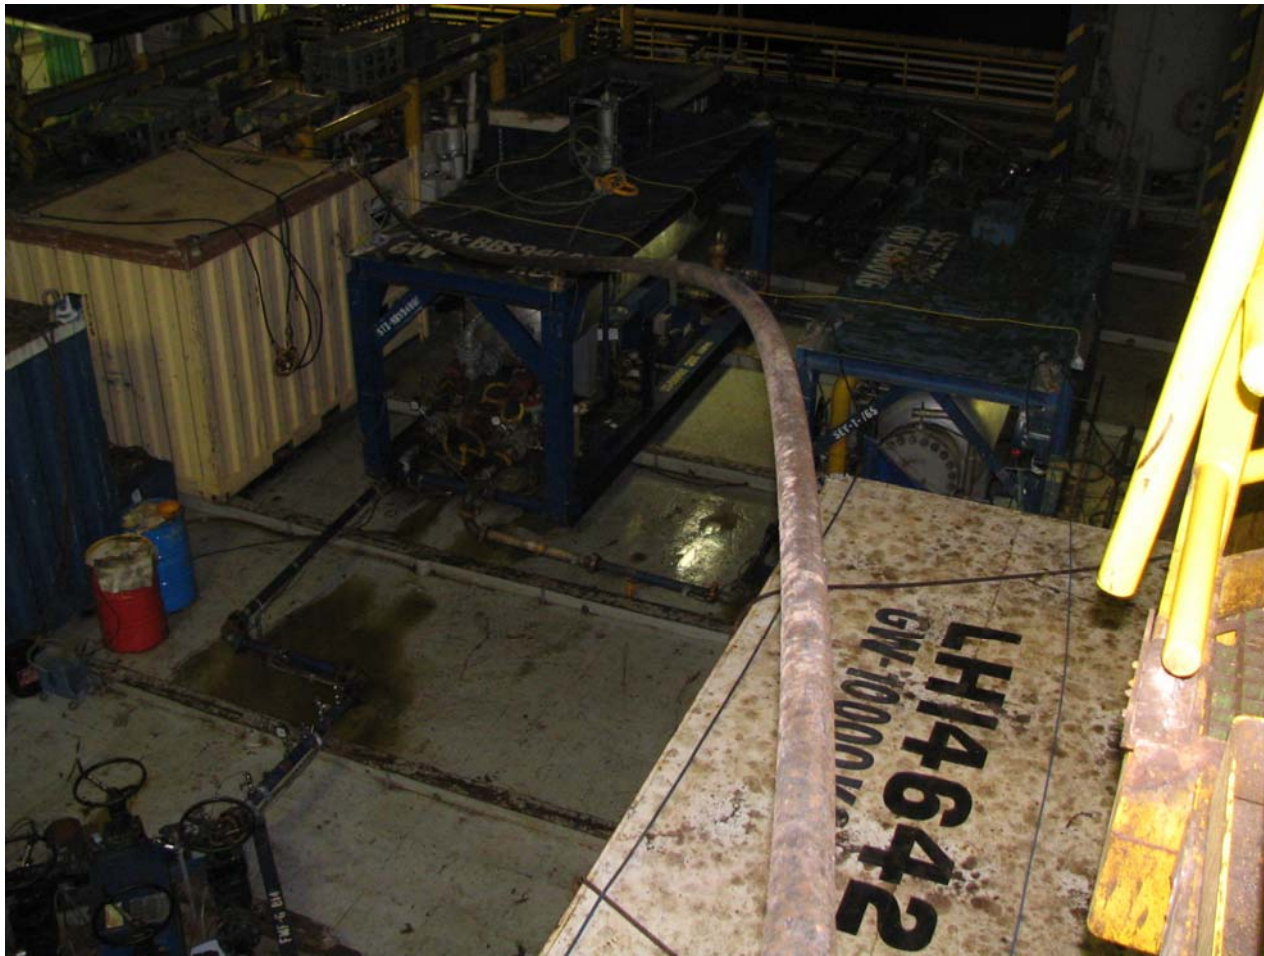
Stand of DP final resting place – looking down towards pipe rack

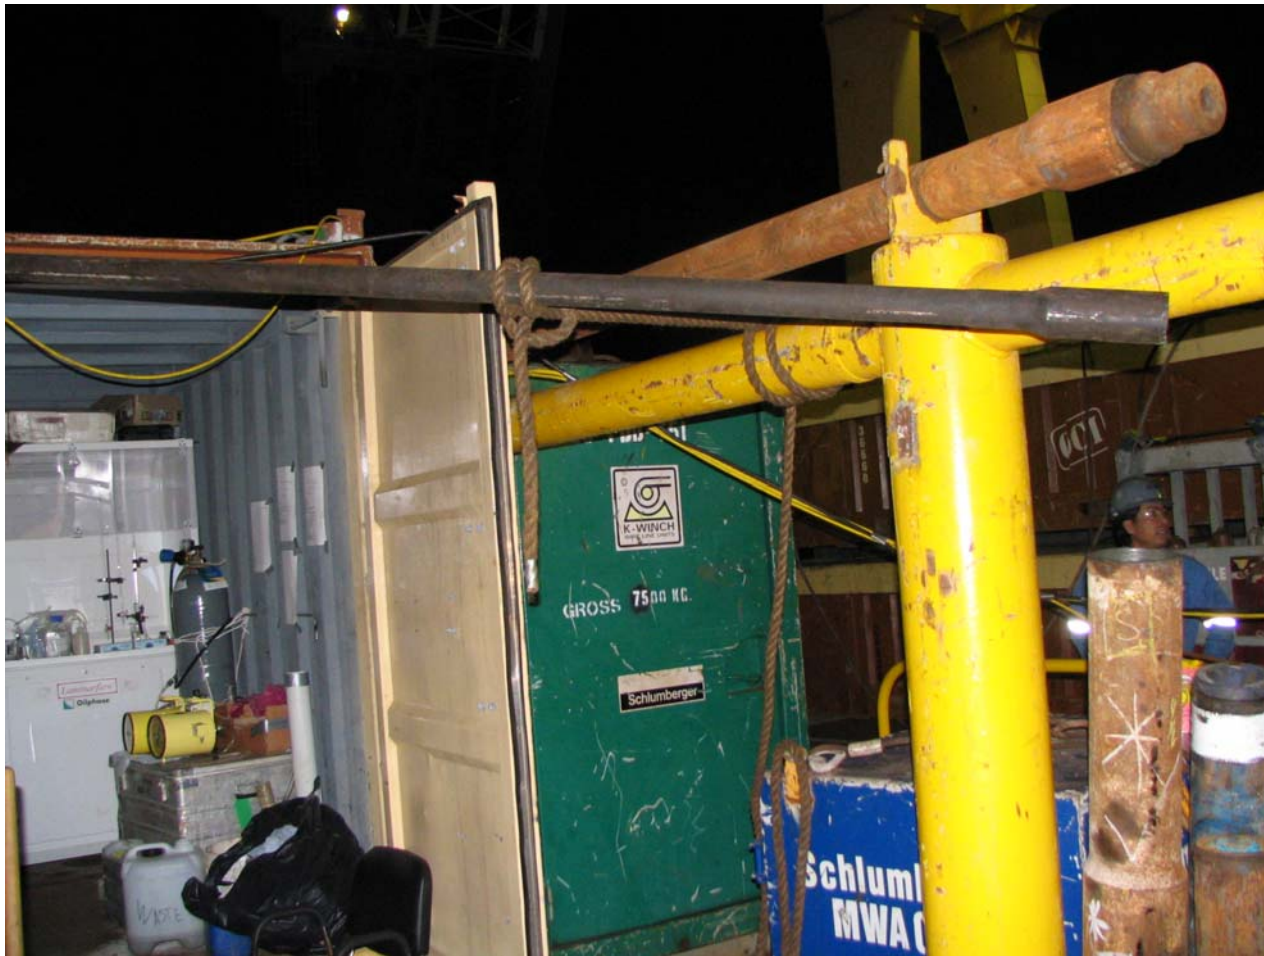
Stand of DP final resting place – top end on well test container

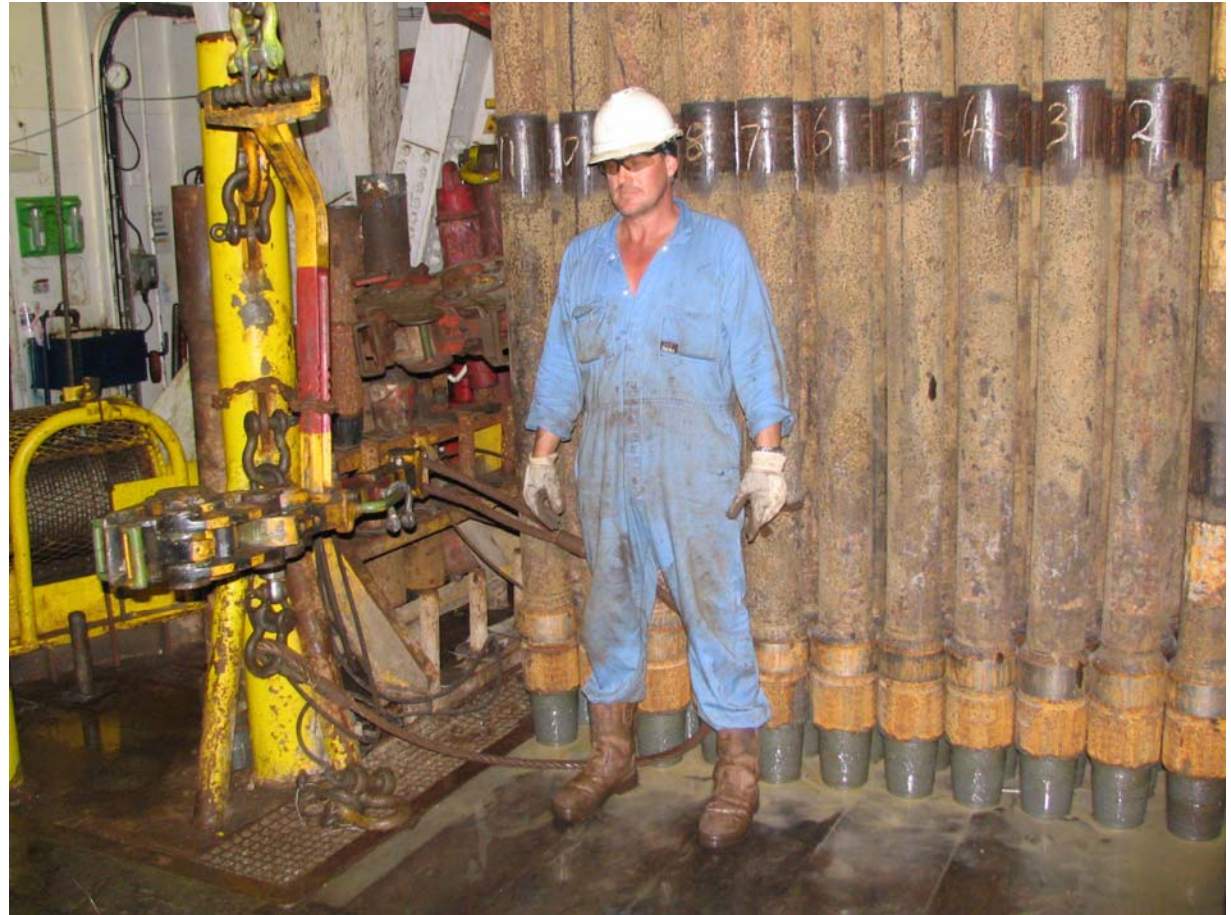
- When the stand fell, the lower end of the stand struck a floorman on the shin lacerating it

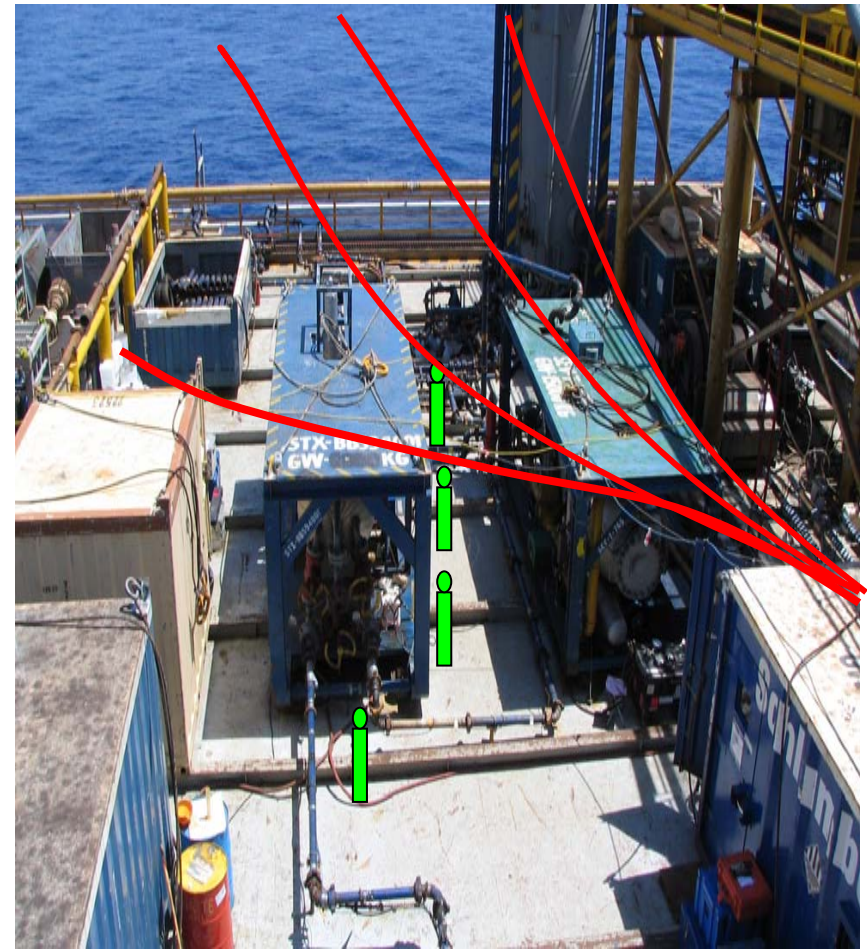
- Location of several Well Testing personnel when the stand fell out of the derrick
- High potential for the DP stand to have hit one of them
