Drillsafe – Perth – 7th March 2007

Dropped Blocks – Rig #3 – 04/04/2006

Ben Prain, HS&E Manager, Century Resources.

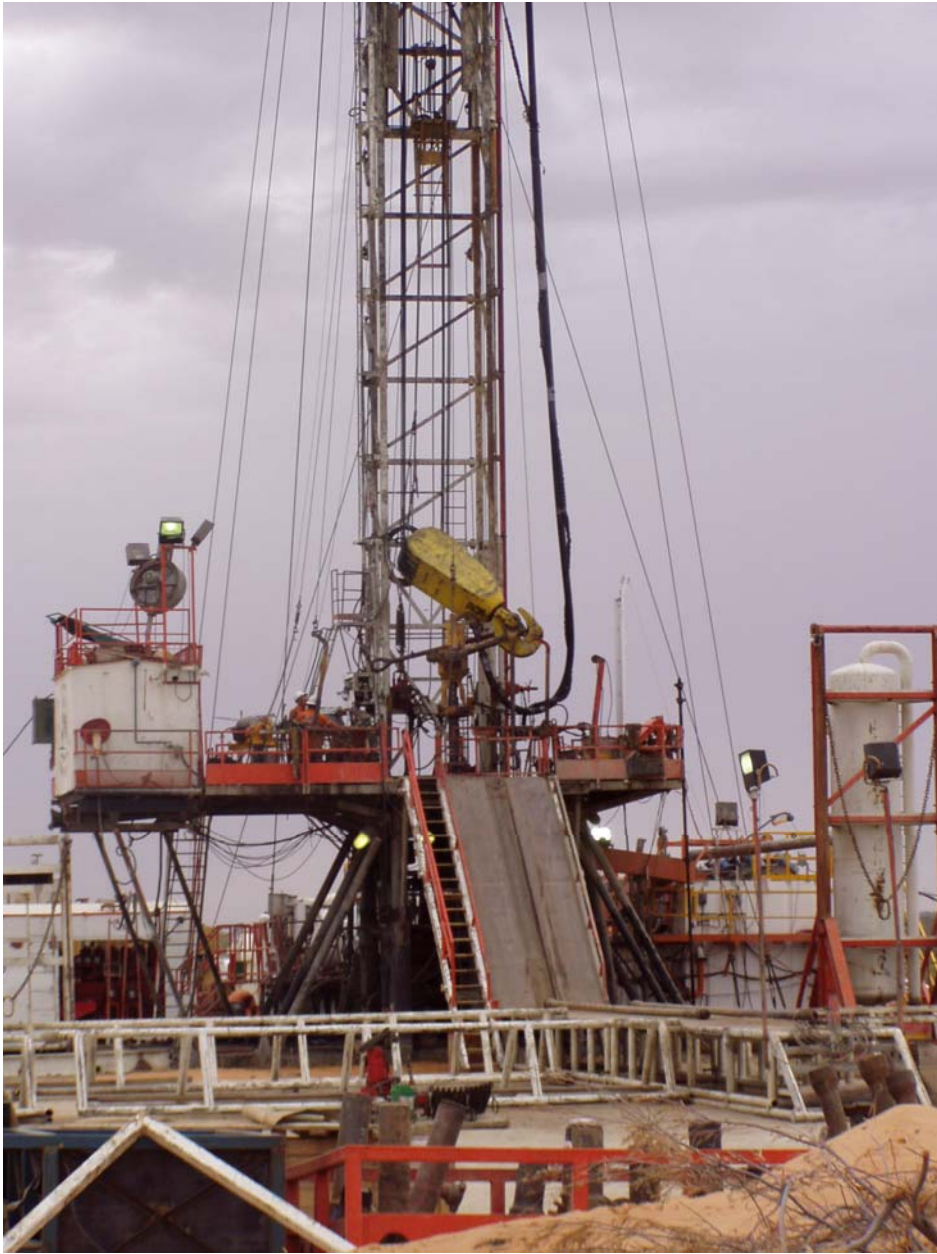
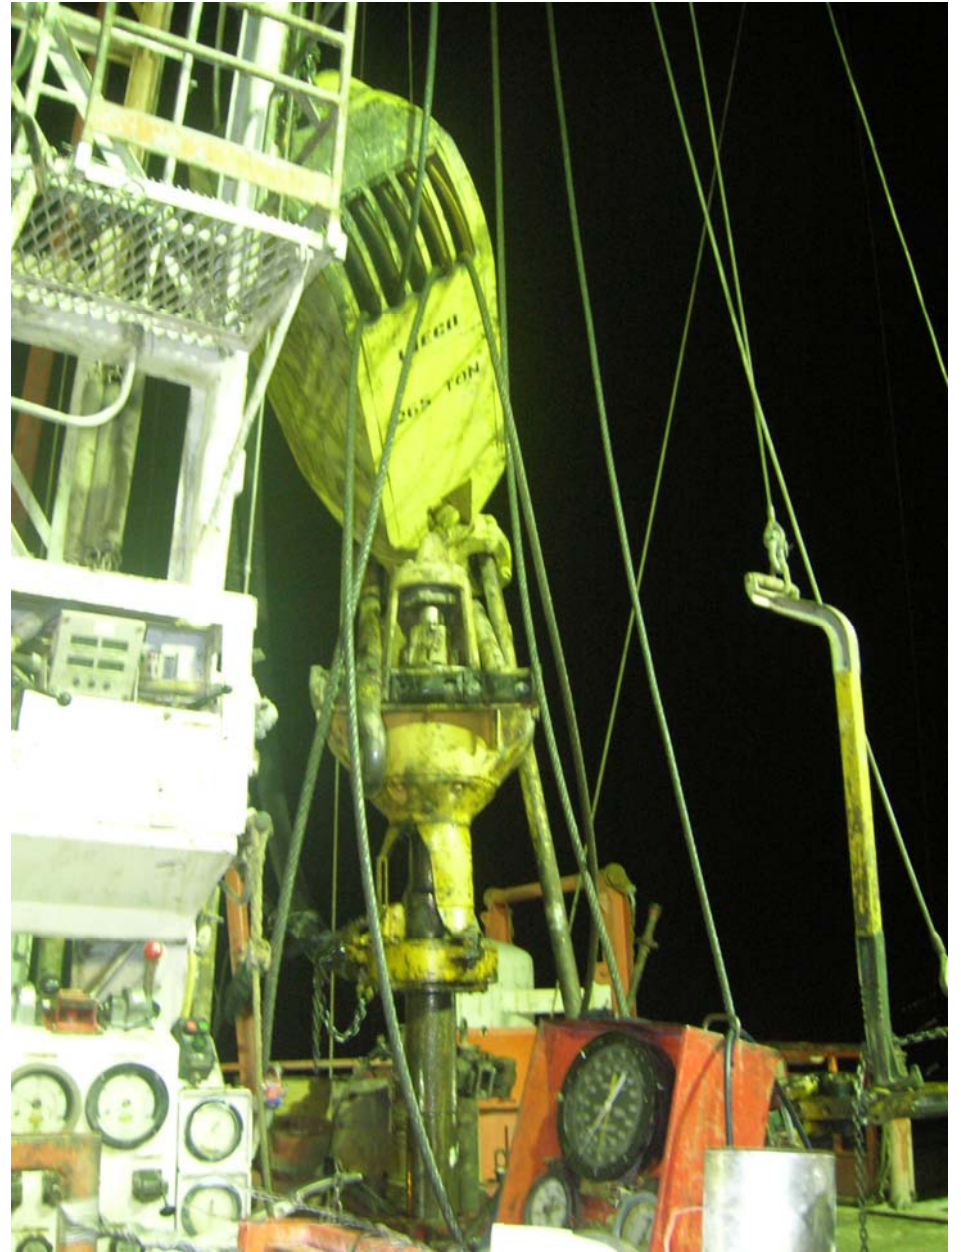
Photographs depicting resting position of blocks following incident.

- High Potential Near Miss and Equipment Damage
- Date: Tuesday 4th April 2006
- Time: 7:15pm
- Location: Christies #5 – Cooper Basin SA
- Rig: Century Rig #3
- Client: Beach Petroleum Ltd.

- 7.15pm - 02/04/06: Slip & cut procedure was undertaken and completed by 3 rig personnel – a floorman, driller and night rig supervisor.
- 7.15pm – 04/04/06 (48 hours later): A subsequent event occurred whereby the drill-line cable slipped and pulled out of the drill-line knuckle and retaining slot in the draw works.

- This resulted in allowing the tension to slacken on the drill-line cable against the draw works drum allowing the travelling blocks to gain additional momentum whilst travel towards the rig floor with no control by the driller or rig braking system.
- This uncontrolled momentum finally resulted in the travelling blocks and swivel impacting the derrick and rotary bushings.
- 4 crew members were on the rig floor when the incident occurred:
 - 2 x Floorman cleared the floor toward the V-door stairs,
 - 1 x Floorman cleared the floor toward the Doghouse,
 - 1 x Driller remained at the brake trying to regain control of the descending blocks.

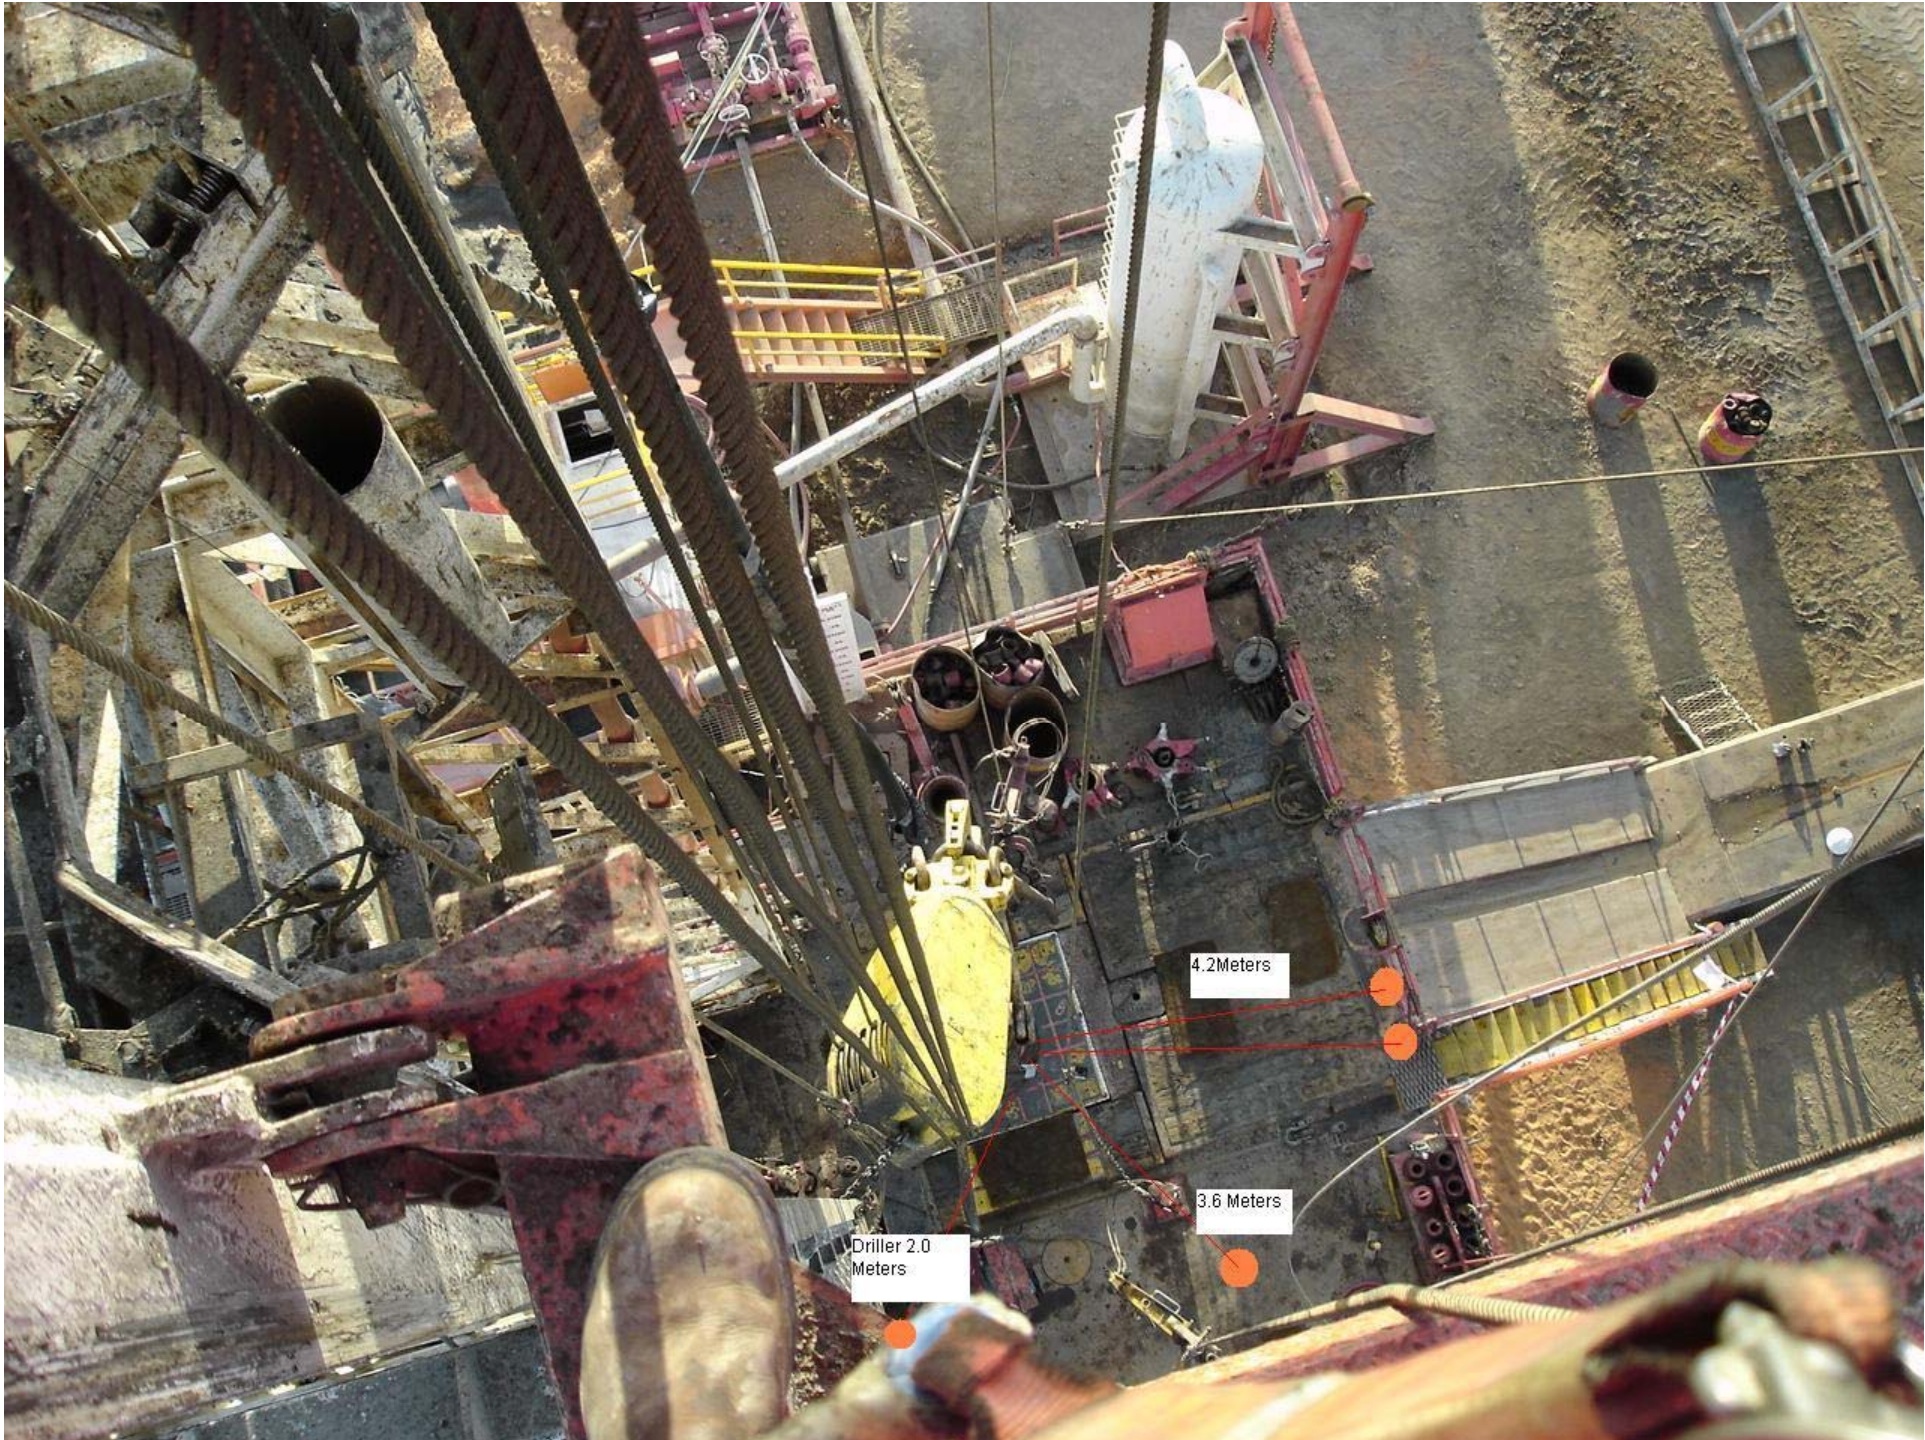
Driller 2.0
Meters

3.6 Meters

4.2 Meters

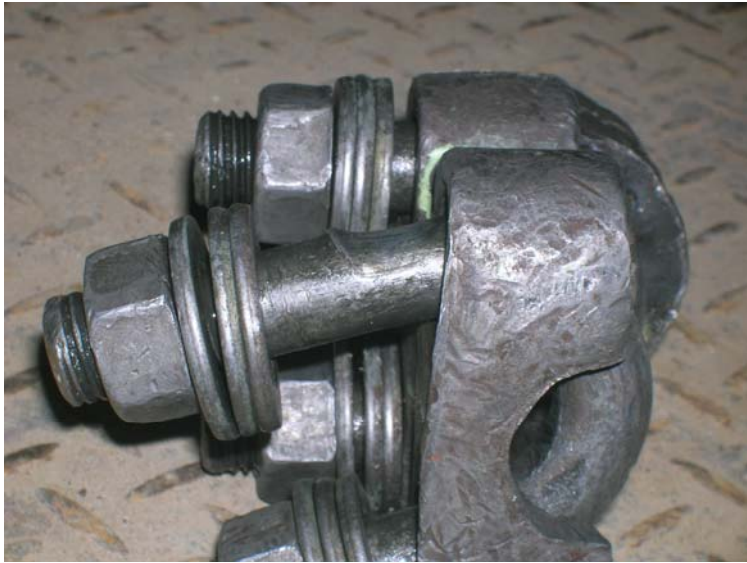
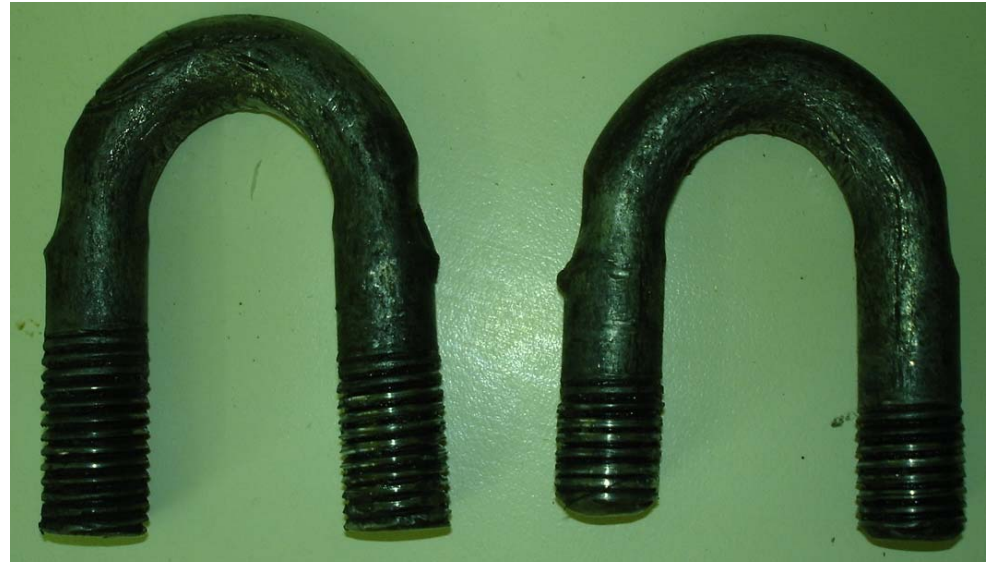
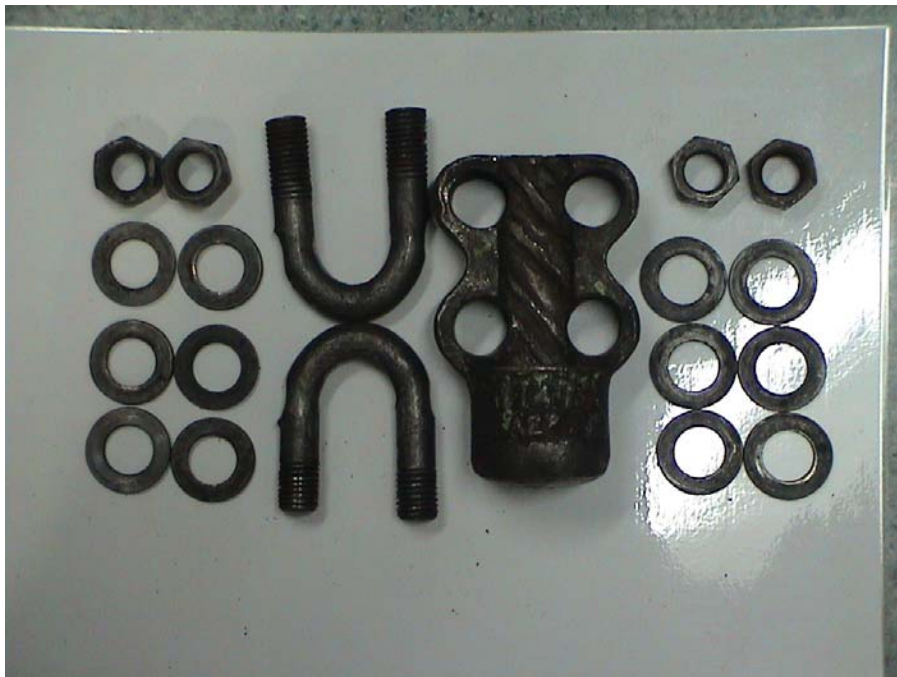
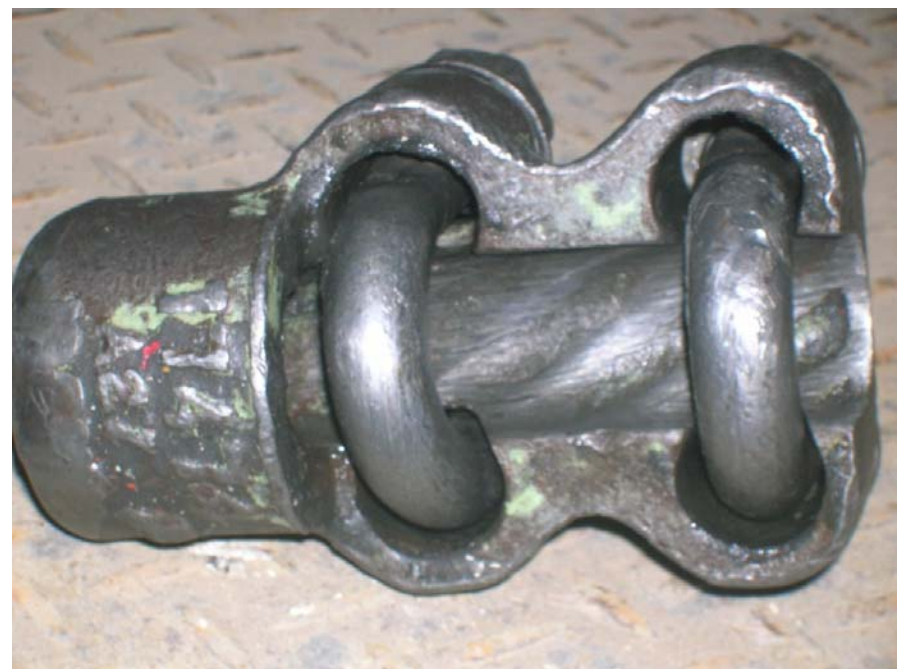
Photographs of failed knuckle condition and wear of u-bolts, threads, washers and nuts

1. Standard Operating Procedure (SOP) for the slip and cut operation (conducted on 02/04/06) was available, but written with assumed knowledge and not enough detail.
2. Oxy cutting the drilling line affected the integrity of the wire line (The correct cold cutting process as outlined in the SOP should have been used).
3. No specific person held accountable for checking knuckle condition and serviceability during slip and cut.
4. No action taken when knuckle showed signs of wear – “ it had always looked like that!!”
5. No preventative maintenance documentation available for the use and servicing of the knuckle.
6. No SOP to specific correct use and torque of knuckle nuts.

- **Immediate:**
 1. Work stopped and incident discussed with crew involved and at Pre-Tour Safety Meetings for other crews.
 2. Safety alert sent across the Century fleet and to industry outlining the incident and immediate corrective actions to be taken.
 3. SOP revised to outline specific technical requirements and supervision expectations.
 4. Knuckle replaced and torque wrenches provided to ensure appropriate tensioning.

1. [Plant Technical Bulletin](#) created regarding the 2 knuckle types used in the fleet and the required torque setting from the manufacturers. This was sent across the fleet using safety alert network.
2. Additional knuckle held on all rigs as part of critical spares and replaced every 12 months no matter what the condition is.

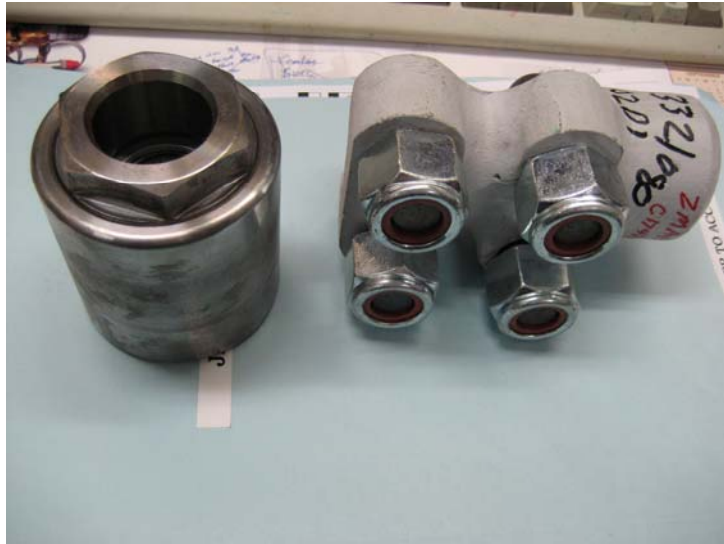
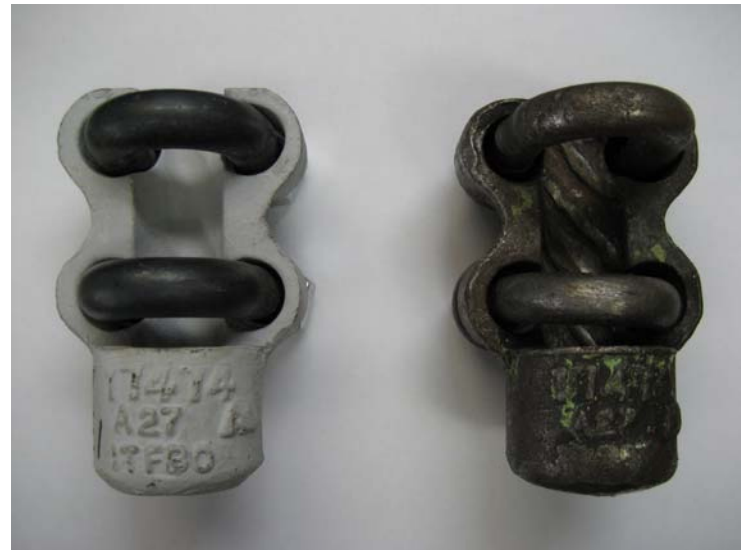
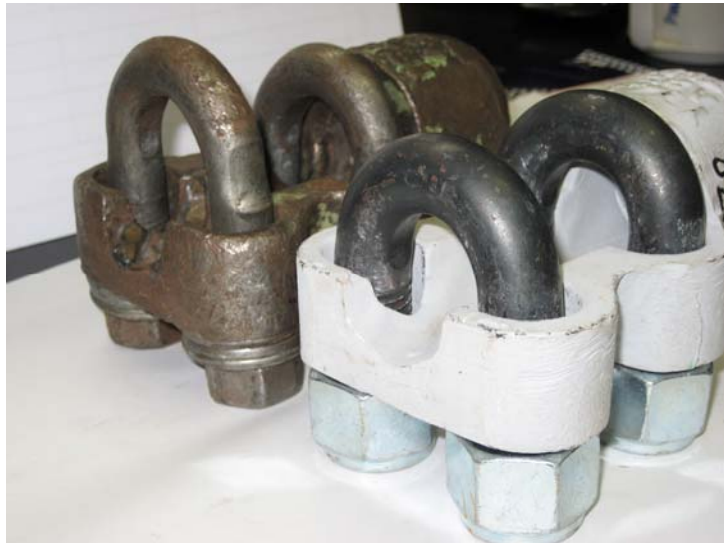
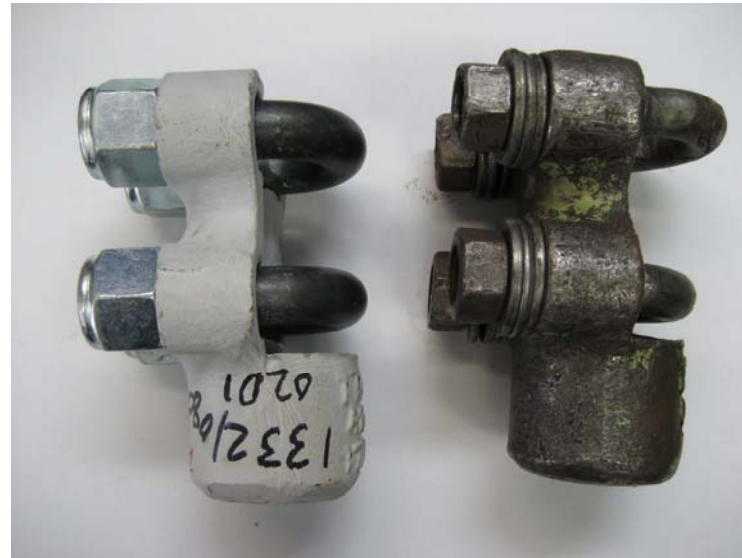
Photographs of knuckle types and comparison of failed vs. new knuckle.
