# High Arctic HSE PNG

Near Miss

Dropped Ring Spanner

22<sup>nd</sup> January 2008

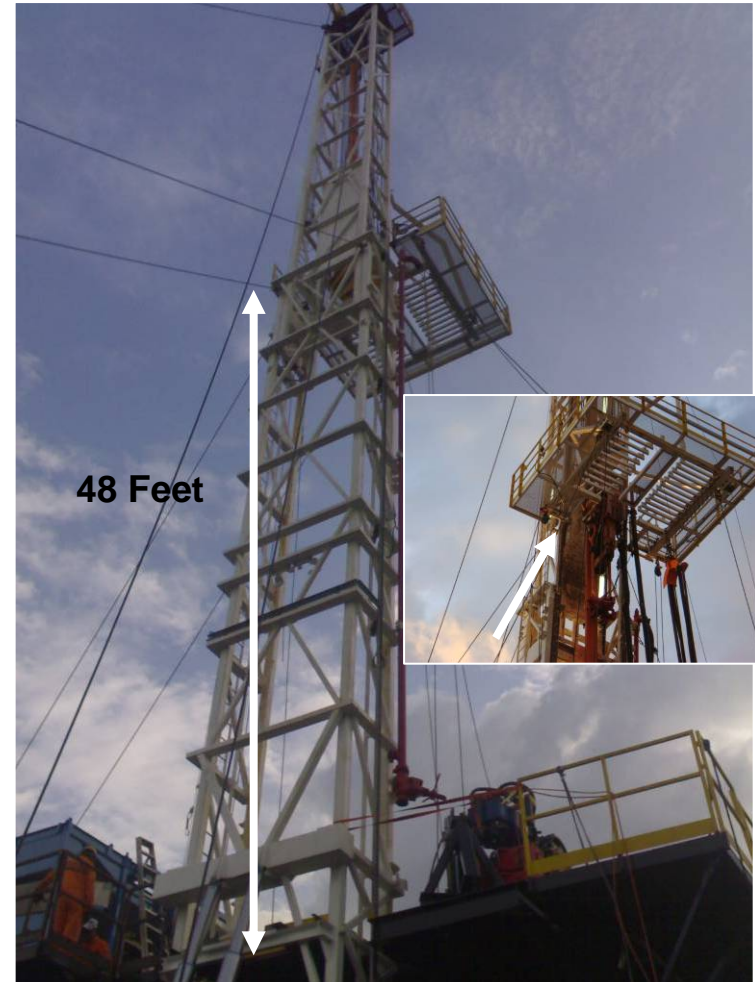
- The open ring spanner fell approximately 48 ft to the rig floor.
- Driller witnessed the spanner landing on the rig floor
- A Permit to Work was in place.
- The “Tool at Height Register” was not completed

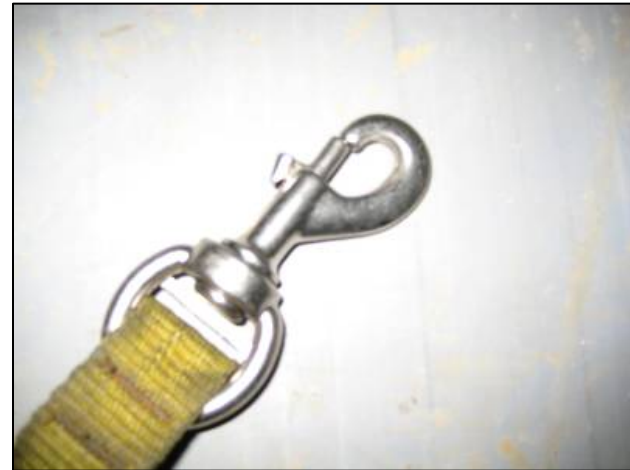
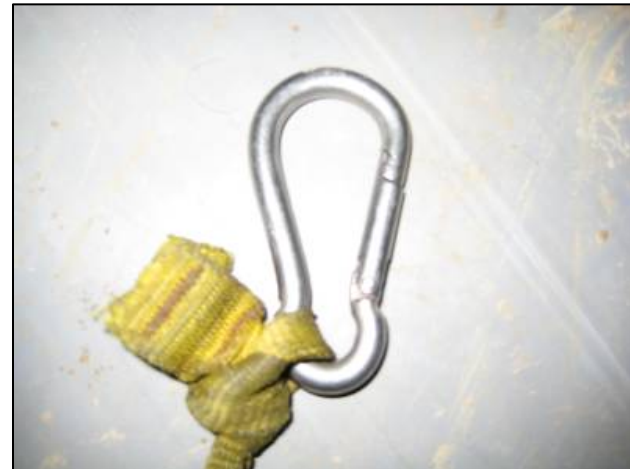
# Did the web lanyard fail?

- Speed clip end was attached to the tool
- The other end was attached to the Derrickman's harness

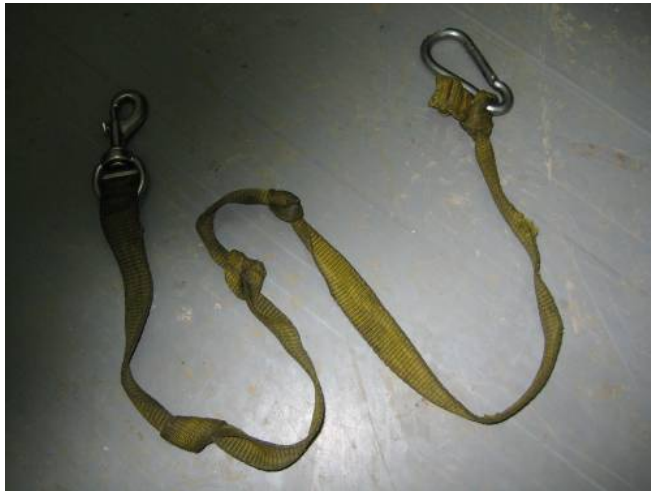
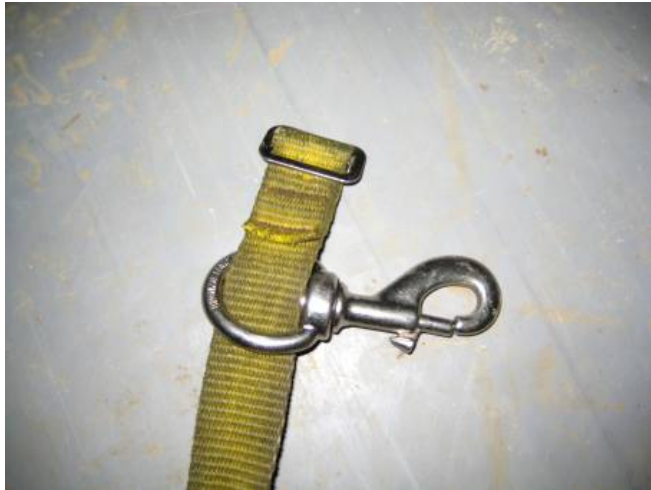
# It did fail but ????

Would you expect

- this quality of lanyard from a \$13,000 Drops
- Karibiner's tied on with knots
- Web lanyard loosely inserted through the speed clip eyelet that can easily slip out

- Home made lanyard removed from service.
- Held Awareness sessions with both crews on site about the incident and the use of the Drops Tool Box.
- Developed and assigned responsibilities within the Drop Program.
- Ordered new tool lanyards

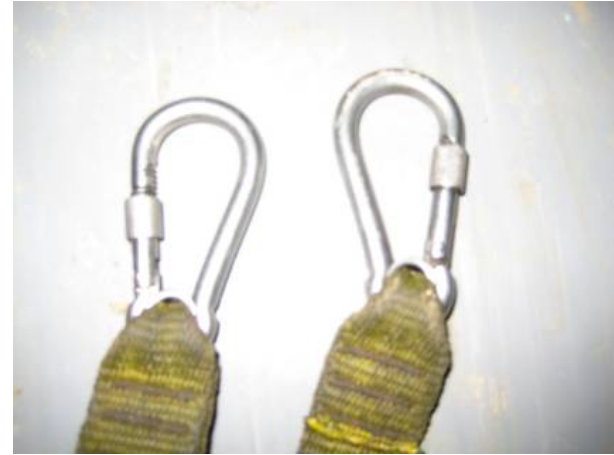
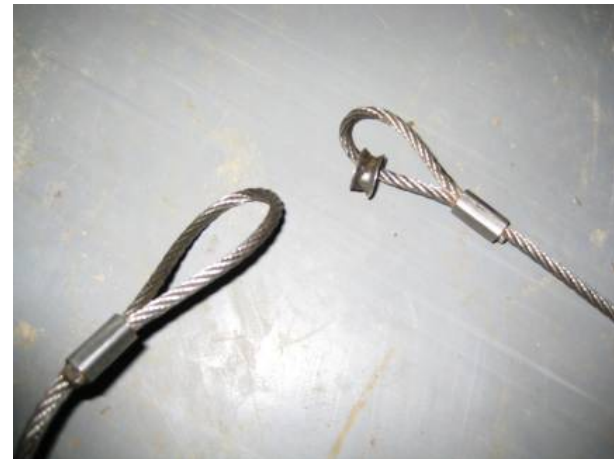
- This was not a OEM Tool Lanyard
- OEM Tool Lanyards are fitted with screw type locking Karibiner's at both ends
- The spring loaded Karibineer came from a wire safety line used to secure lights at heights

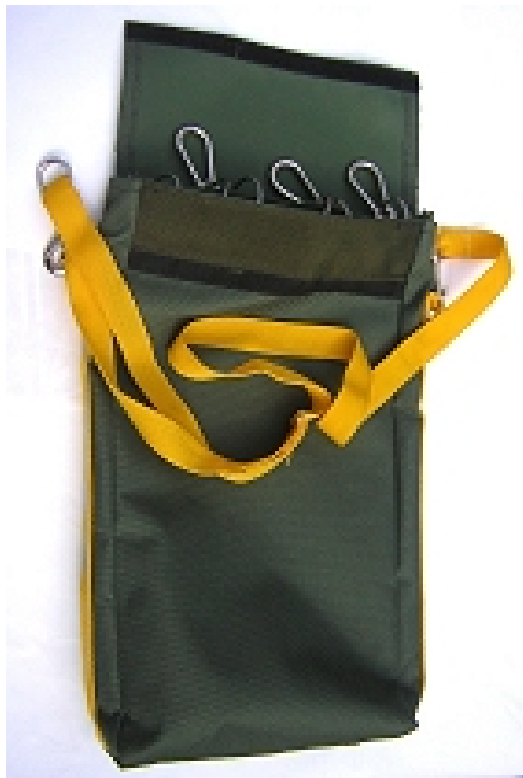
- The web lanyard used for the tool lanyard was the shoulder strap for the tool bag
- The tool lanyard with locking Karibineer's was attached to the tool bag
- The Tool lanyard used failed but it was **home made**, the **wrong tool for the job** and certainly **not fit for purpose**.
