UPDATE SM-07-048-LTA

**Crushed Finger
Injury**

06 November 2007

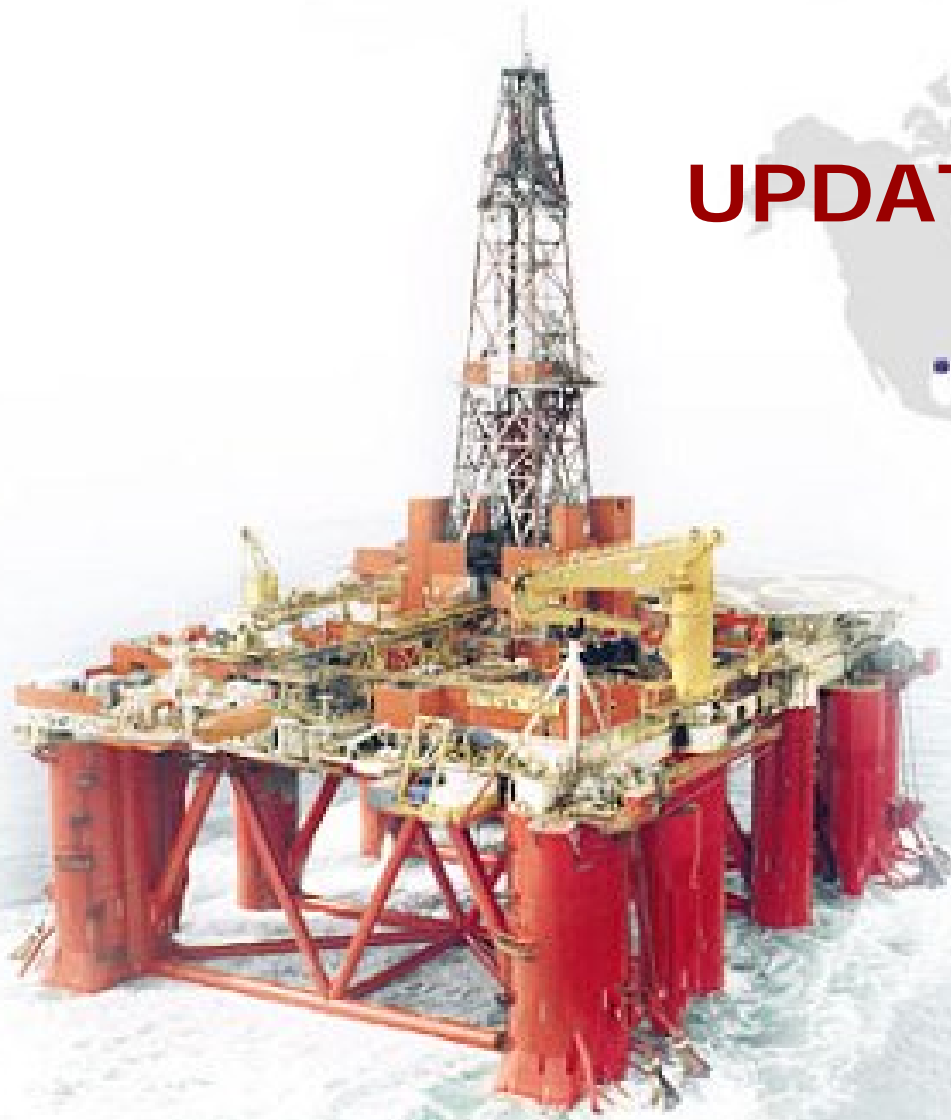
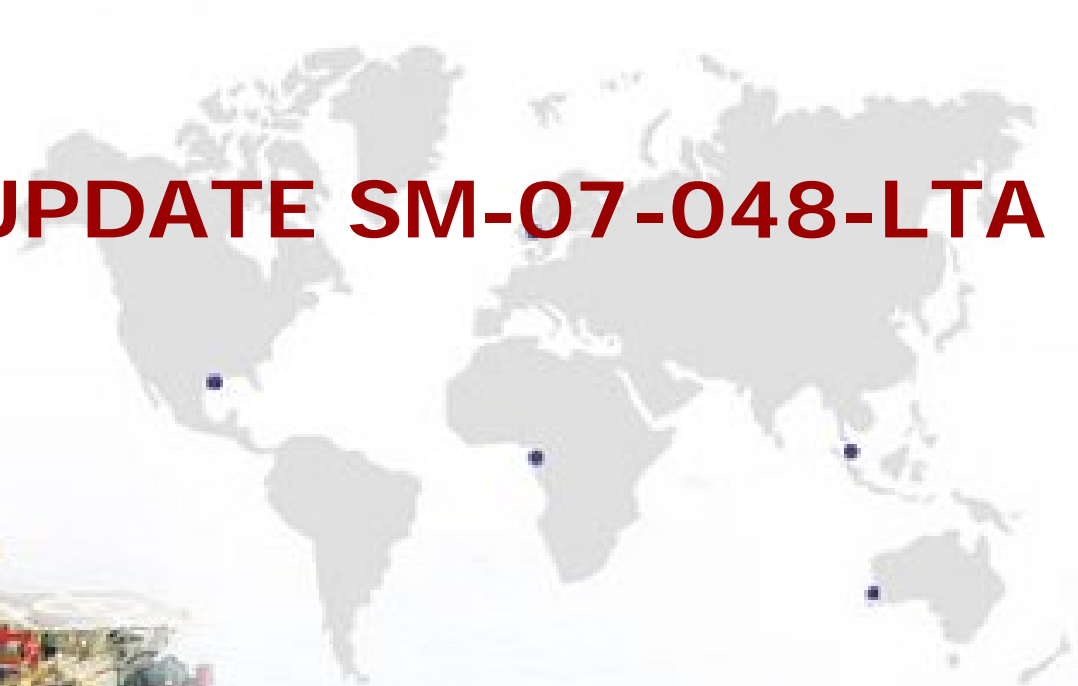
- **Who:** Derrickman
- **What:** Open fracture of the left ring finger
- **When:** 6 November 2007 at 17:55 hrs
- **How:** The Derrickman sustained a serious crush injury to his left hand ring finger during man riding activities to remove the marine riser tensioner cables from the Riser Tensioner Ring (RTR).
- **Why:** During the release of pressure from the Marine Compensators (a process required to ease the tension on the tensioner cables prior to removing the RTR clevis pins), the IP inadvertently placed his left hand ring finger between the load ring retainer brackets and slip joint.
- **NB** Tension on the marine compensator cables raises the RTR thereby creating a pinch point gap when the air pressure released.
