Stena Clyde

Engine Room Fire
20th October 2007

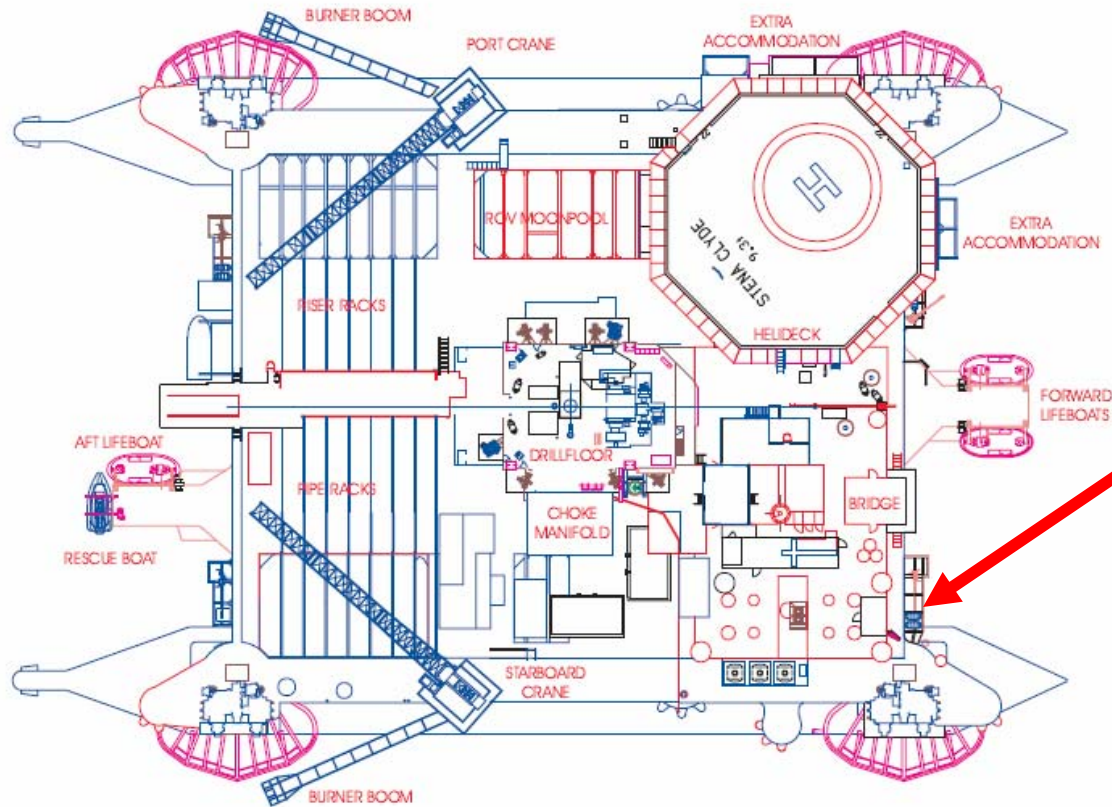
Detail of Area

The initial fire alarm was initiated by an automatic thermal detector in the engine room, which houses 4 engines. The fire was reported as being located between and/or behind engines 2 and 4.

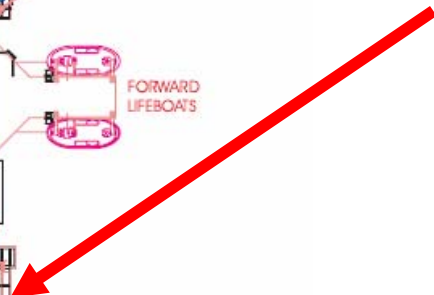
Engine room is located STBD fwd location.

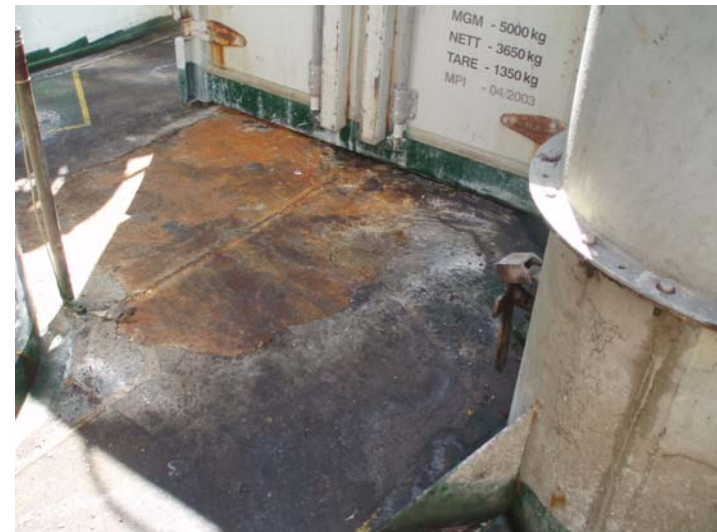
Fire team 1 entered the engine room to fight the fire and fire team 2 were directed to the roof of the engine room for boundary cooling, where equipment was stored (top deck).

Fire water pressure was initially lost and shortly afterwards both teams did attempt to provide boundary cooling.

Standby vessel Pacific Ariki, was called in and did provide boundary cooling on the engine room roof as directed by personnel on the rig. In the process however the satellite dome and all Vsat comms were knocked out..

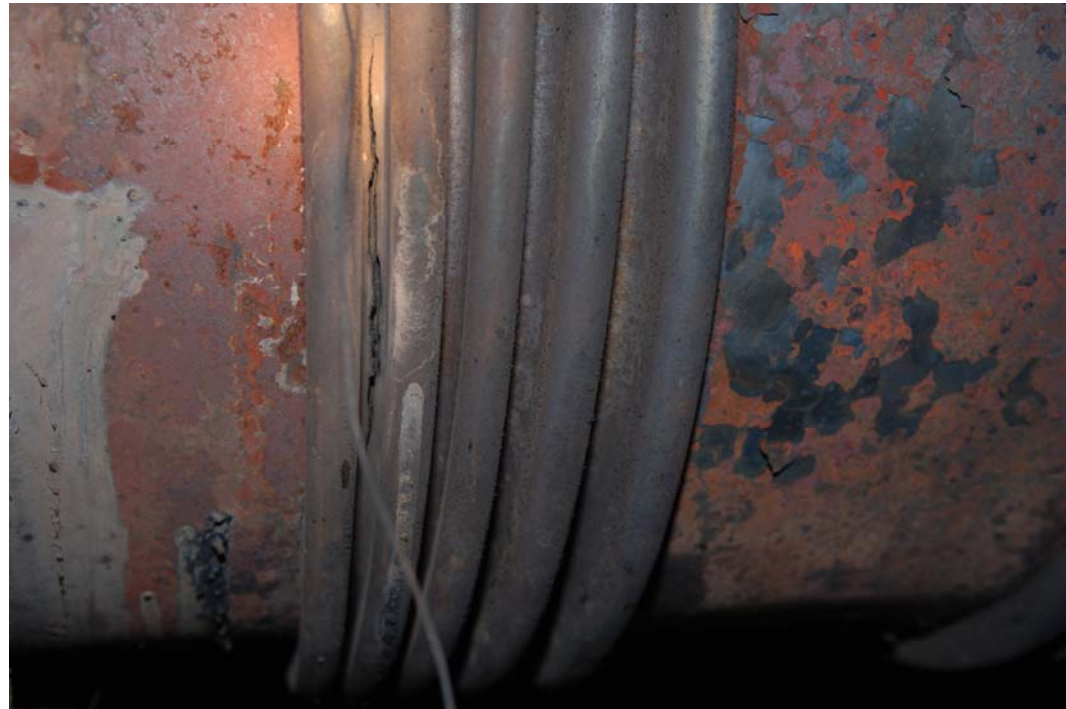
Fire investigation team found the probable cause of the fire to be a crack within the exhaust bellows where the radiant heat created combustion of the thermal insulation fixed in the ceiling area.

- Increase awareness of importance of criticality based preventive maintenance:
- Inspection of bellows is now a PM
- Align rig MAE to ERP and SCE ... and PM prioritisation.
- Review bowties and add into VSC.
- 3rd party was brought in to assess fire fighting competencies.
