## **LTI Injury to Biceps – S703 – Nov 30 2007**

**Stuart Douglass / Gary Jones**

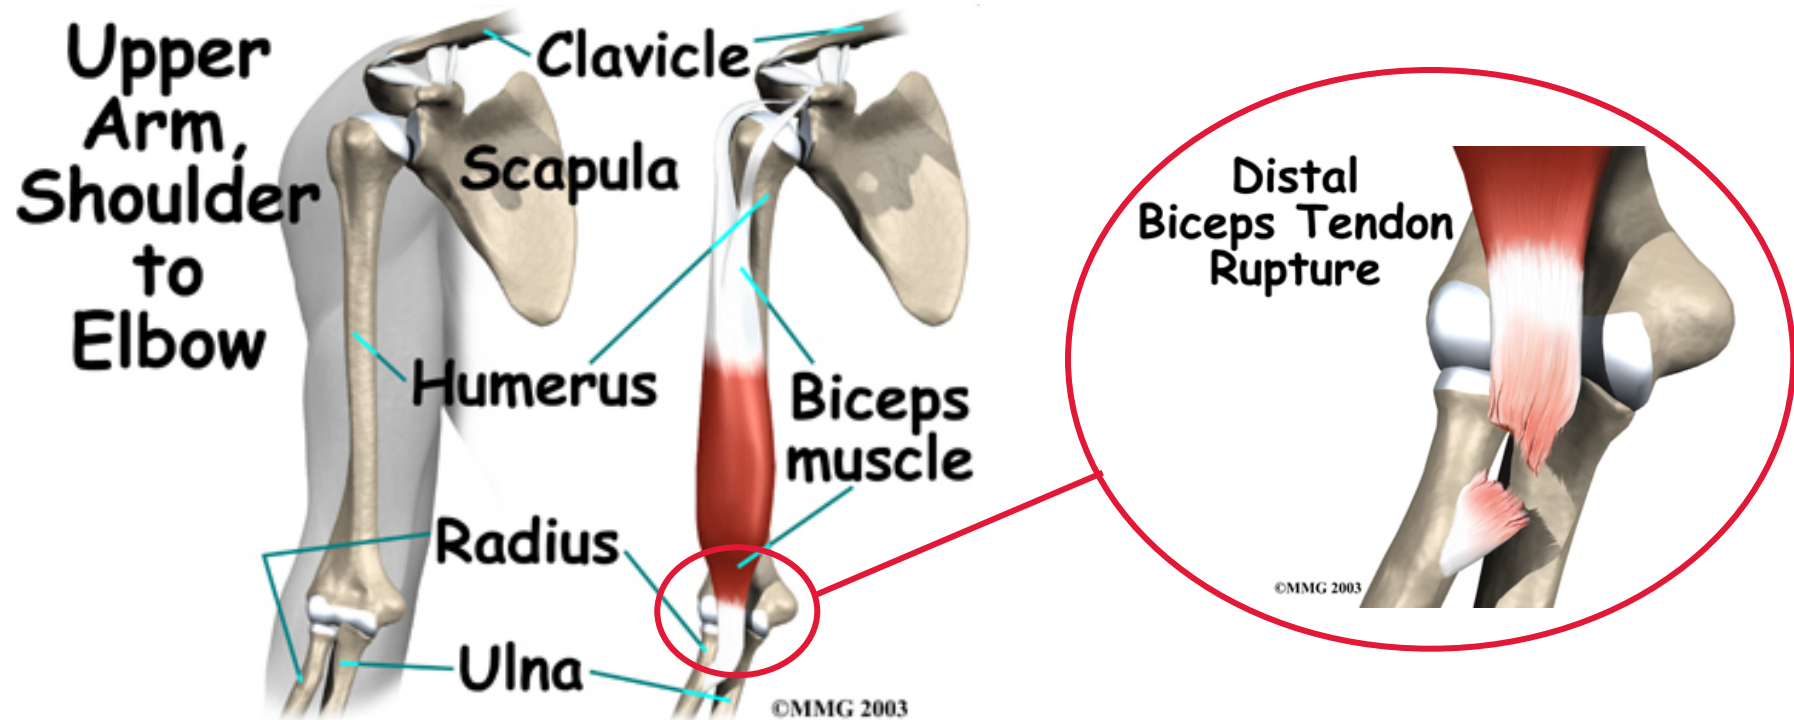
## The Injury

**The tendon that connects the Biceps muscle to the Ulna below the elbow ruptured. This must be reconnected using surgery.**

**Six to Eight weeks of intensive post operative physiotherapy are followed by a further four months of gradually increasing workload before full functionality is restored.**
