Near Miss

Dropped 13 3/8 inch Casing

6th November 2008

DrillSafe Forum Presentations - Perth Western Australia – 5th Mar 09

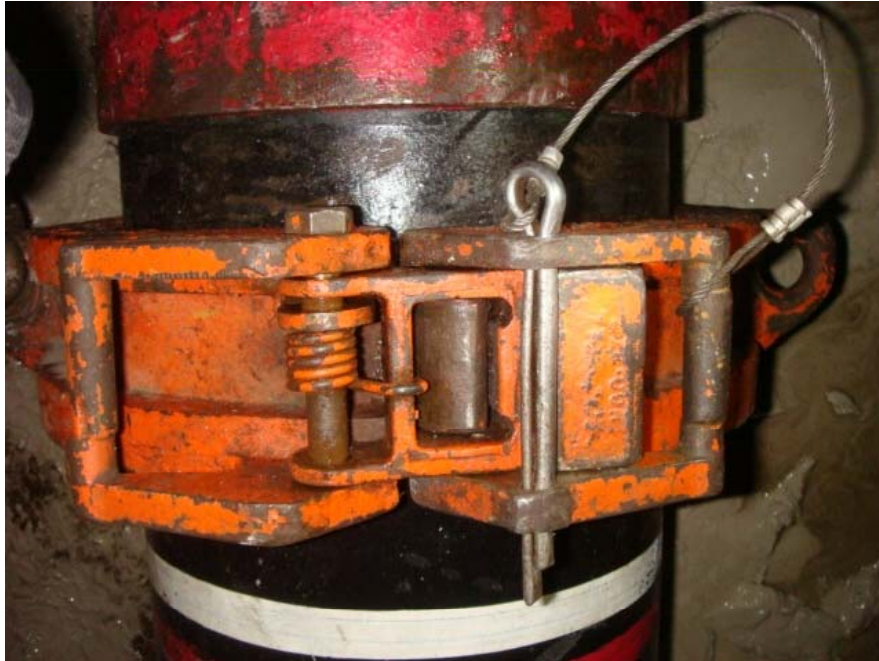
Correct latching - not possible to open without there being signs of damage to the pin and latch.

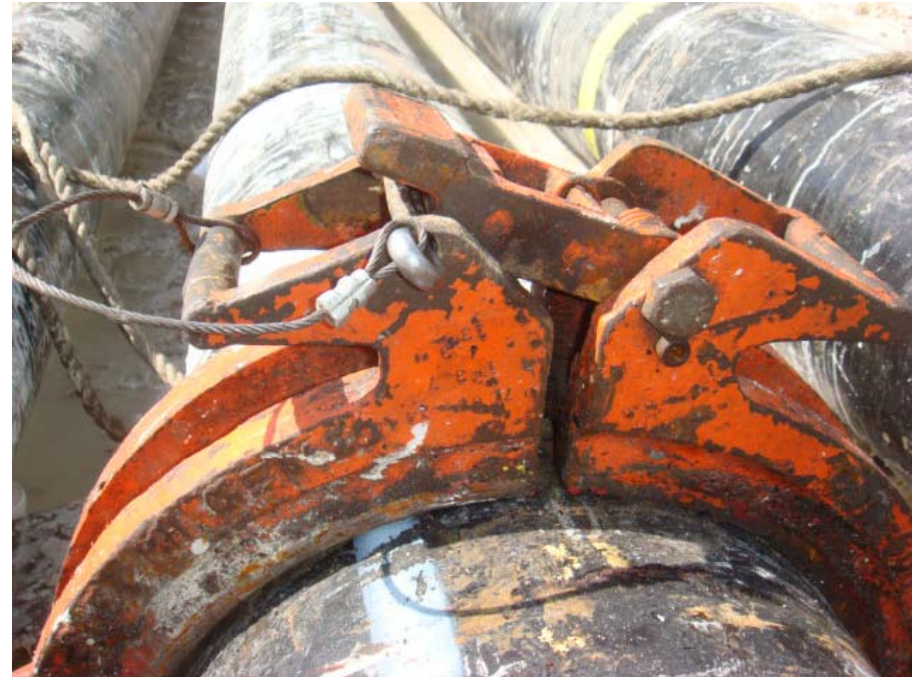
Incorrect latching - partially latching still allows the latch to bite and for the pin to be inserted behind the latch.

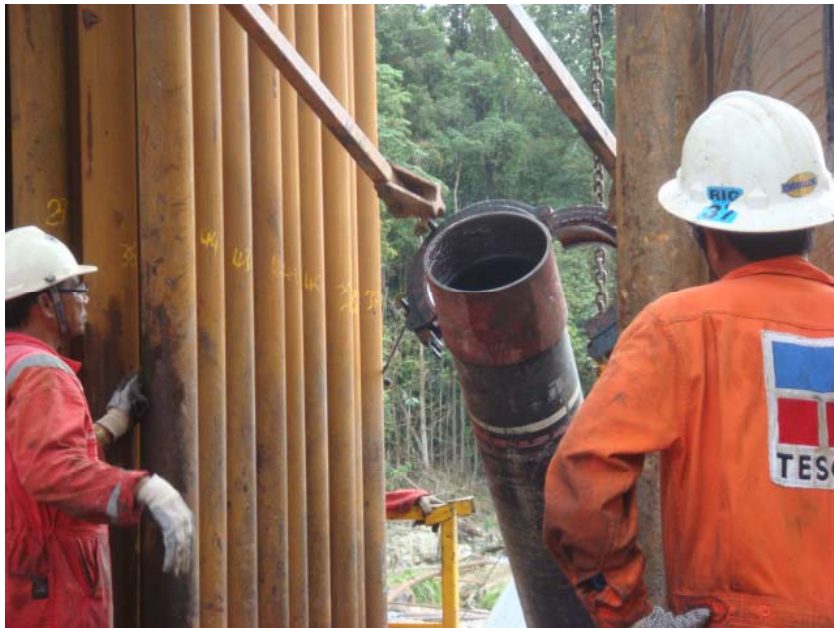
Elevators being latched from above the casing.

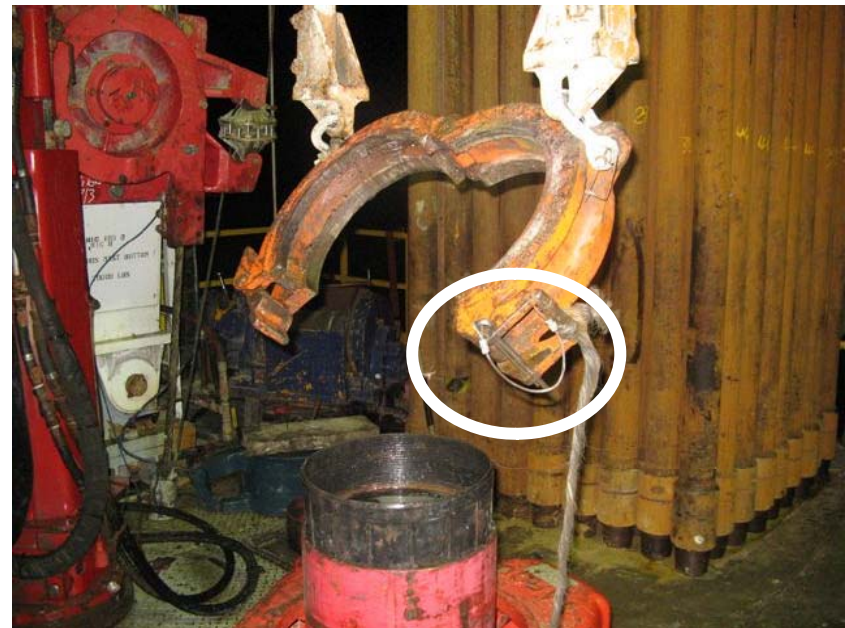
Immediately after the incident note safety pin still inserted.

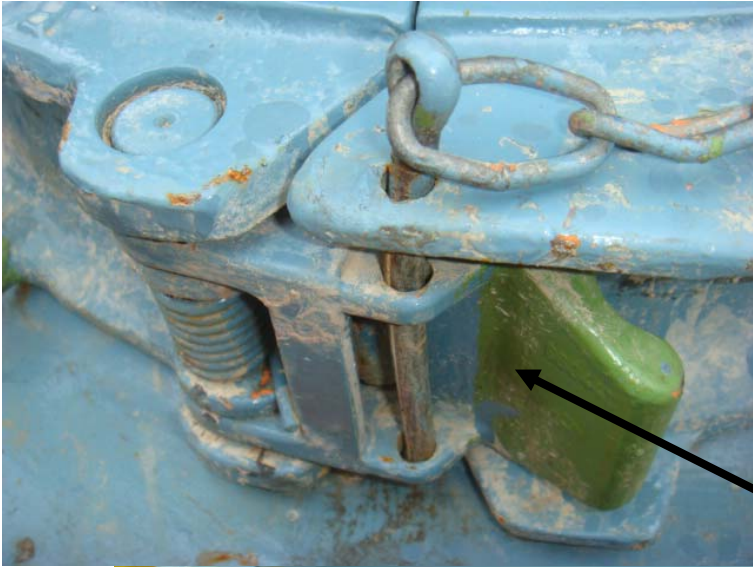
Blohm and Voss SGE.
Note pin through latch.

- The Tesco used Den-Con elevators were immediately replaced with HAES Blohm and Voss single joint elevators.
- HAES Blohm and Voss Elevators are considered a better design and must be latched to insert the pin.
- **DEN-CON Elevators DID NOT FAIL. The incident was caused by a lack of situational awareness – error induced.**
- A Pre Job Meeting was held and recorded.
- A generic JSA running casing was reviewed. This was a HAES JSA and there was no mention of second checks on the elevator latching nor any reference to checking the safety pin.
- A Tesco JSA on site at the time did have the above hazards mentioned.
- The rig was not equipped with any form of secondary safety device to prevent drill pipe, casing etc. from sliding down the v-door.
- Crews were taken regularly breaks.

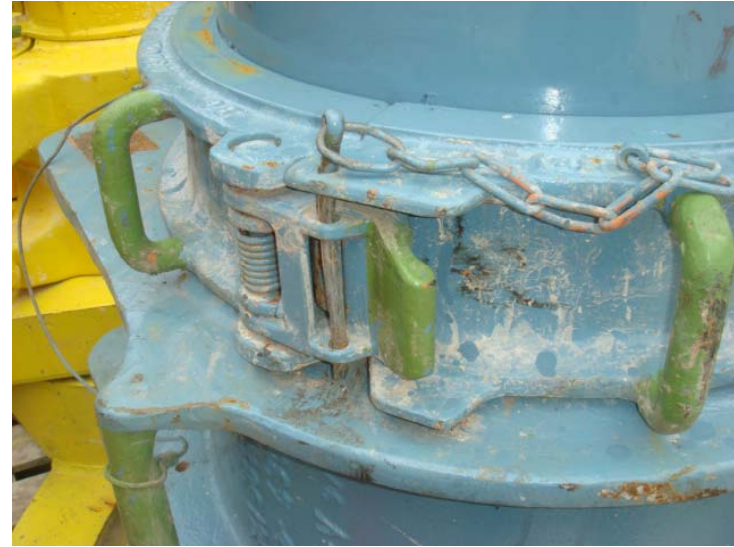
Note able to insert pin
when open

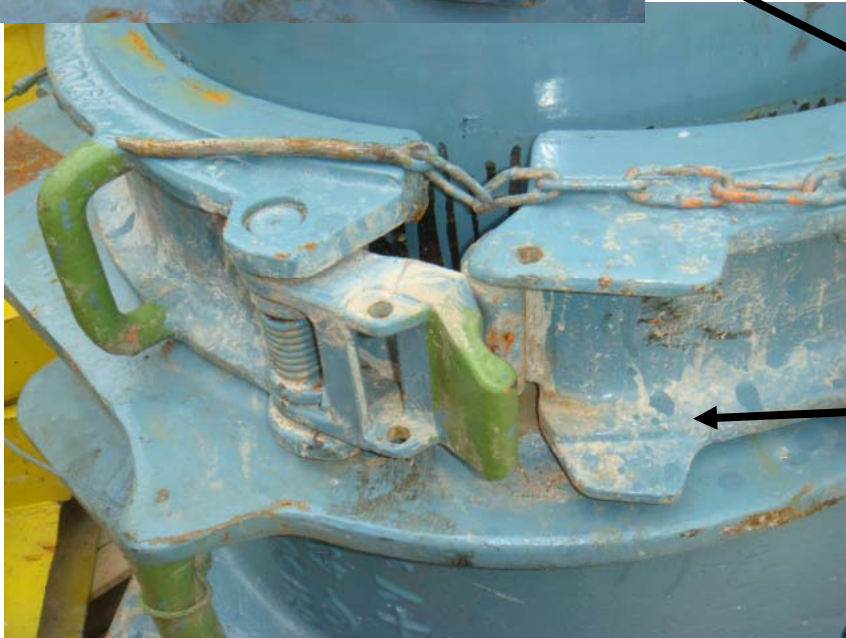
Pin has been tack welded
at top and bottom to
make single pin

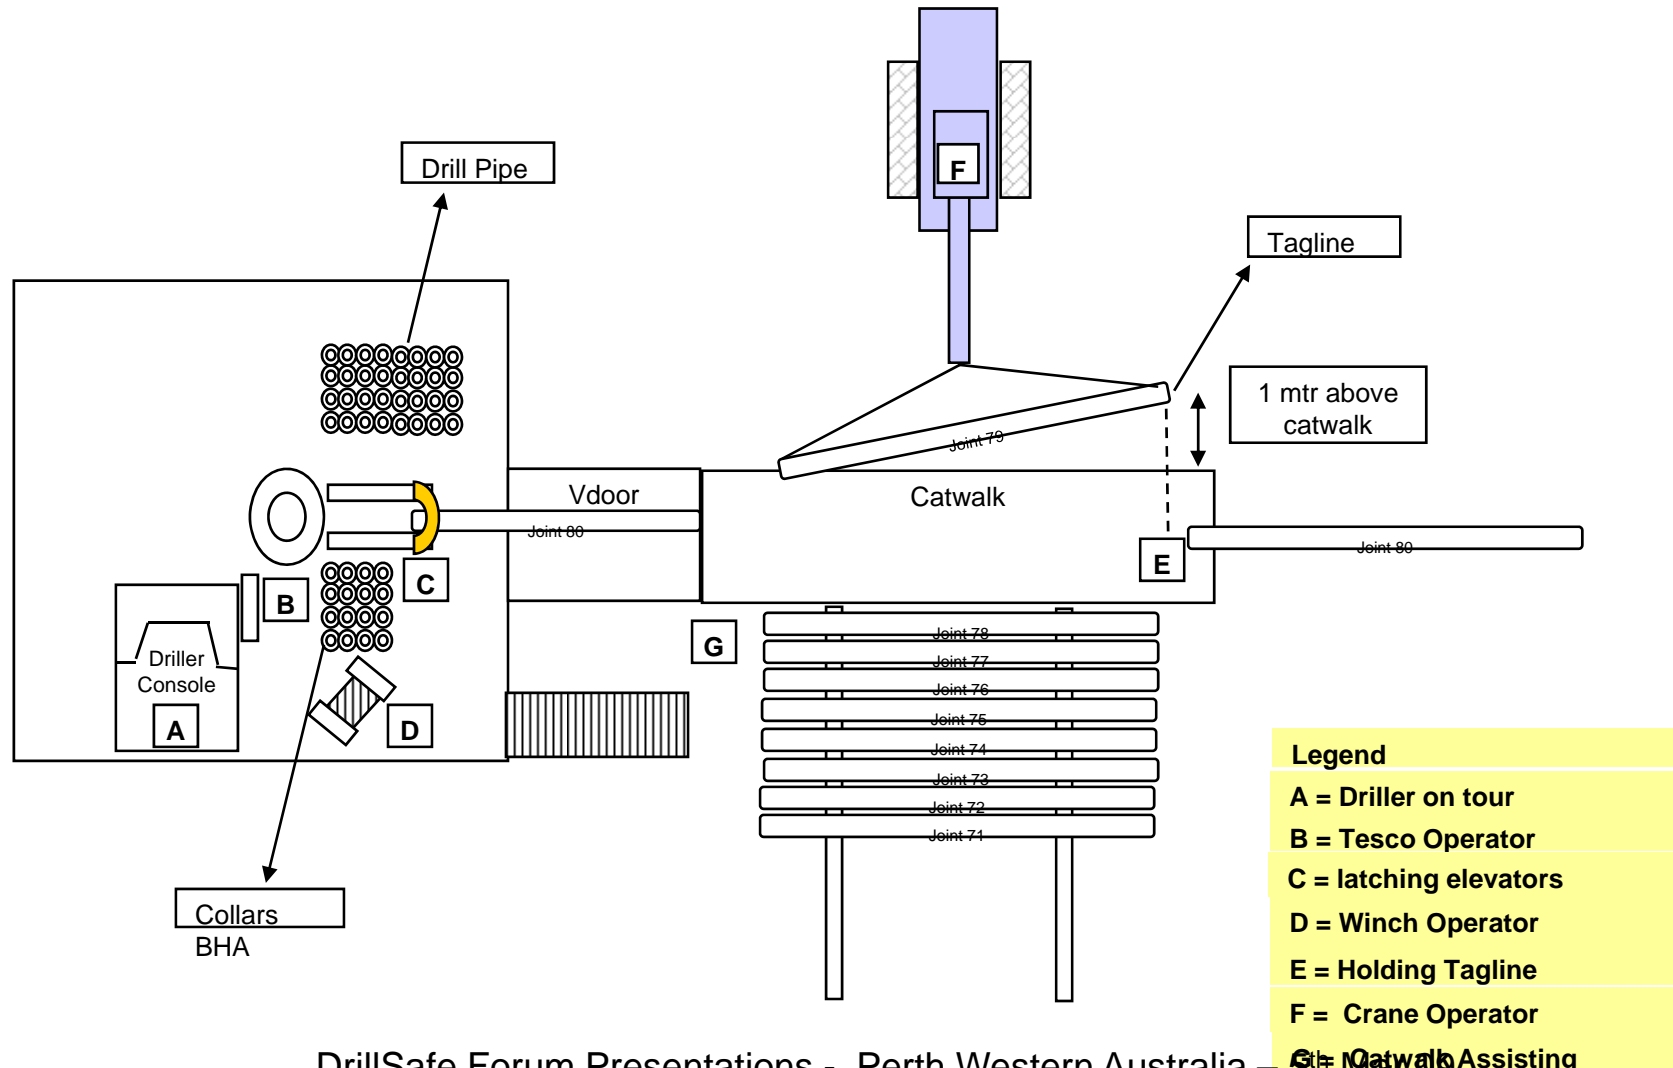
Rig Floor Layout

- A crew member was on the catwalk when the casing was released
- Crew on tour had run 60 joints of casing prior to the incident.
- The crew and Driller were considered competent.
- Driller view to the elevators or v-door was obstructed by the racked 16 inch BHA.
- The safety pin was retained in the elevators after the casing was released.
- There was no noticeable damage to the elevators, latching device or safety pin.
- It is not possible for the latching device on the elevators to open if they are latched correctly and the pin is inserted correctly
- It is fully possible too not fully latch the elevators and then place the safety pin in behind the latch.
- The person who latched the elevators believed they were latched correctly

1. Utilise the HAES Blohm and Voss SGE as they have a better designed latching device.
2. Ensure pipe is racked in the derrick which allows the Driller a clear visual. Where this can not be achieved pipe is to be layed out.
3. Design and fabricate a catwalk stopper to prevent pipe moving down the catwalk in the event of a human error again.
4. Update JSA to rig specific and include learning from this incident i.e. double check latch closed, pin inserted correctly and vdoor stopper in use when fabricated.
5. Develop and distribute an industry wide Safety Alert through IADC.
