Support Vessel Incident

Laceration To Head

Steve Furze, 5 March 2009

Support Vessel Incident – 9th Oct 08

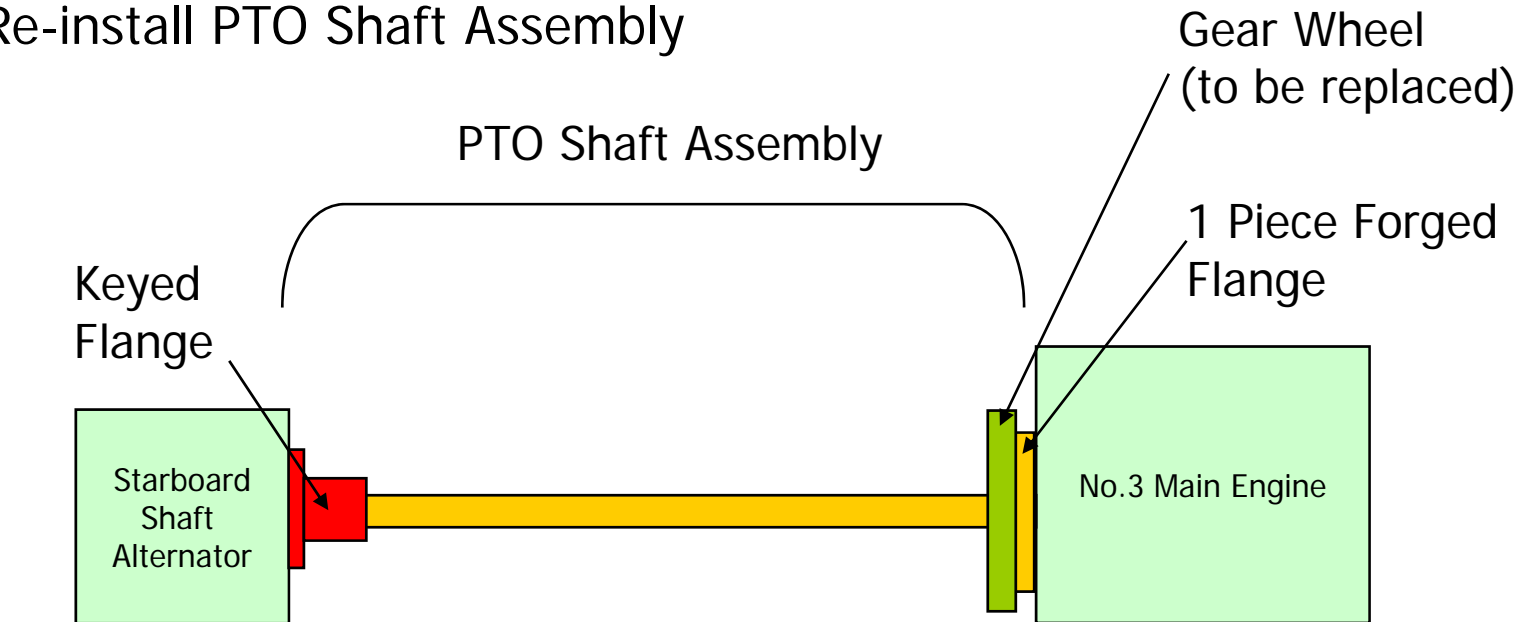
Power Take Off Shaft Arrangement

- Replace gear wheel drive for the No.3 Main Engine lubricating oil & fresh water pumps.
- Wheel is fitted to a Power Take Off (PTO) shaft positioned between the No.3 Main Engine and the starboard shaft alternator.
- Entire shaft assembly must be removed to replace the gear wheel.
- A keyed flange must be removed from one end of the shaft and re-installed after replacing the gear wheel.

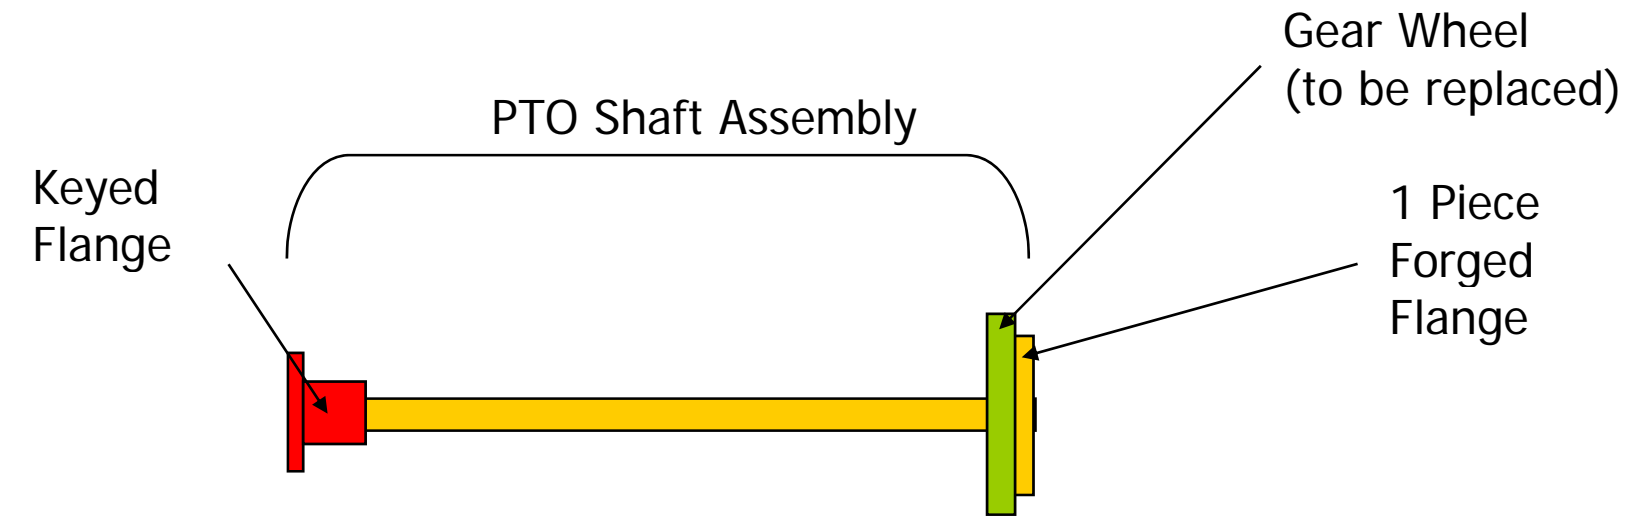
- Removal of the keyed flange had proven more difficult than expected, heat and hydraulic jacks were required.
- Change out gear wheel.
- Re-installation of the keyed flange onto the PTO shaft commenced at 15:00 hrs Thursday 9th October.
