# **West Atlas**

## **Near Miss**

**20<sup>th</sup> January 2009**

**Parting of Monkey Board Tugger Wires**

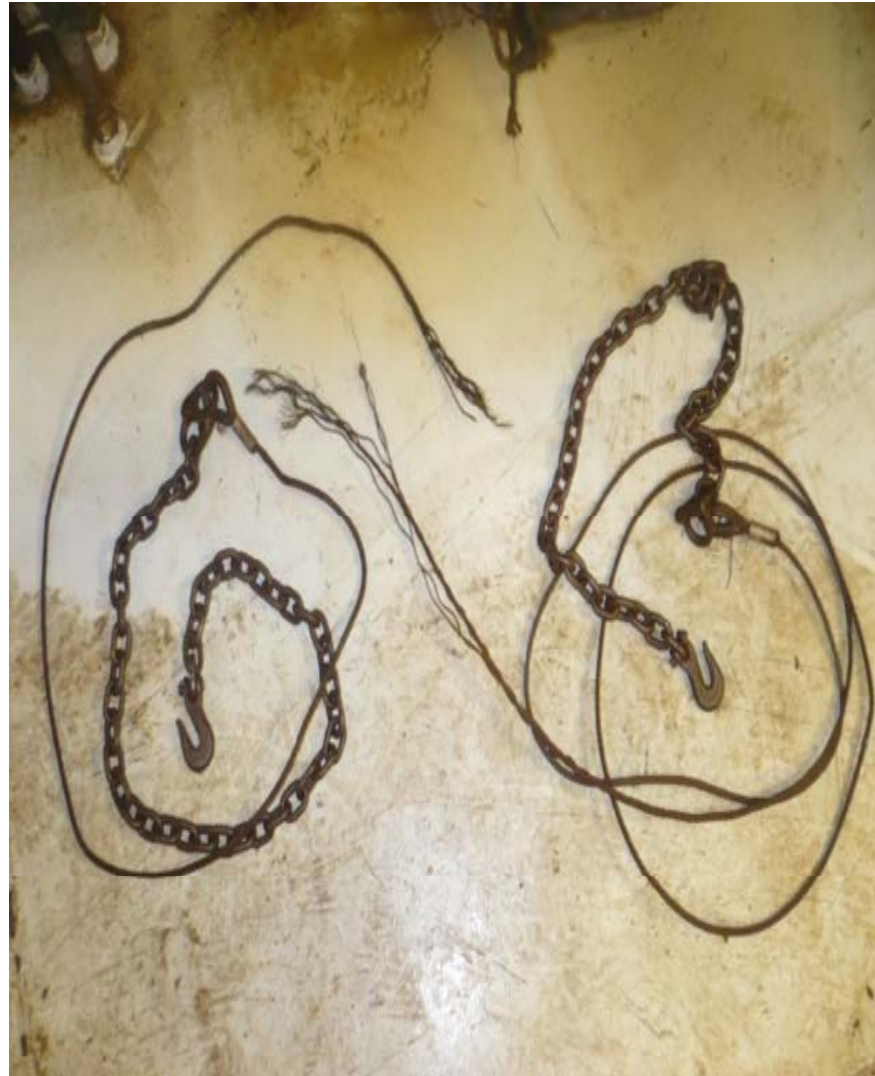
## West Atlas parted derrick winch wires

TapRoot was used to investigate this incident during which both derrick mounted air winch wires and associated chains parted falling approx 90' (27m) to the rig floor.

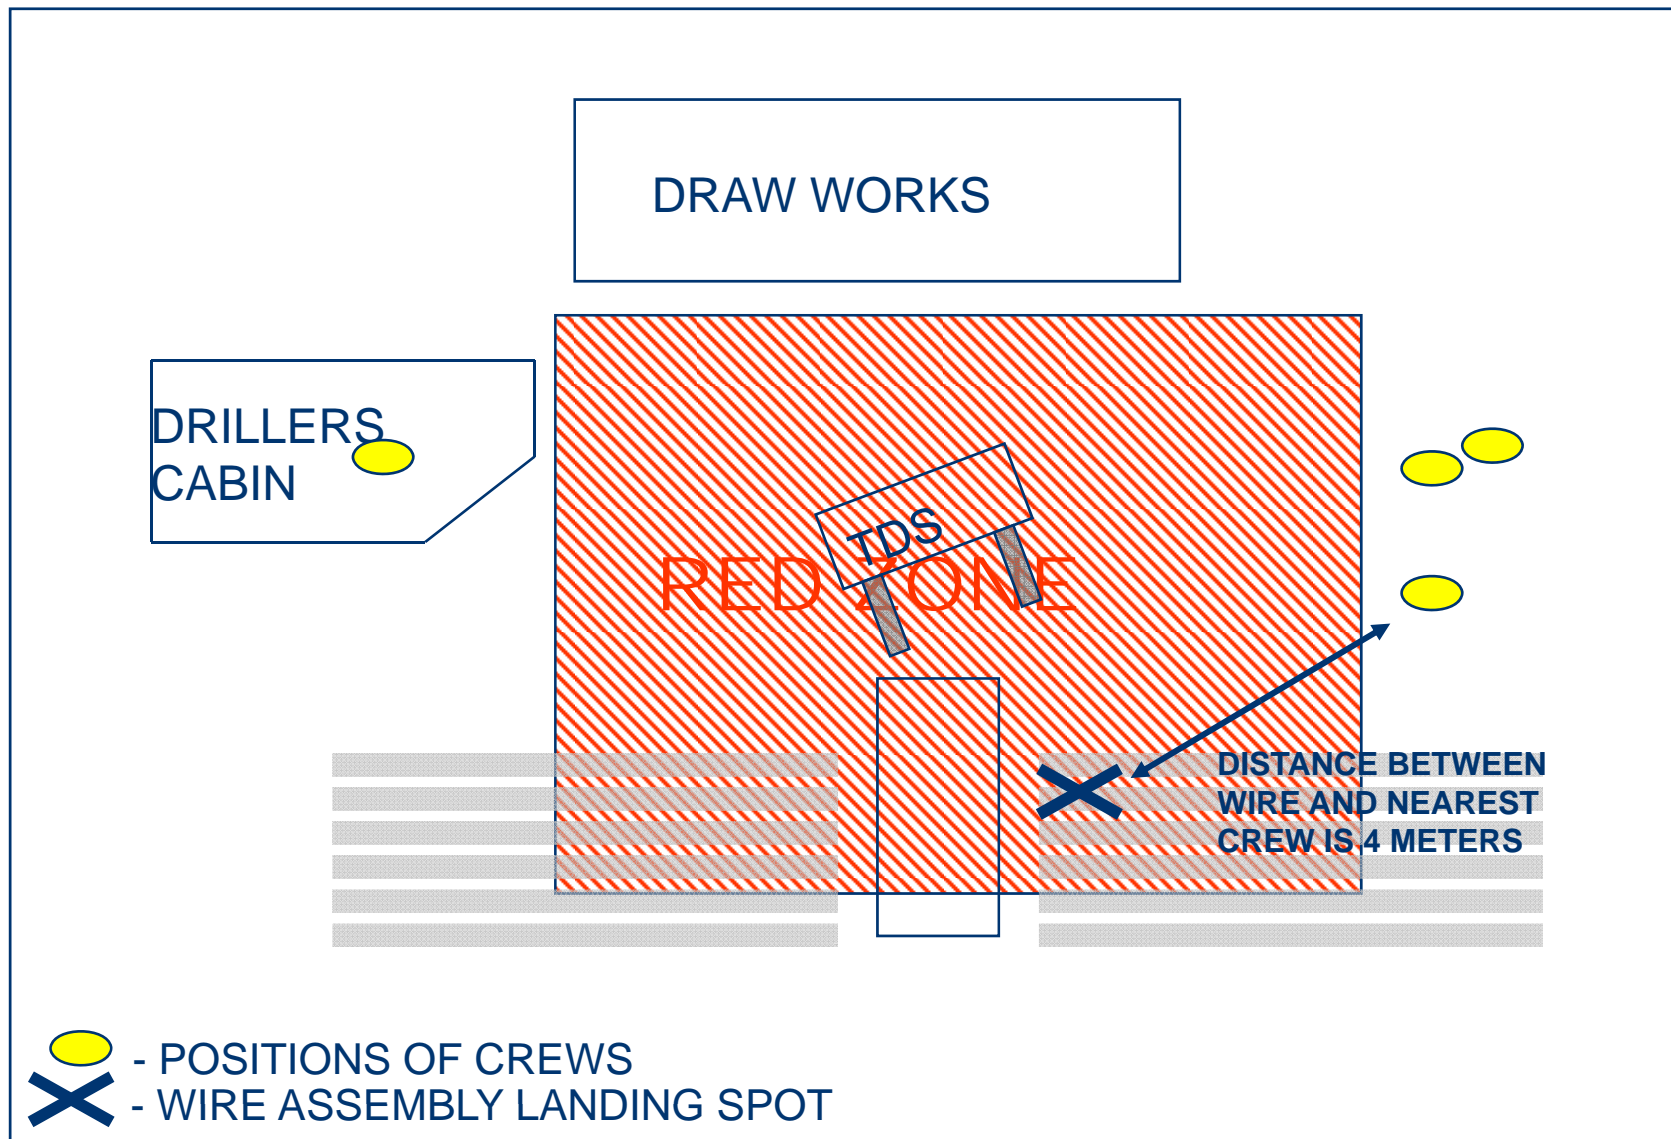
## POSITIONS OF CREWS ON THE RIG FLOOR WHEN FIRST WIRE ASSEMBLY FELL

While guiding the BHA into the elevators with the two monkey board tuggers, the forward tugger wire parted allowing a section of wire and the chain to fall onto the forward set back area.

The drill collar came to rest against the monkey board.

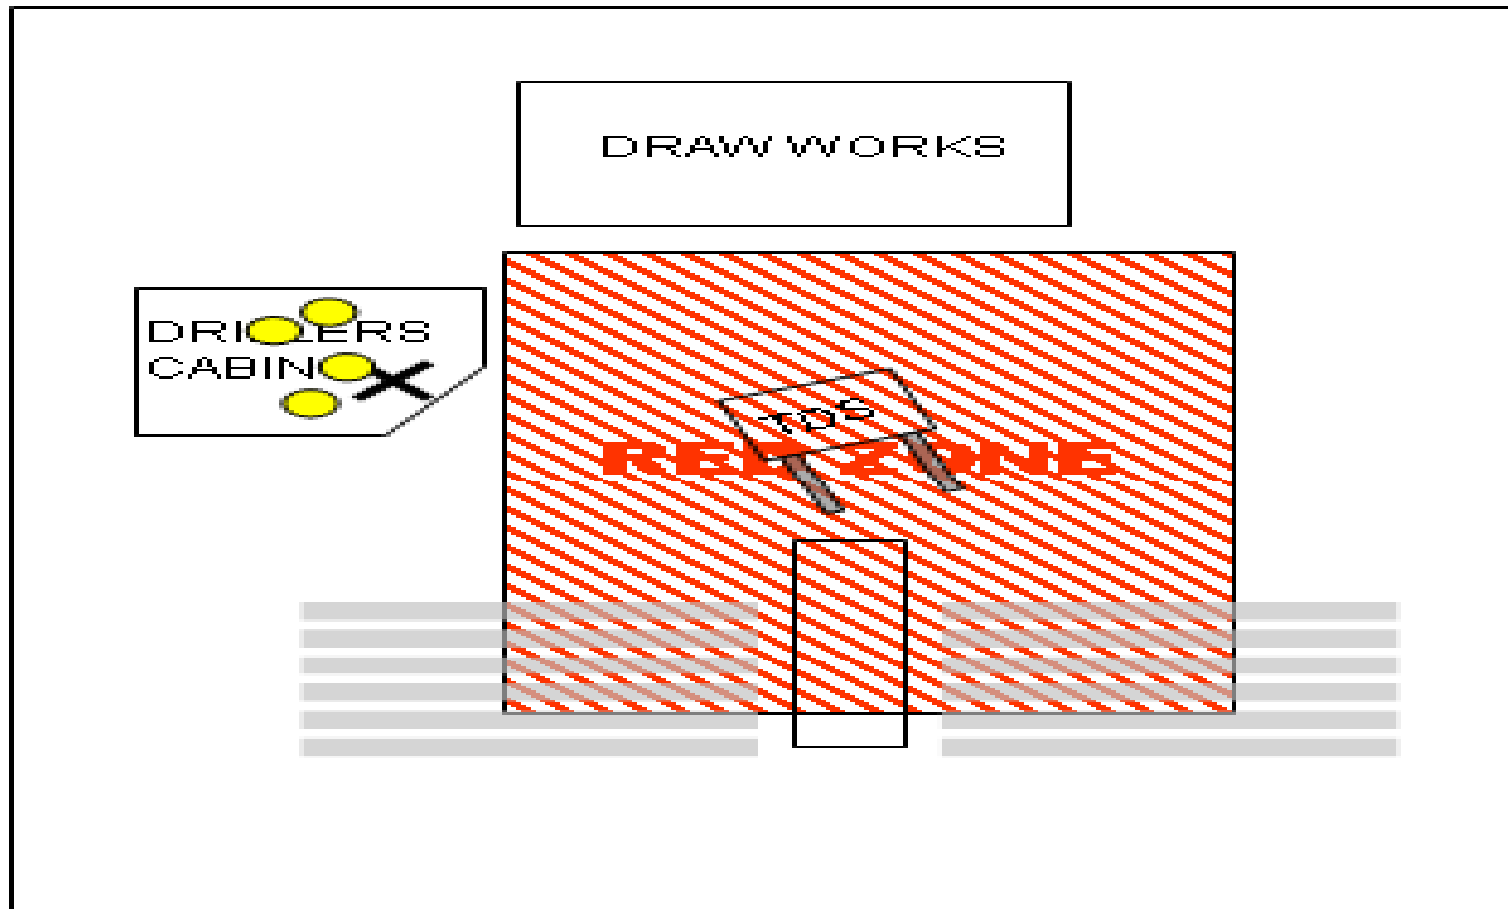
POSITIONS OF CREWS ON THE RIG FLOOR WHEN  
SECOND CHAIN ASSEMBLY FELL ONTO THE FLOOR

This motion over loaded the aft tugger wire which parted allowing the stand to fall across derrick and the second section of wire and chain to fall onto the driller's cabin roof damaging a glass panel.

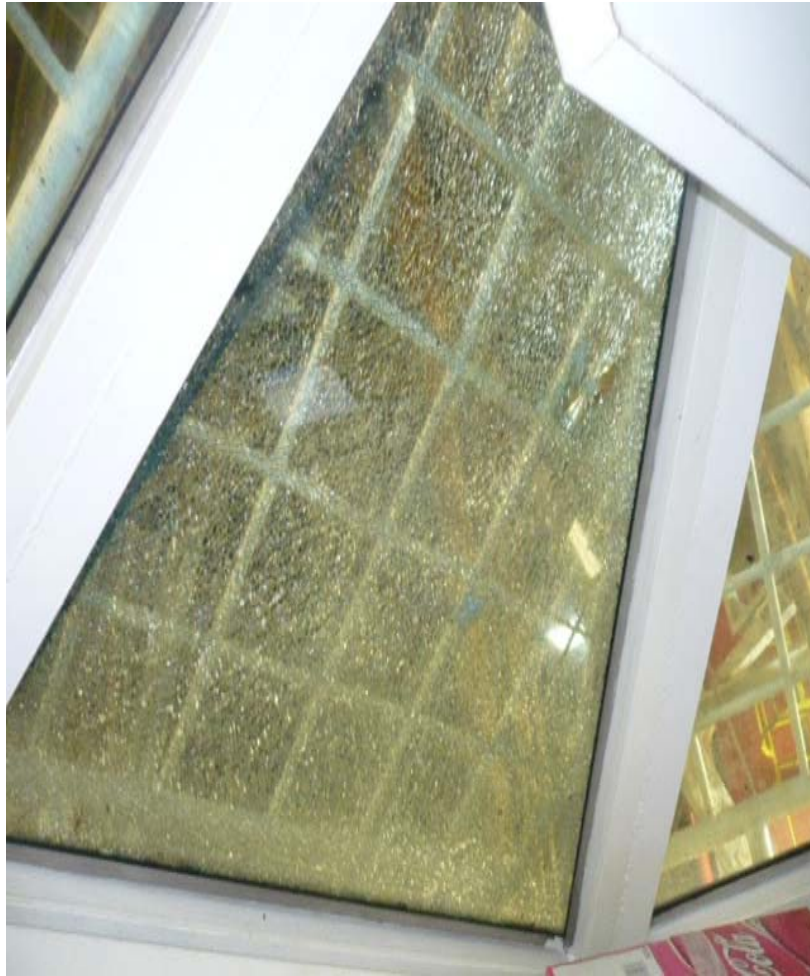
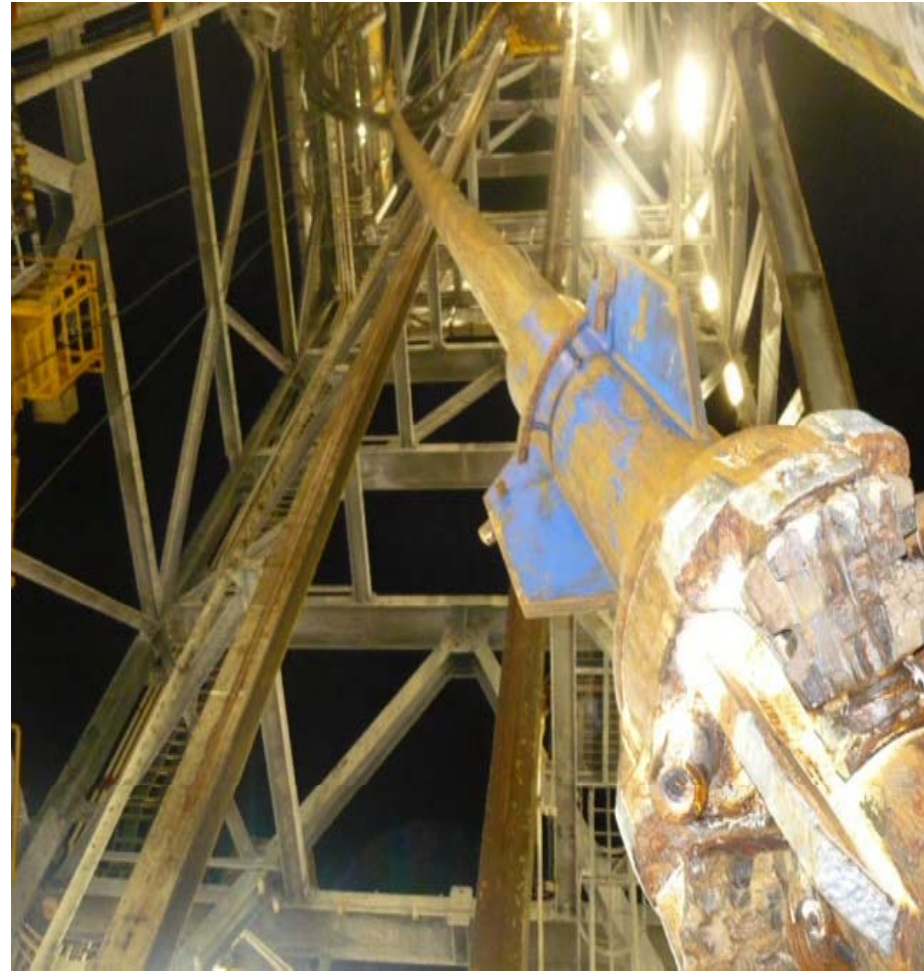
## West Atlas parted derrick winch wires

- All personnel were clear of the area and compliant with the Red Zone – there were no injuries
- The tugger wires showed significant signs of deterioration
- The monkey board tuggers are rated at 1,000 lb line pull
- NOV compact racking system had been decommissioned and the ability to safely rely on the 1,000 lb tuggers had been overlooked
- The BHA, a stand of 9 1/2" drill collars 37m' tall, was on the limit of the monkey board winches capacity assuming the wires were in good condition.

- ✓ Ensure all modifications to rig equipment, including decommissioning, is managed under the MOC process
- ✓ Operational procedures reviewed and amended to include a thorough visual inspection of tugger wires and jewellery prior to starting operations in the derrick
- ✓ Coaching of supervisors to lower risk acceptance and emphasise incident reporting expectations
- ✓ Maximum 'routine' racking height for BHA components now limited to 33.5m unless under PTW
- ✓ Engineering study commissioned to investigate upgrade of derrick tuggers
- ✓ Tugger wires to be changed out on a minimum 3 monthly period or sooner if condition dictates
