Stena Clyde

Pod line tensioner failure

The Incident

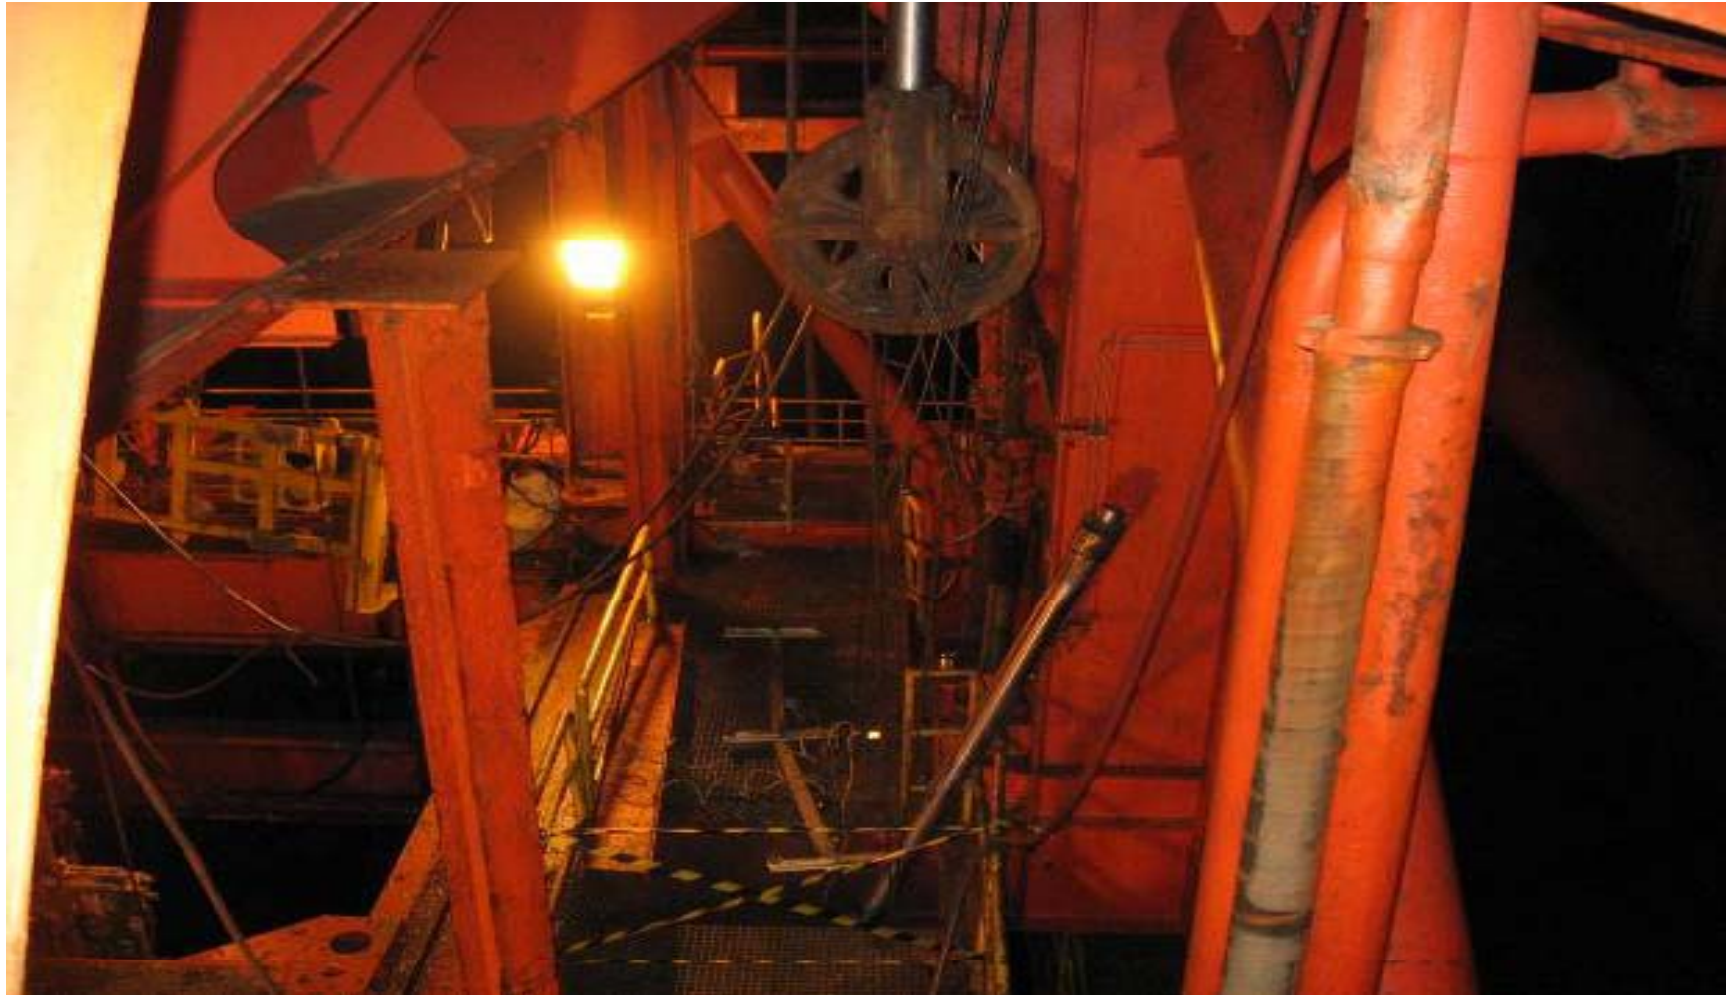
- 23rd October 2008 - The blue Pod line support wire parted in the tensioner system and the blue Pod line storm loop and saddle (see photo) falls into the sea.
- The tensioner piston strokes down rapidly, shearing the bottom securing bolts of the neck bush housing assembly, allowing the rod and piston assembly to fall to the lower moonpool deck.
- Upon inspection it was observed that the wire had parted at the tensioner turn down sheave, due to wire fatigue. The BOP had been deployed some three months prior to this incident, rendering the normal procedure of changing the wear points, by slipping and cutting the wire impossible.
- When the wire parted the piston should have stroked out and the travel speed should have been restricted by the flow of oil through the control orifice. In this instance, the correct sequence of events did not take place due to insufficient fluid in the system.

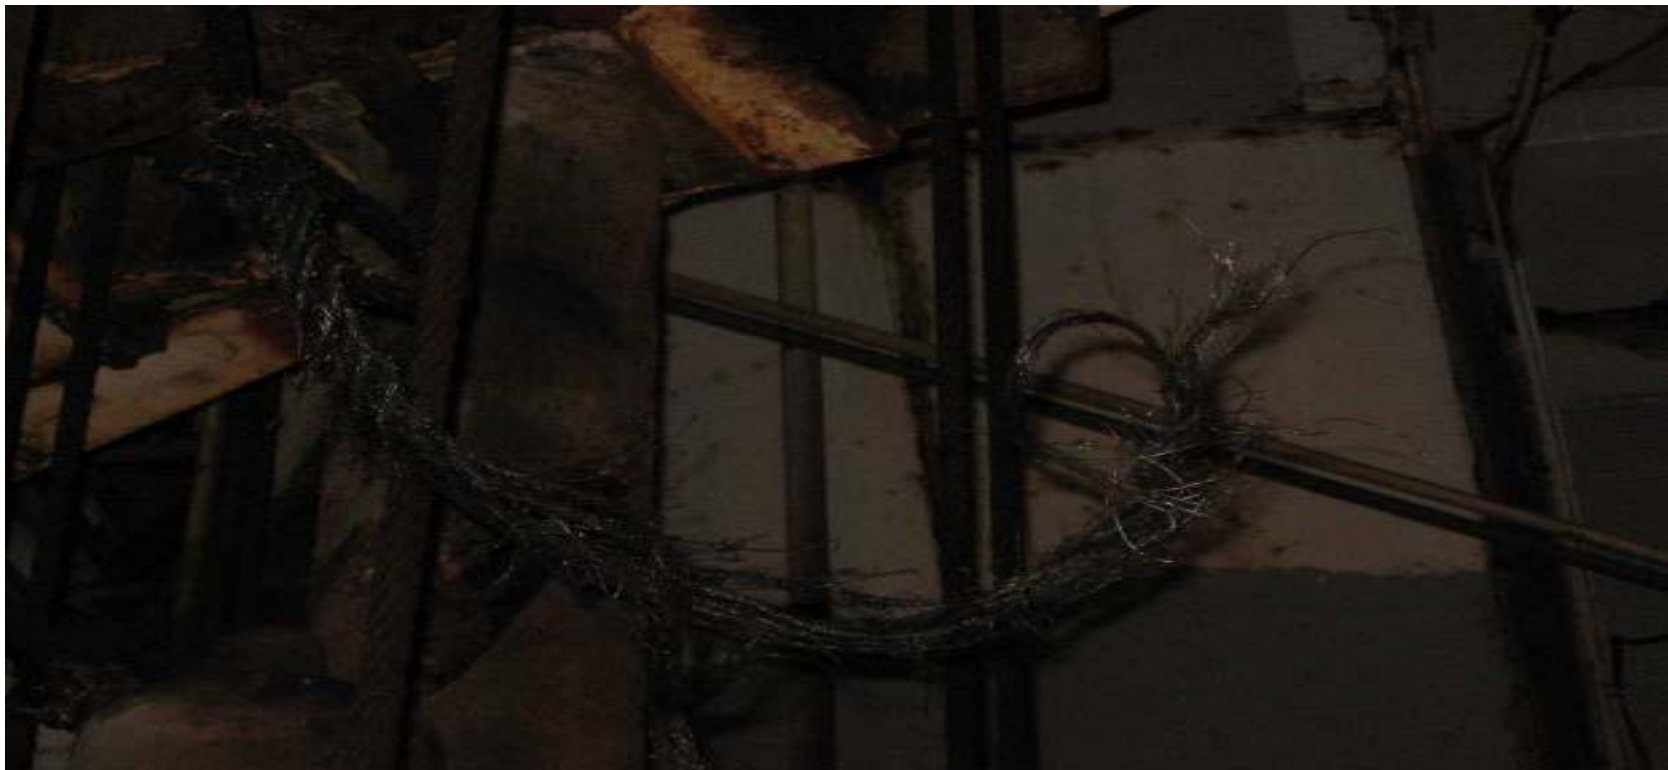
- The wire broke at a wear point in the tensioner system

- Due to the BOP being deployed subsea for an extended period and being unable to slip the wire to move the wear points.
- There is a PM which requires the piston to be stroked out, then retracted fully to expel all air from the system, also checking the levels in the underside oil chamber. But this could not be undertaken once the BOP had been deployed.

- All the pod line and guideline tensioners were inspected and fluid levels were checked.
- PM system was reviewed to take into account long deployment operations.
- A full review was undertaken of the type and construction of the wire. (A better construction wire has since been fitted to the pod lines).
- Access to service the unit and to carry out the PM's has been reviewed. Modification request has been submitted for a engineered platform to be fitted.
- All the units have been rebuilt with new barrels and long-life seals.
- Restraining cables have been fitted to stop the full extension of the rod.
- A review of all tensioner systems has been undertaken by shore management.
