DrillSafe

Ferrule

Transocean
Legend
LGD-2000

We recently experienced 2 members of the team needing first aid treatment after contact with wires protruding from the end section of the ferrule. Both cases were fortunate not to escalate into something more severe.

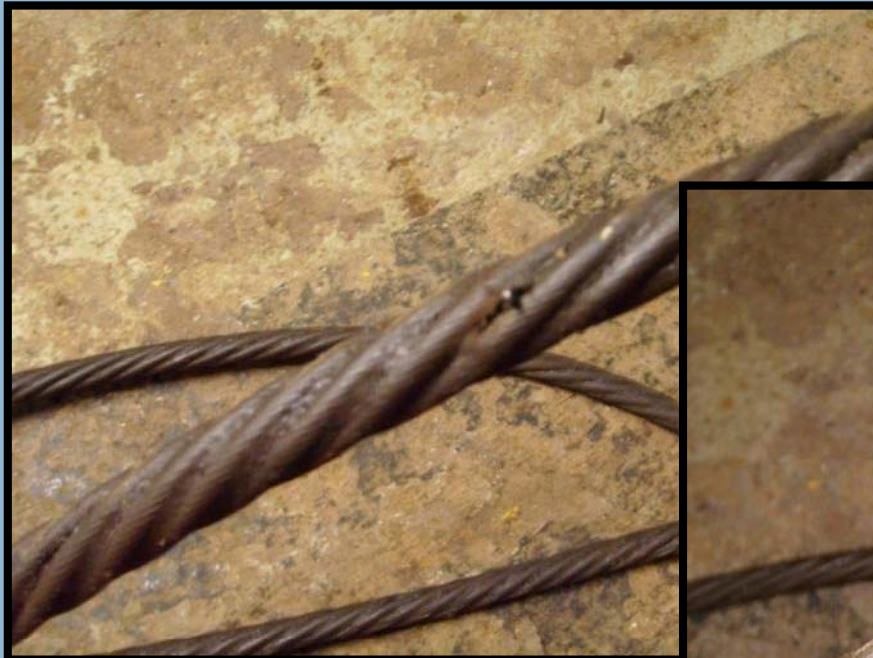
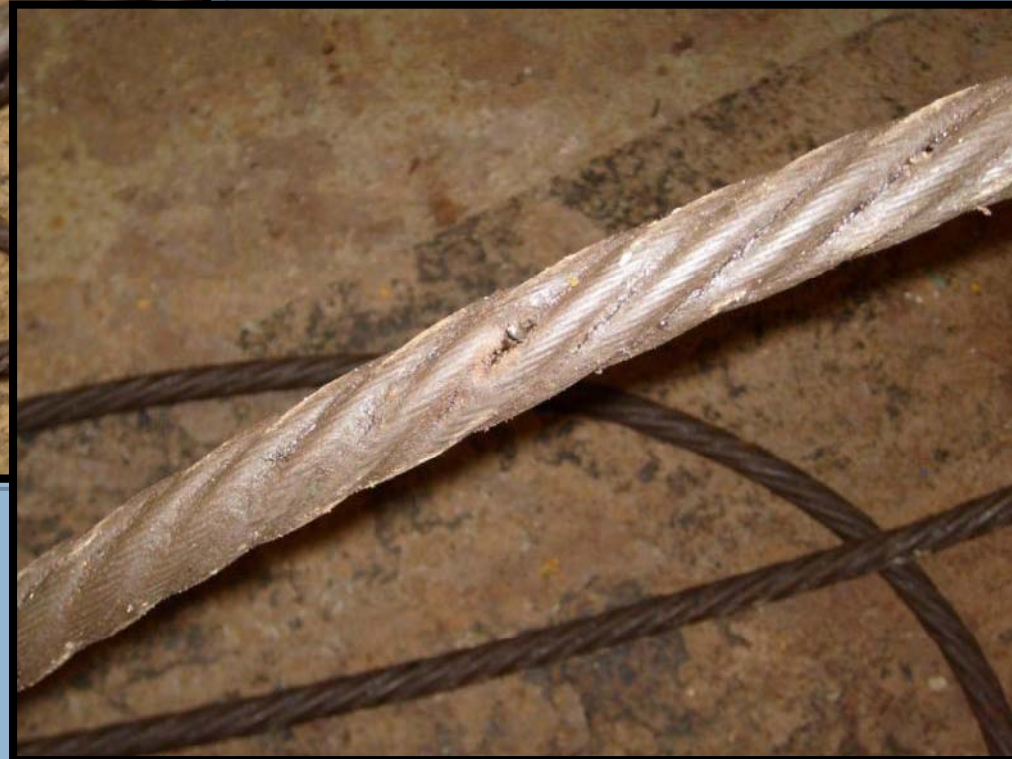
What do you do if you find a barb
(broken Strand) on a crane stinger

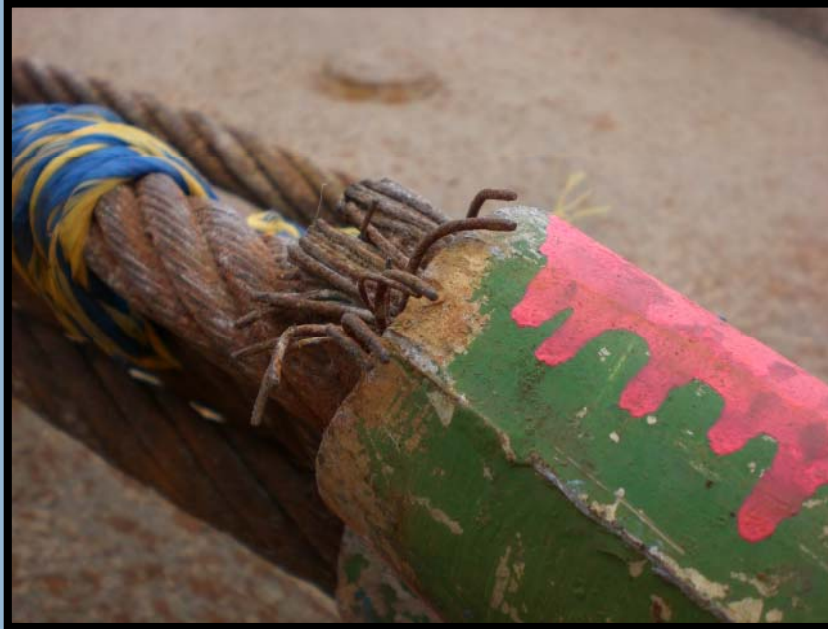
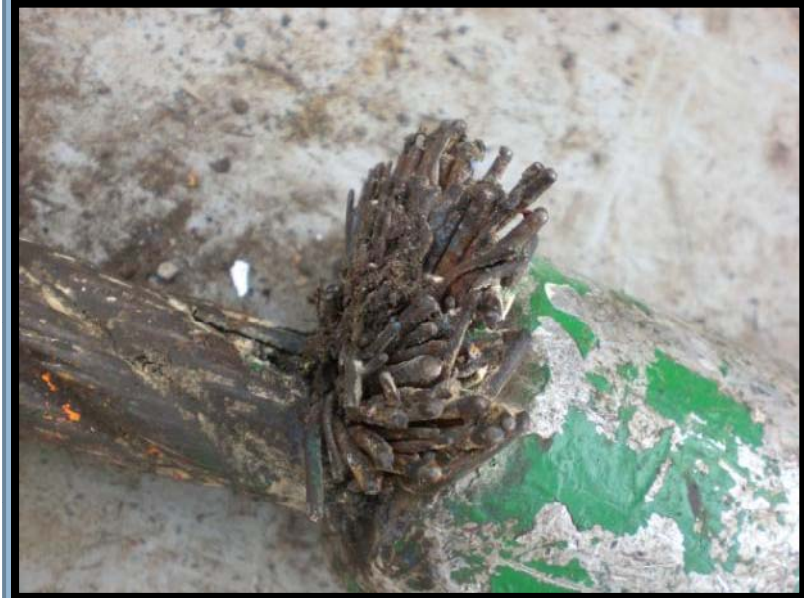
We know we have to remove a single barb from a pennant or sling as it does pose a realistic hazard, yet we accept over 50 at the ferrule end of the sling

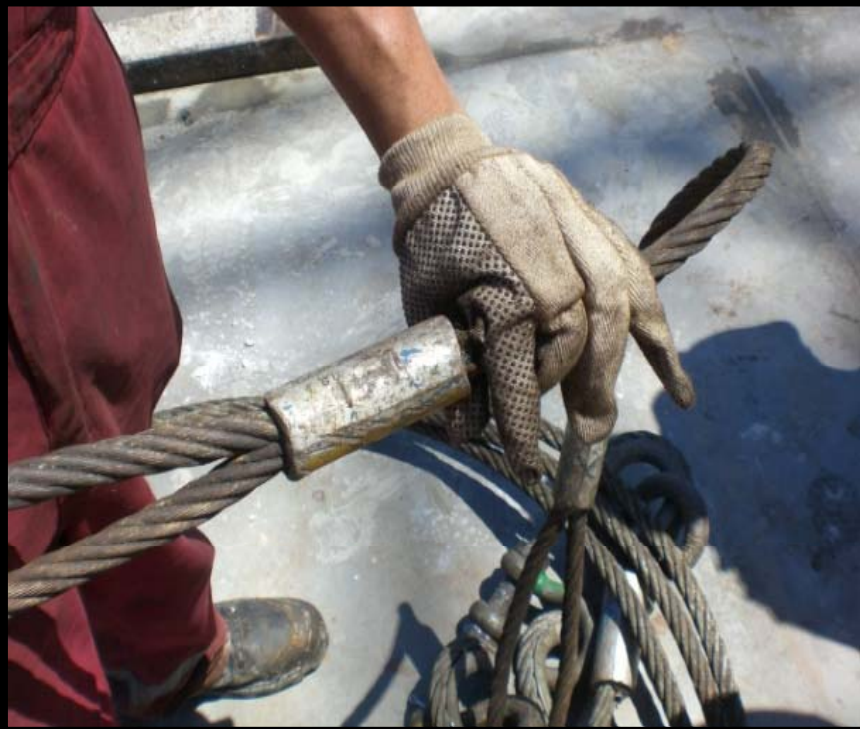
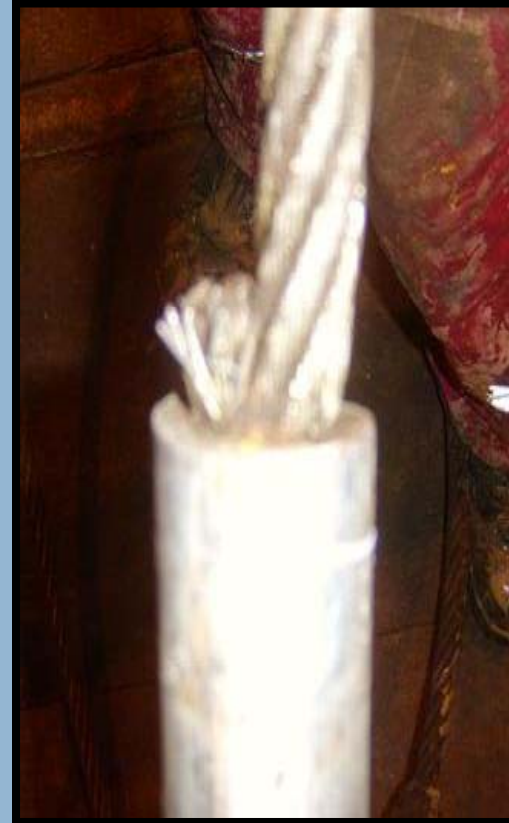
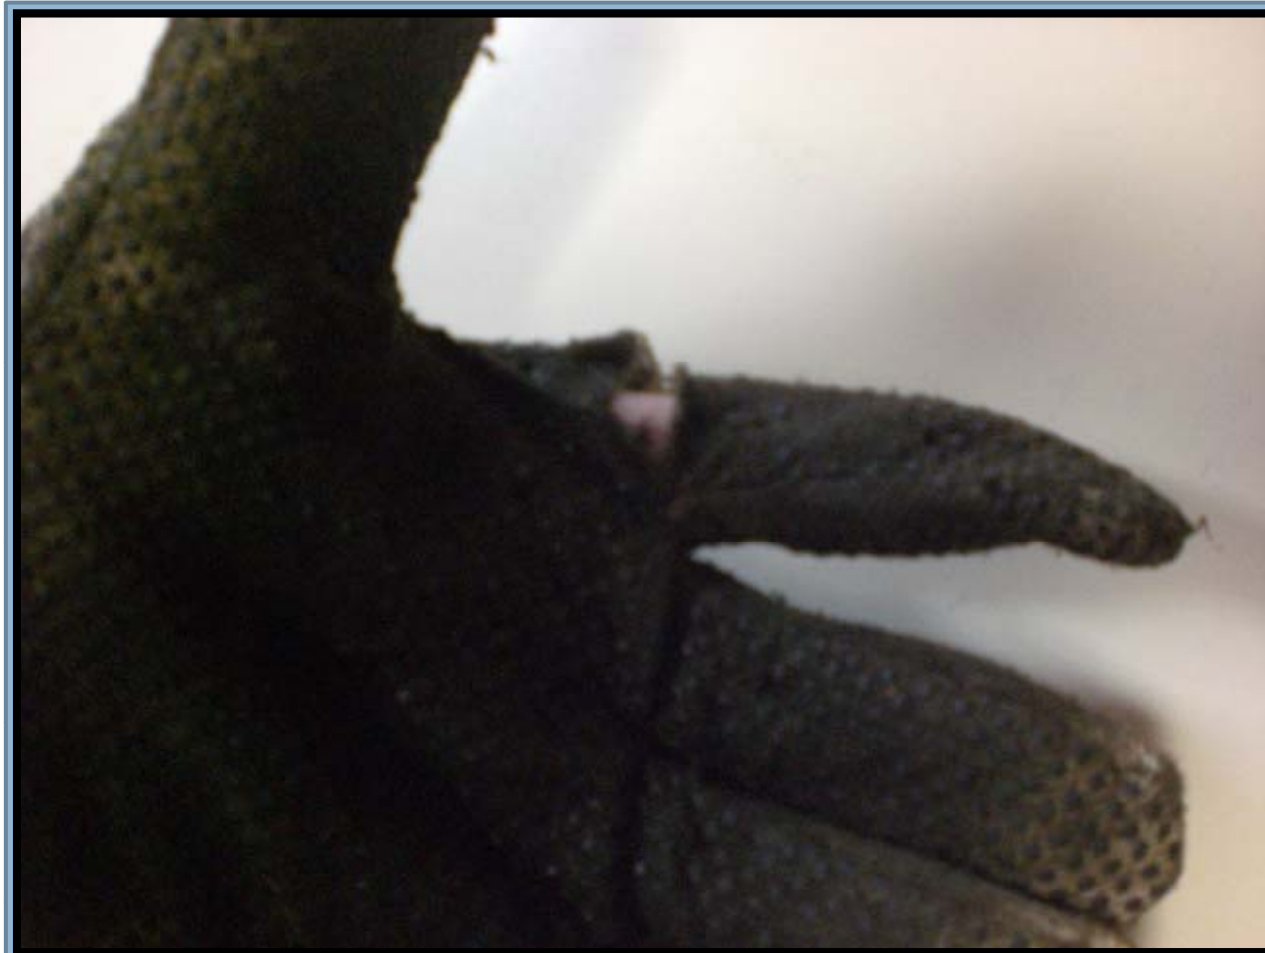
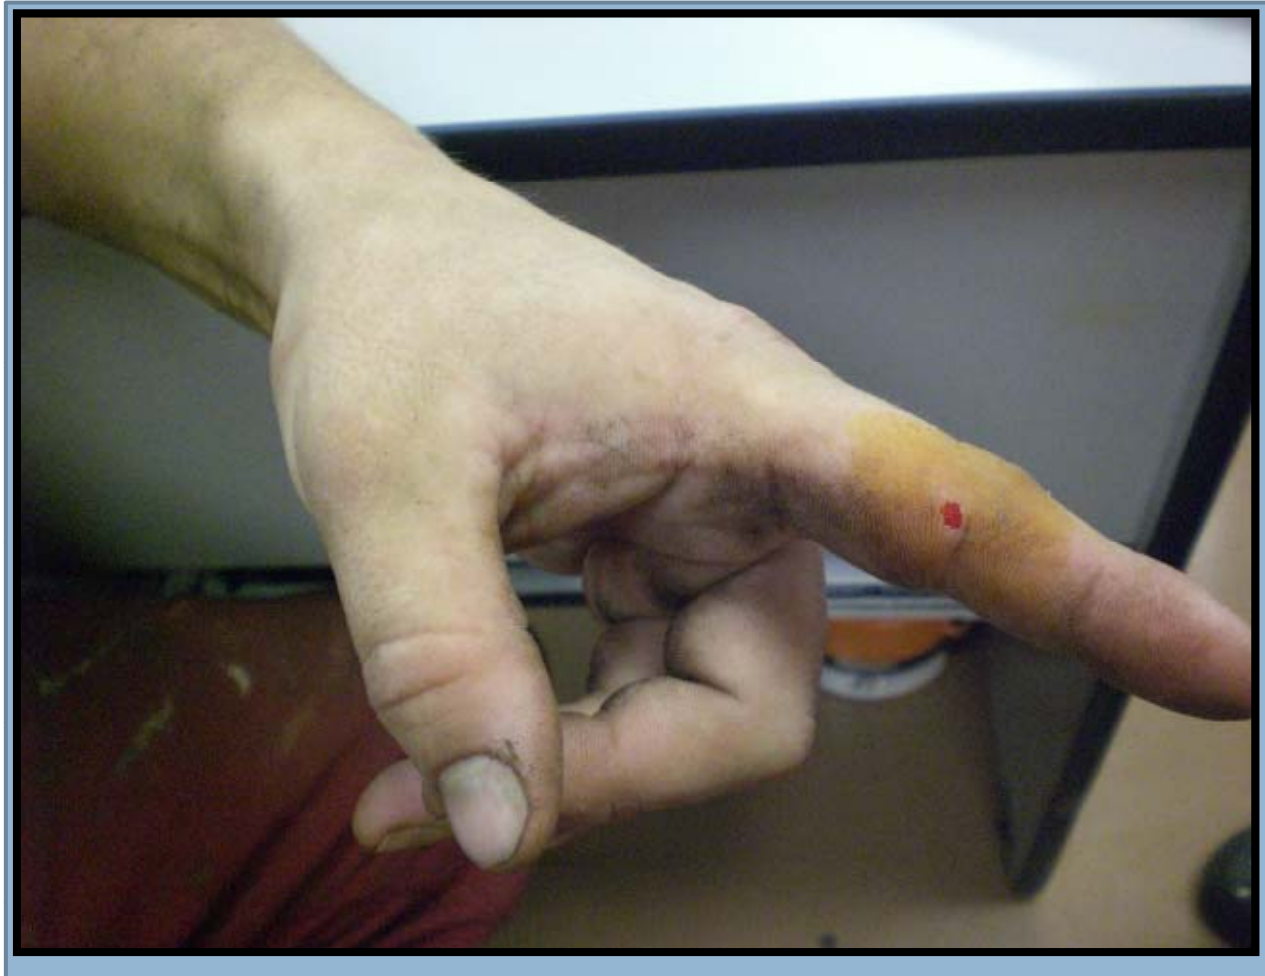
Case 1

A roustabout was part of the team moving tubulars on the main deck. As he picked up the sling the section protruding from the ferrule made contact with his finger resulting in a puncture wound.

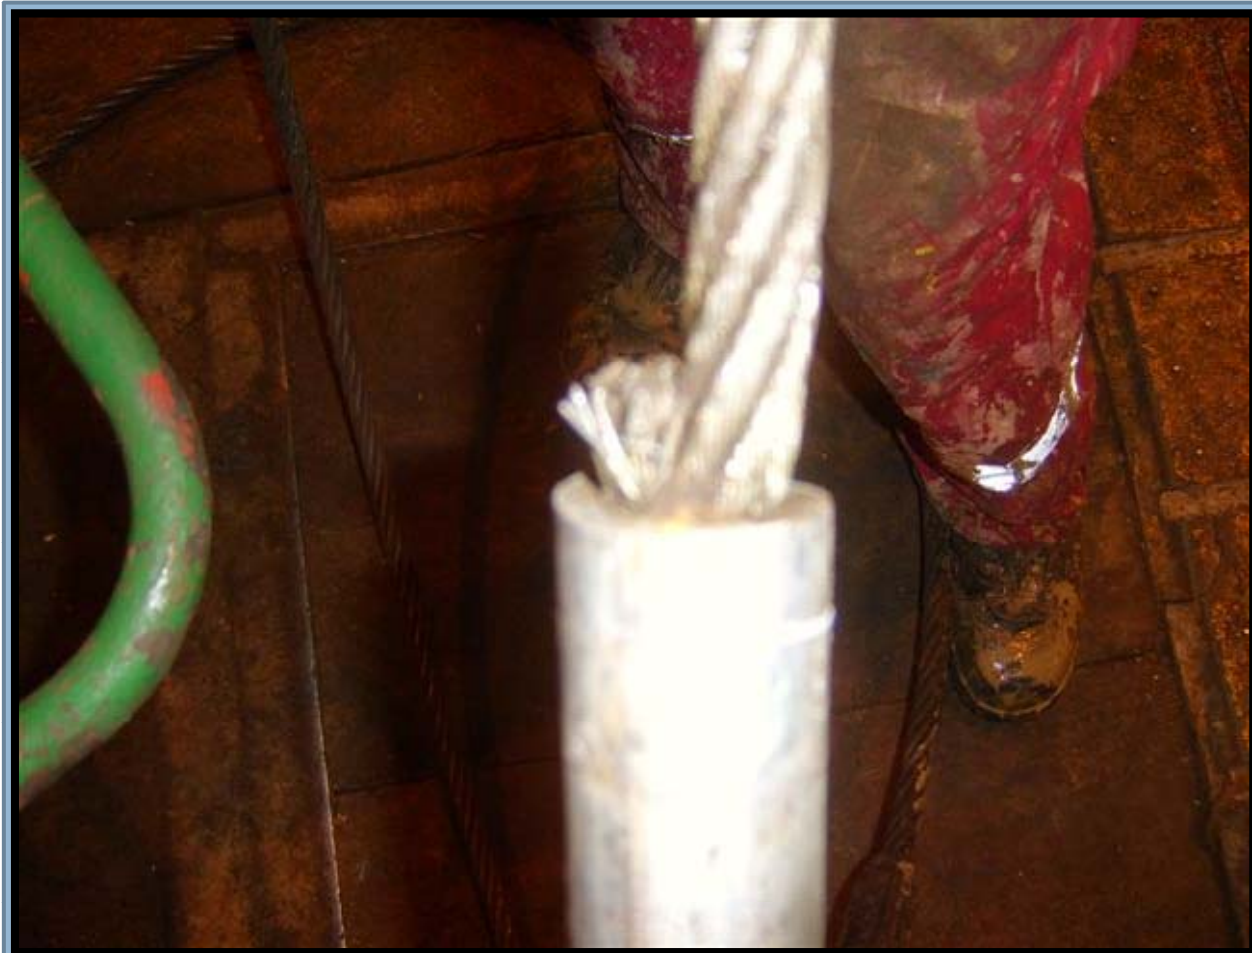
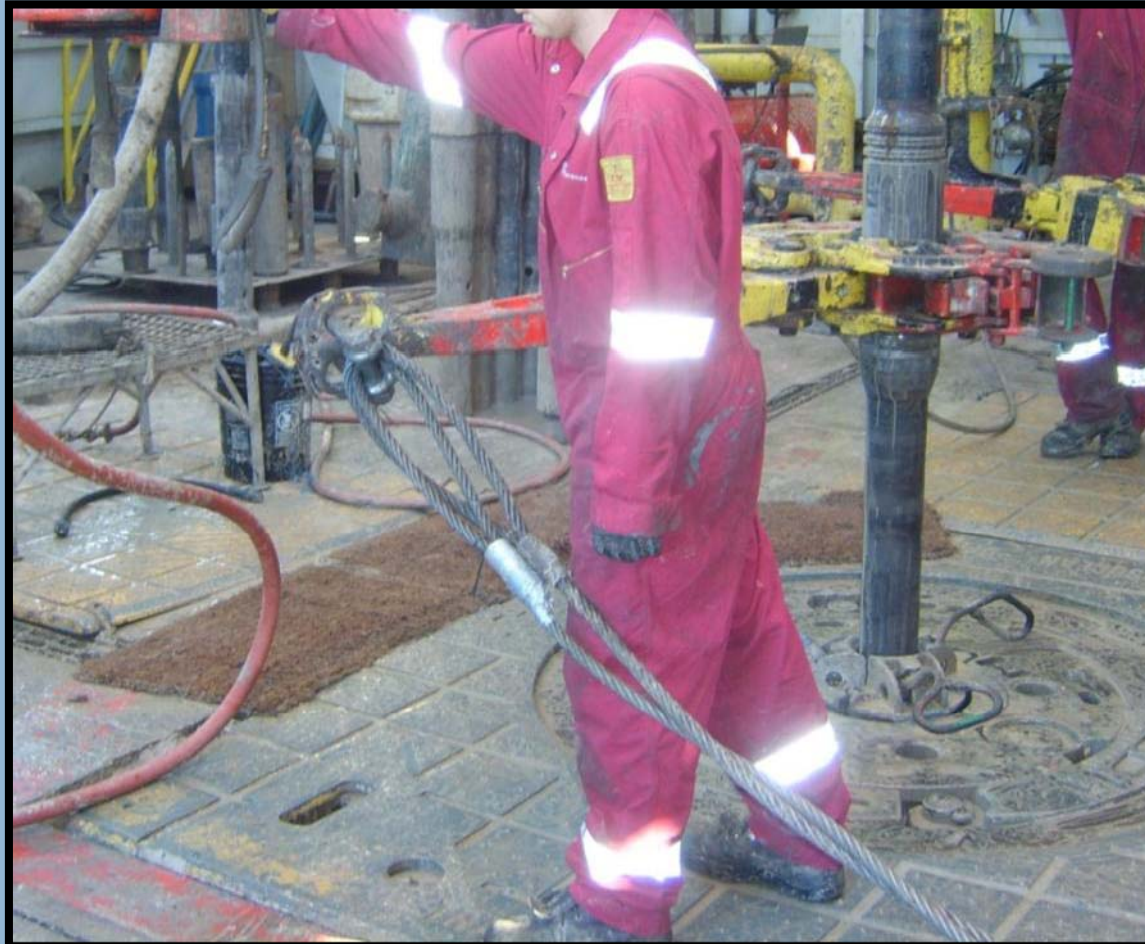
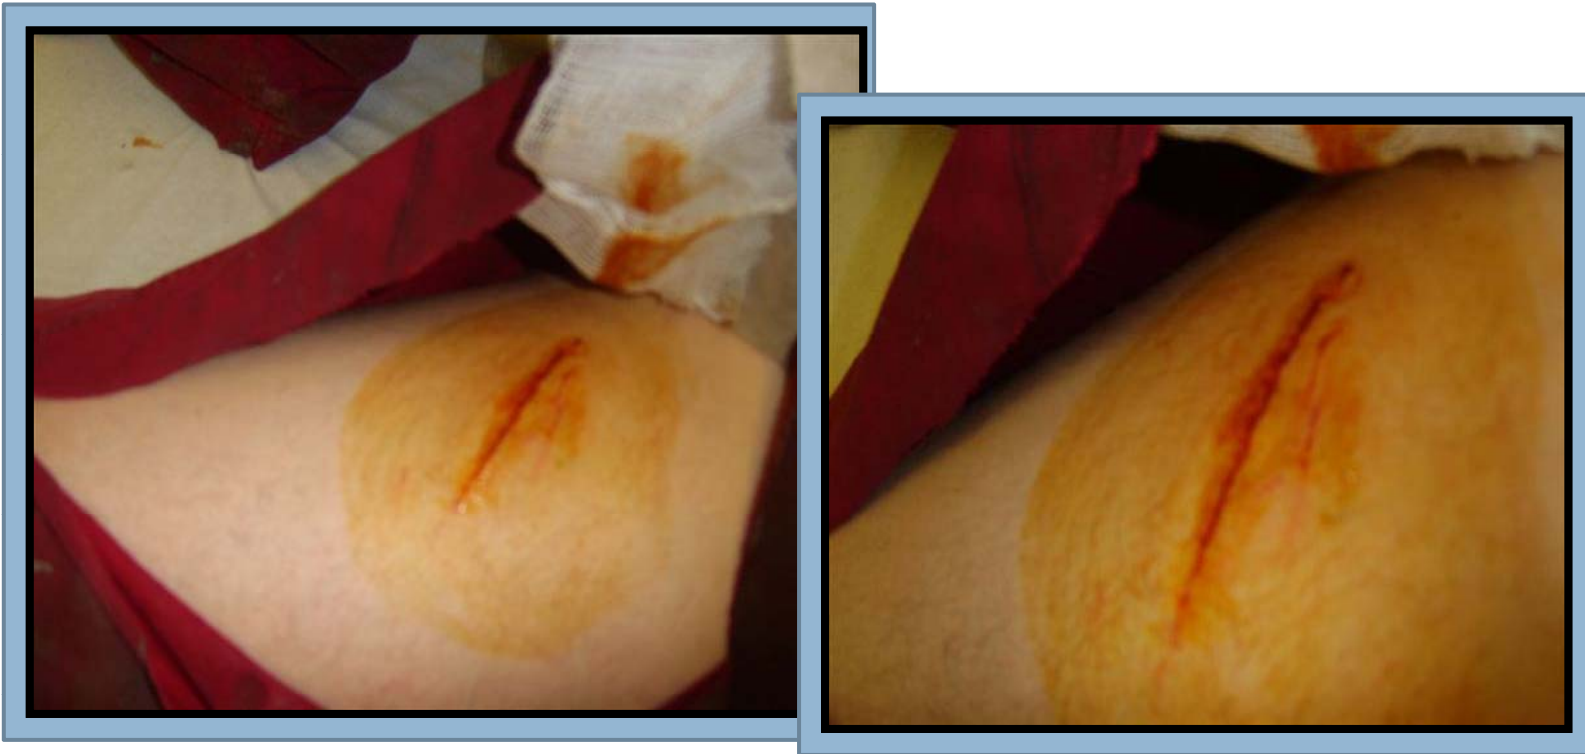
Case 2

The drill crew were making up 5 inch pipe running in the hole. As the makeup tong was latched the bite on the breakout tong was released. The floor-man moved forward to assist with making the tong bite in doing so contact was made with the wire protruding from the ferrule on the snub line.

This resulted in a tear to the coveralls and a 6 inch cut to the thigh.

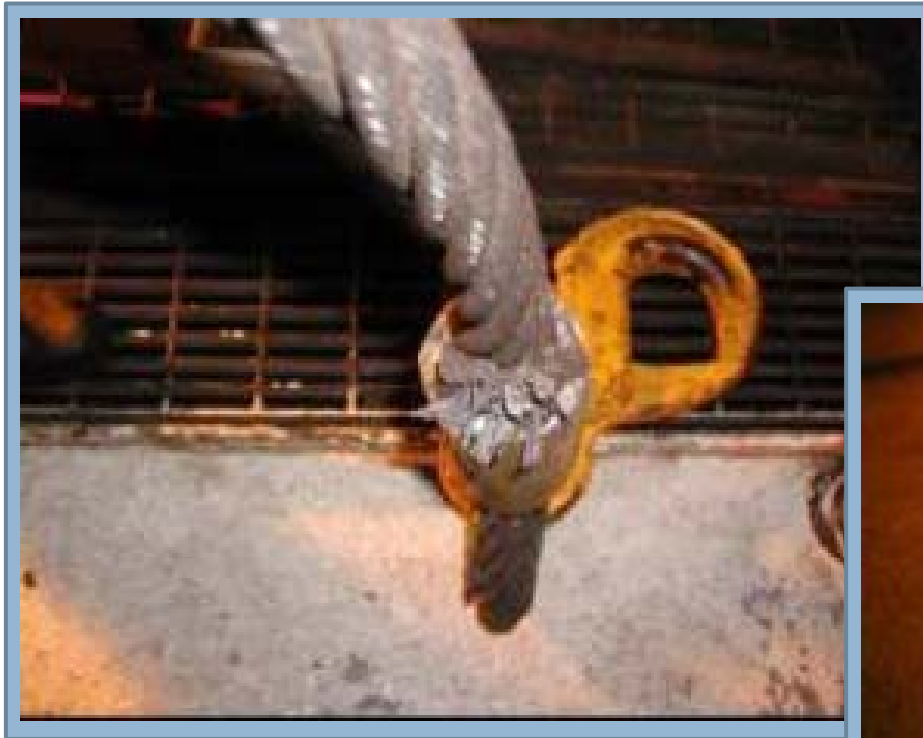
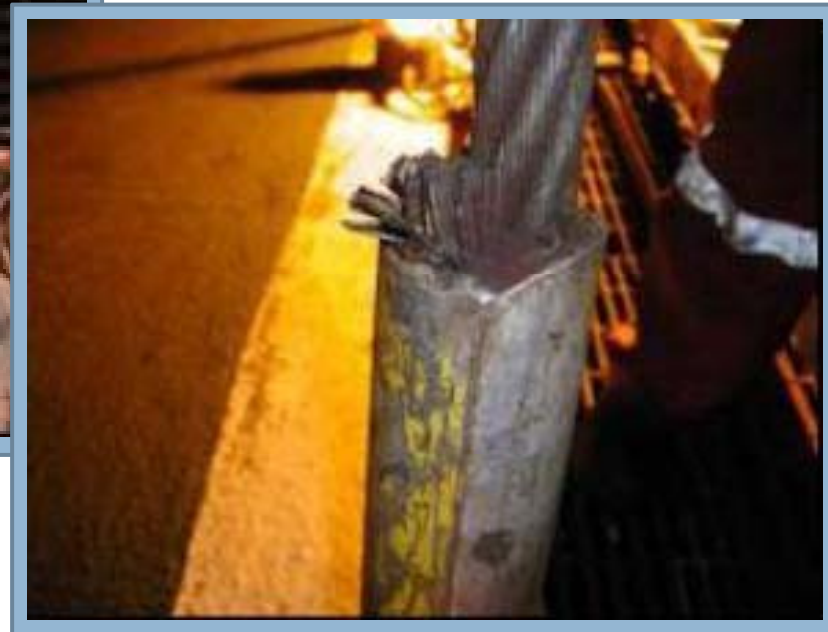
The crane wire termination is a standard aluminum ferrule which is widely used in the industry. Investigations revealed that there were a number of wires protruding from the top of the heavy lift pendant ferrule. The wire tail has to be present to ensure full wire penetration and although they can be trimmed it is very difficult and carries a high risk of cutting the standing part of the wire.

From evidence it is clear that the IP's hand came into contact with the wires that were protruding the ferrule. Despite the IP wearing gloves, they were not of a satisfactory rating for the job; the wires were sharp enough to penetrate his glove and cause the deep cuts.

The condition of the wires protruding the ferrule created a clear hazard to personnel. Following discussions with operators it has been noted this condition is common.

It is recommended that all operators inspect their lifting equipment for similar type of deficiencies.

In the long term these types of terminations require to be re-assessed, consideration should be given to terminations that do not create such hazards.
