INCIDENT PRESENTATION

SERIOUS NEAR HIT

“Drawworks Disc Brake System Failure”

(November 27th, 2007)

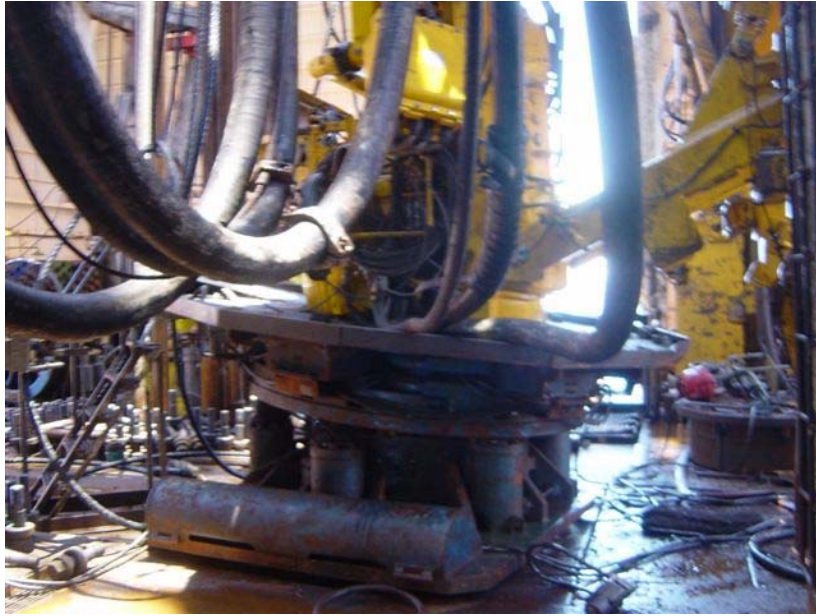
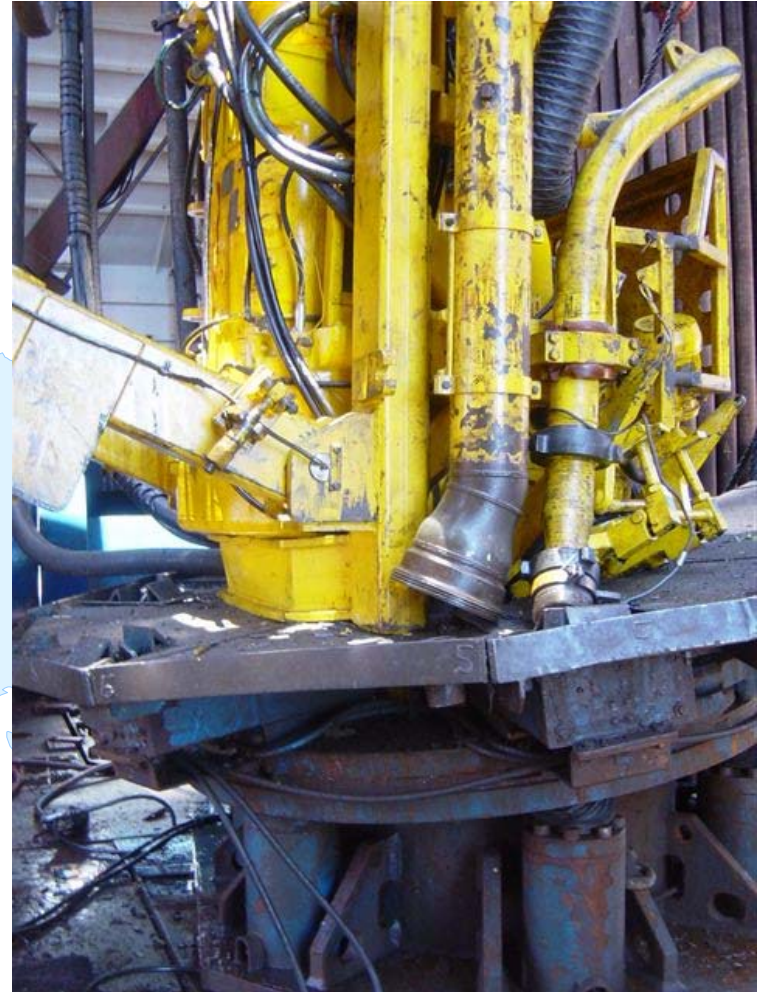
Post Incident Photos

- The TDS impacted the spider gimbal and stopped, suspending the load with the riser double below the rotary table and BOP beneath the surface of the water. The dead end of the drill line had been pulled from the drawworks drum, traveled around the crown fast-line sheave and fell to the traveling block which was resting above the TDS and Compensator.
- One Floorman sustained a minor First Aid injury while taking evasive action.
