Monkeyboard Incident and Work at Height Initiatives.

Drillsafe HSE Forum – 16 June 2005

Incident Background.

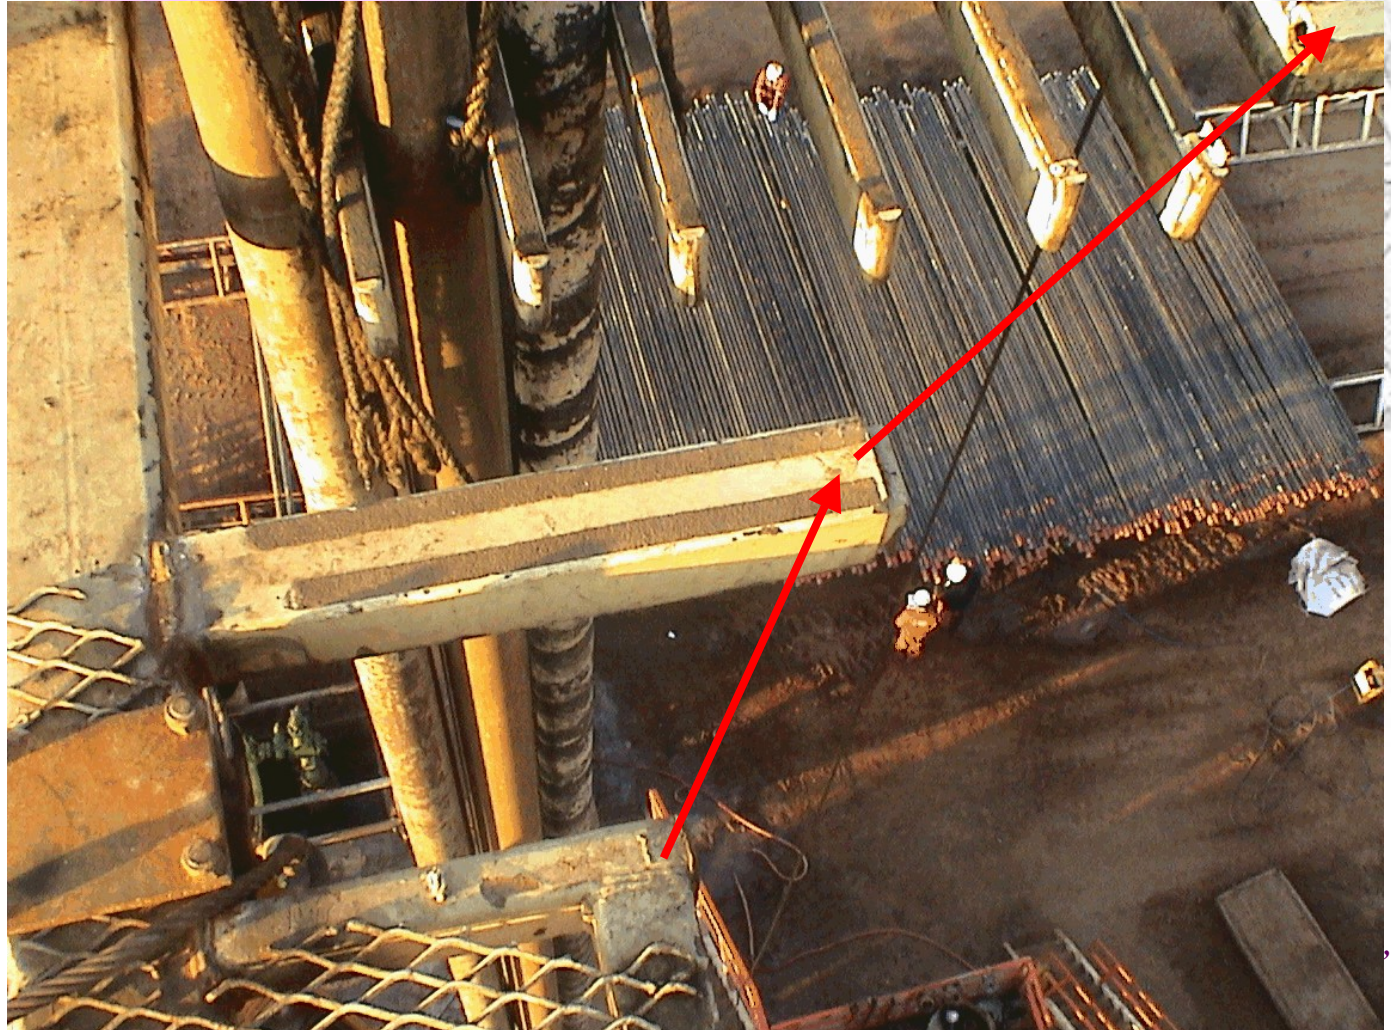
Photograph 1 – Step across fingers.

(NB. Fingers were full of pipe)

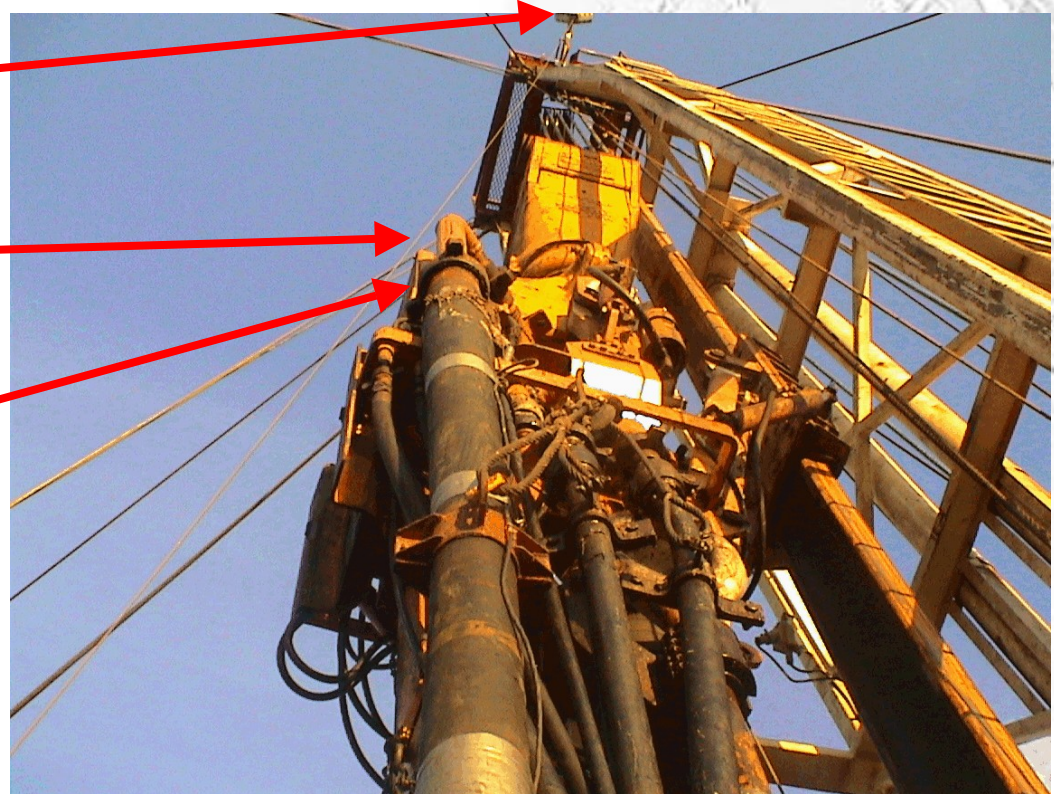
Photograph 4 – Top-drive and Inertia reel set-up.

- Inertia reel from crown
- Reel Line
- Gooseneck hammer union

1. The inertia reel static line became snagged on the top drive.
 2. The blocks / top drive were in motion.
 3. The gooseneck hammer union protrudes from the top drive.
 4. The SOP was not specific enough.
 5. No JSA was completed.

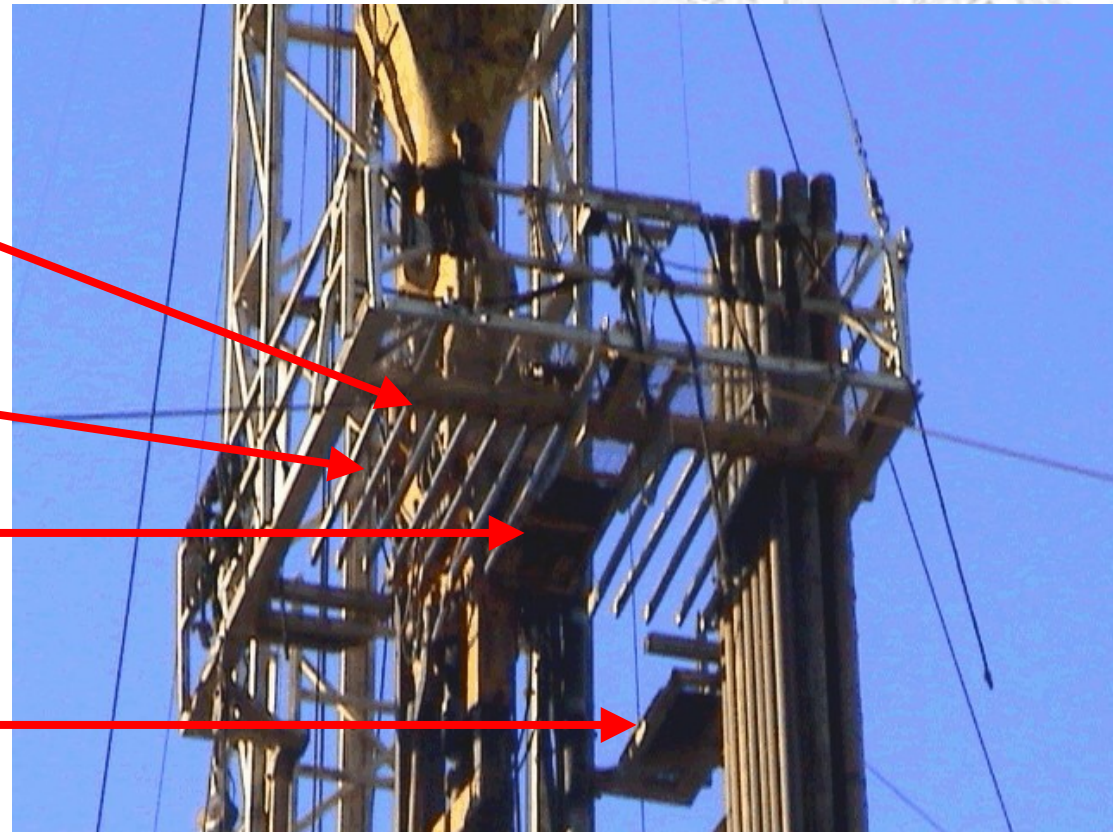
Photograph 5 – Monkeyboard set-up.

- **Top drive
(behind m-board)**

- **Pipe fingers**

- **Diving board**

- **Platform
beside ladder**

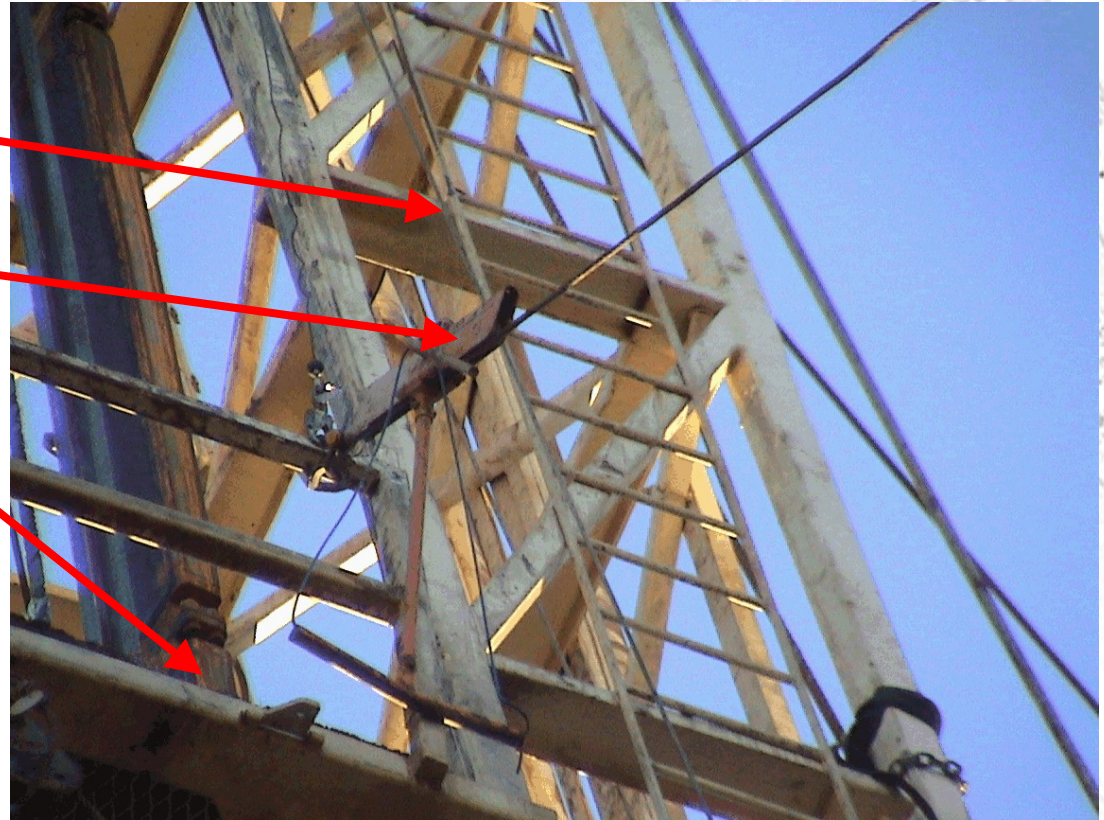
Photograph 6 – Ladder access point.

- Ladder
- Geranimo Line
- Monkeyboard Platform
