# Sedco 703 Riser Spider

# OMV “Maier-1”

**While laying down the Riser Spider, the tugger line parted, resulting in the Spider descending unrestrained down the V-Door.**

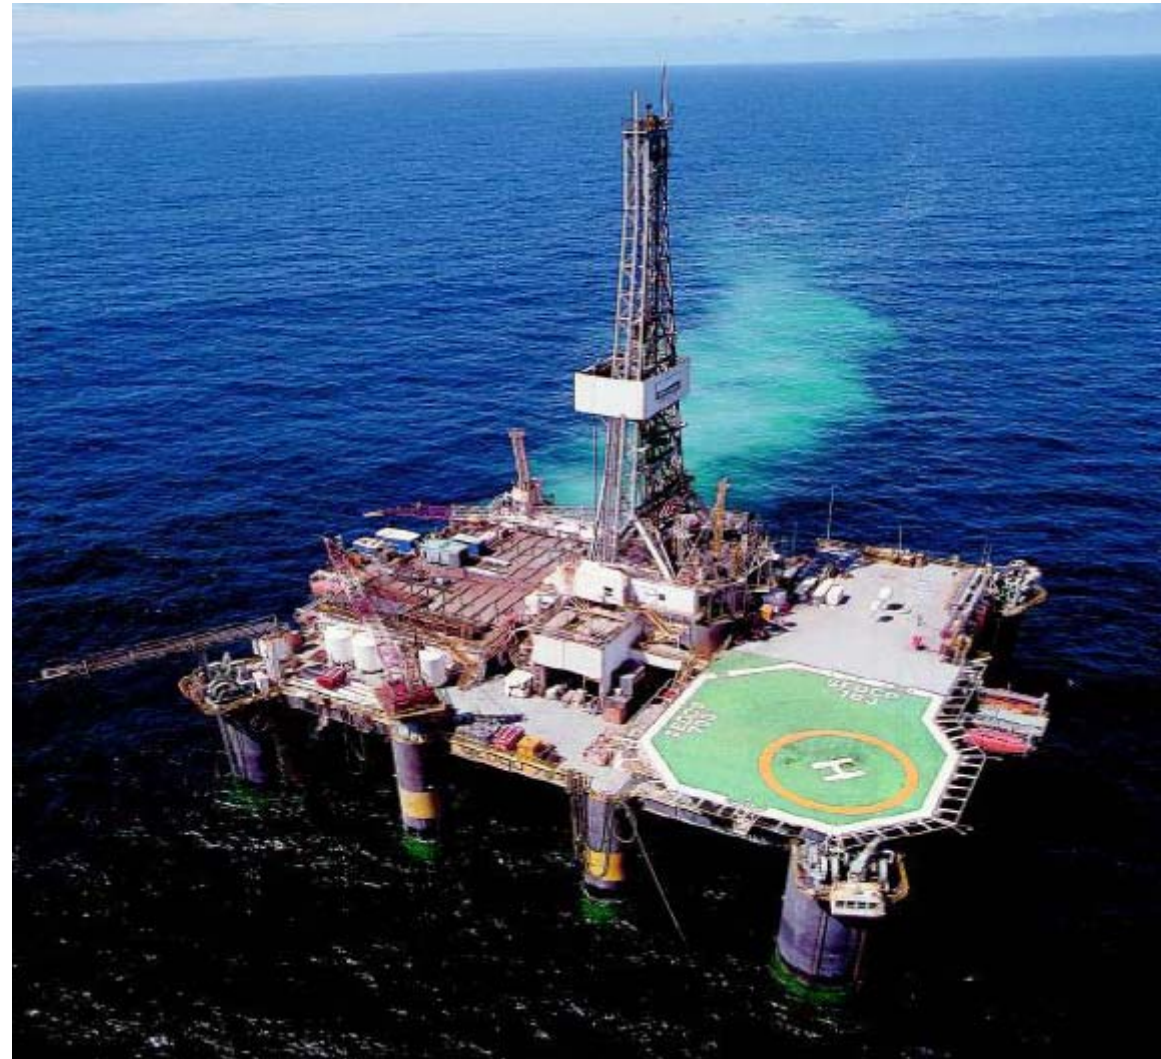
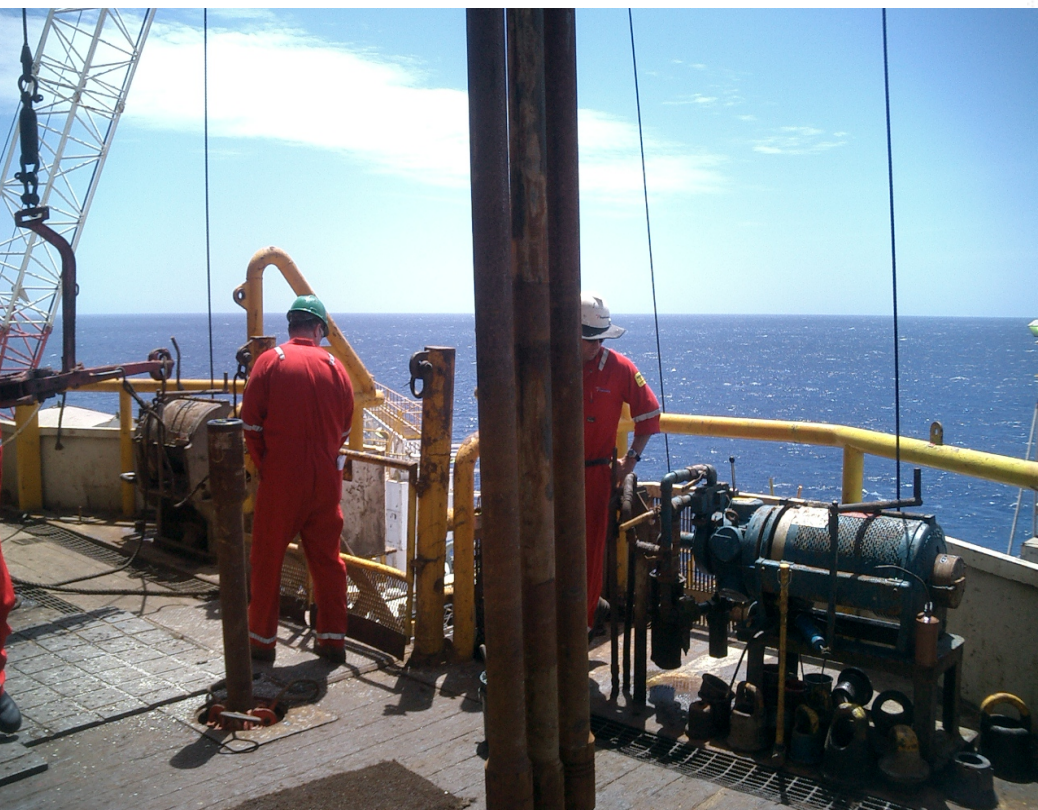
**No injuries.**

Blue Tugger      Vee-Door Posts      Grey Tugger

- Rigged up blue tugger to Diverter R/T (per plan), through elevators
- Released R/T, but left it in place – to serve as hole cover
- Transferred tugger to spider, attached catwalk tugger
- Picked up spider, pulled out V-Door
- Tugger line failed as Spider was crossing Vee-Door posts
- Spider fell down Vee-Door, striking rails twice, then settling on catwalk edge

Overloading tugger line.  
Inadequate knowledge of weight of load (investigation revealed that this extends to other similar-sized items which may be delivered to the rig floor).  
Supervisor getting too close to the job (driving tugger and giving signals).  
No independent observer providing co-ordination & oversight.  
Running tugger line through elevators resulted in increased tugger line load (to point of failure).  
Gap in Task-Specific-THINK-Procedure for running riser (no riser-spider handling details).

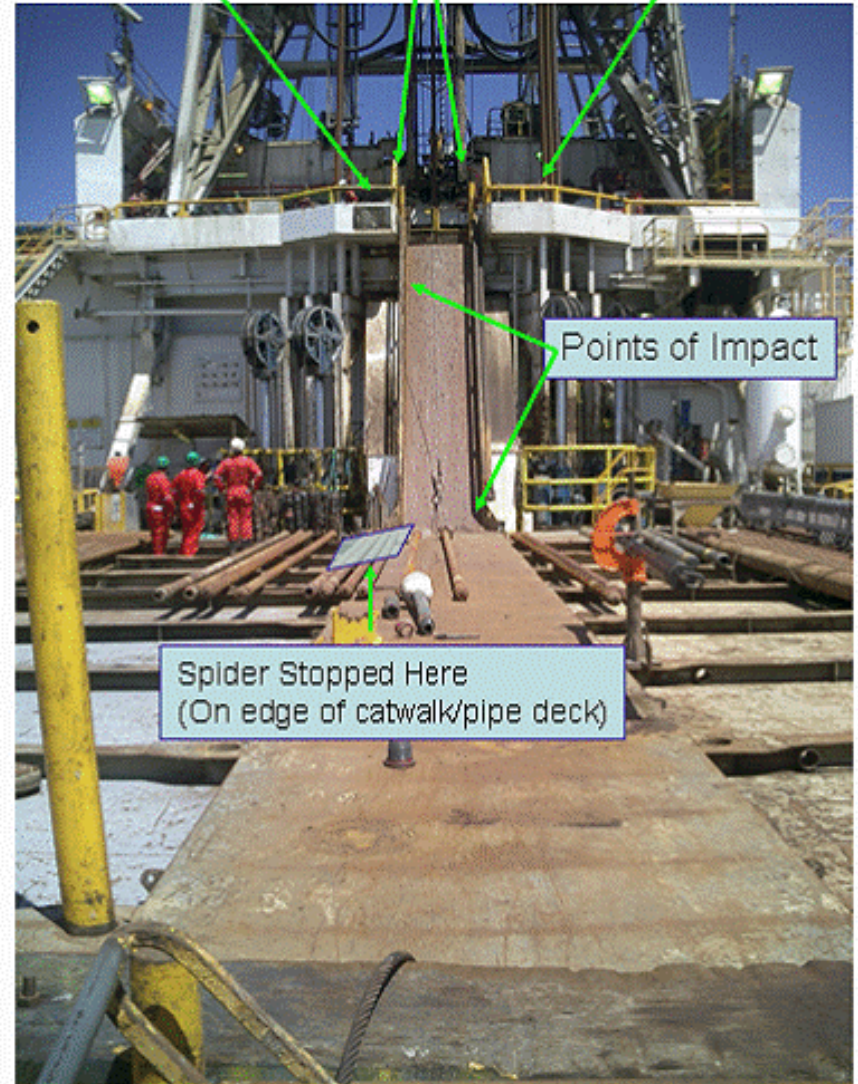
View from Catwalk Tugger  
(Picture taken on 16-March)  
Spider resting position superimposed on this picture
