Drillsafe Meeting
June 2006 - Sydney

Stena Clyde Start-up in
Australia

Stena Clyde – Electric Shock Incident

Stena Clyde - Monkey Board Fall

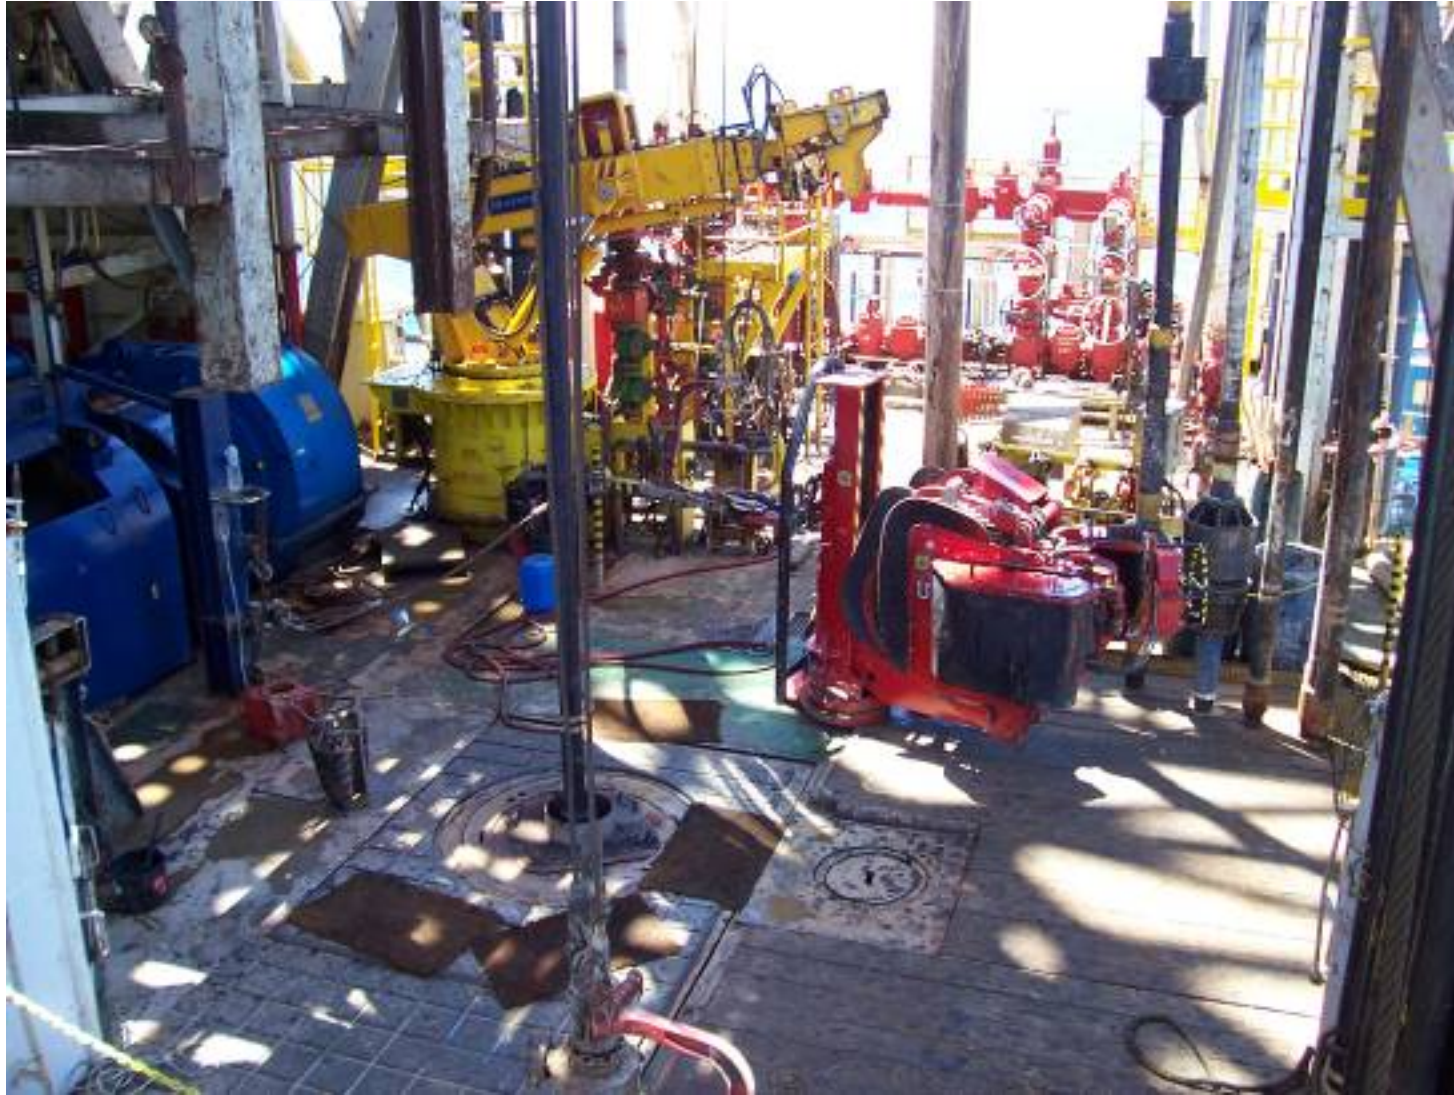
General view of the Rig floor

On 24th Dec @ 1300 hrs while drilling 12 ¼" section, after completing a connection, the Iron Roughneck was being pushed clear of the rotary when the guard of the control panel came into contact with a hang off tool. The bracket for the control panel came across and the Floorman's finger was caught between the bracket & the guard rail.

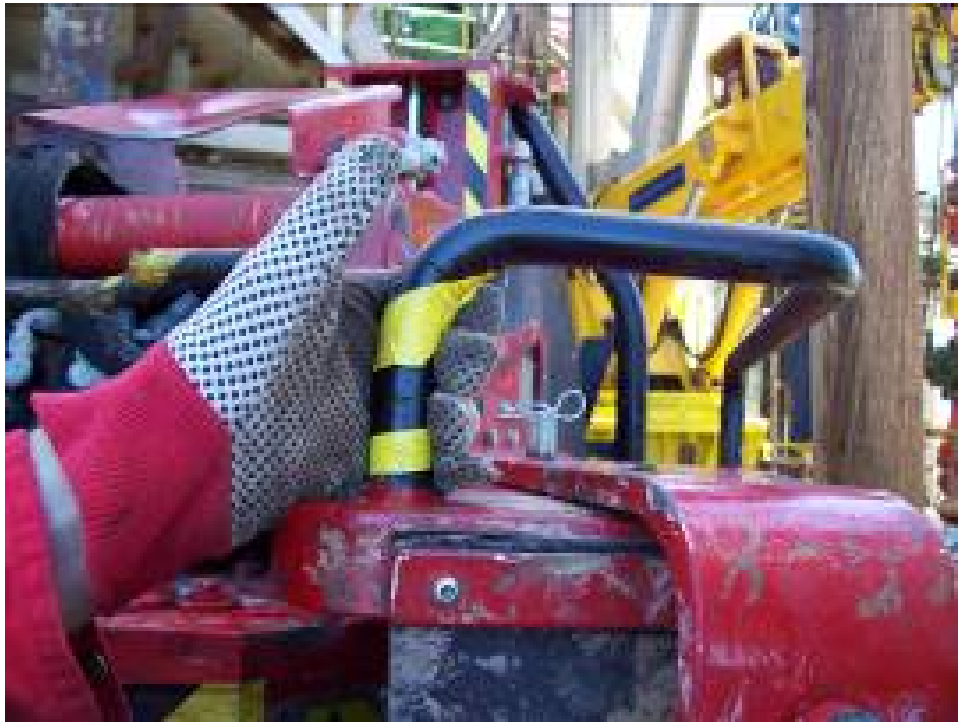
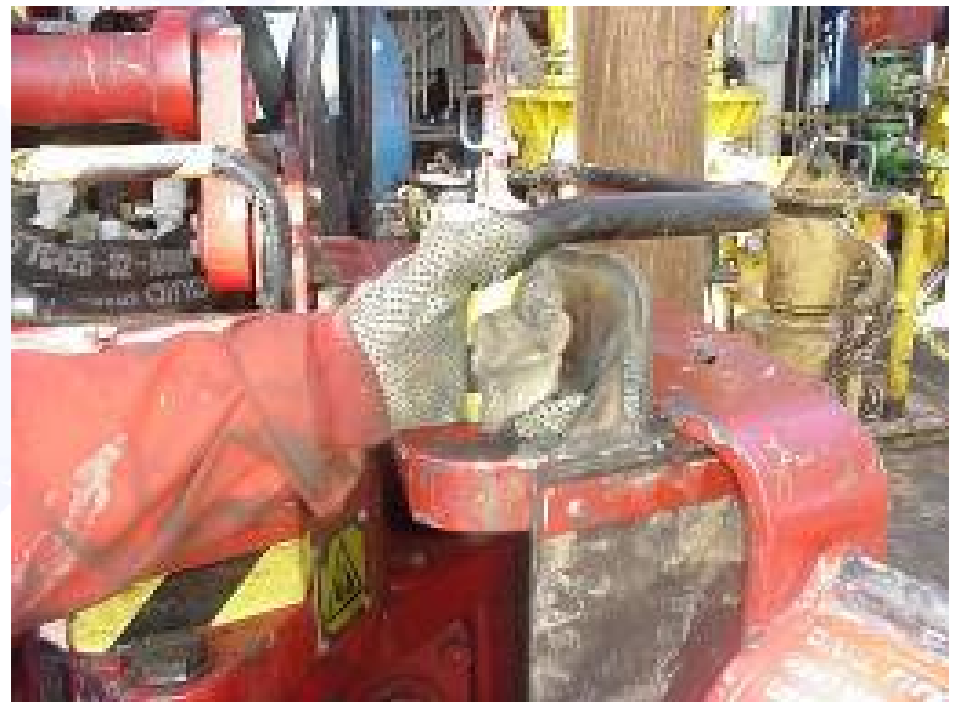
Pinched finger

2 sutures required to the injured finger.

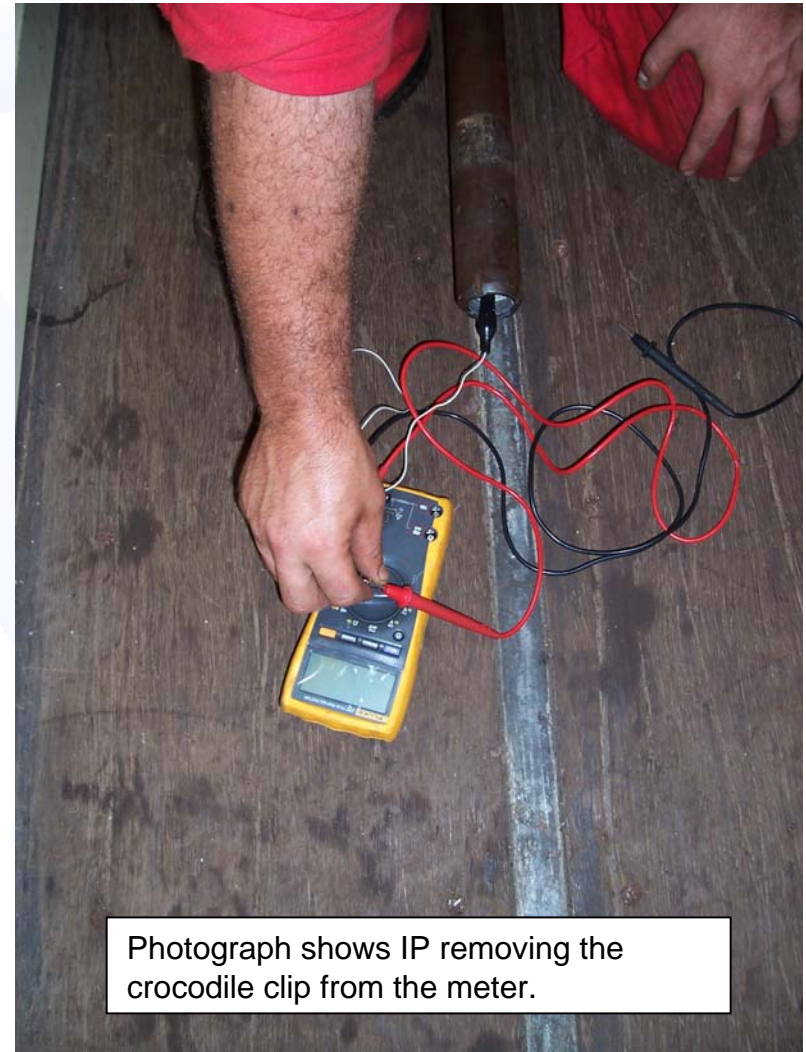
Schlumberger crew were preparing the Swetec cutter tool to be run down hole to sever the drill pipe. At 03.30 hours during the process of checking the voltage being applied to the end of the tool string, the wireline operator received an electric shock.

Photograph shows IP removing the crocodile clip from the meter.

- Travel time must be considered when authorizing working hours.
- A risk assessment is required to evaluate the potential hazards of working in excess of 12 hours or work within 12 hours on the day of arrival onboard after travel.
- Better communication needs to take place between the OIM, night Toolpusher and Client representative concerning third party's working hours. Only the OIM is permitted to authorize work in excess of 12 hours and must be consulted.
- Personnel required to work with high voltage must be competent in electrical safety and handling.
- There should be procedures and a formal risk assessment for this job and it must be reviewed prior to the job.

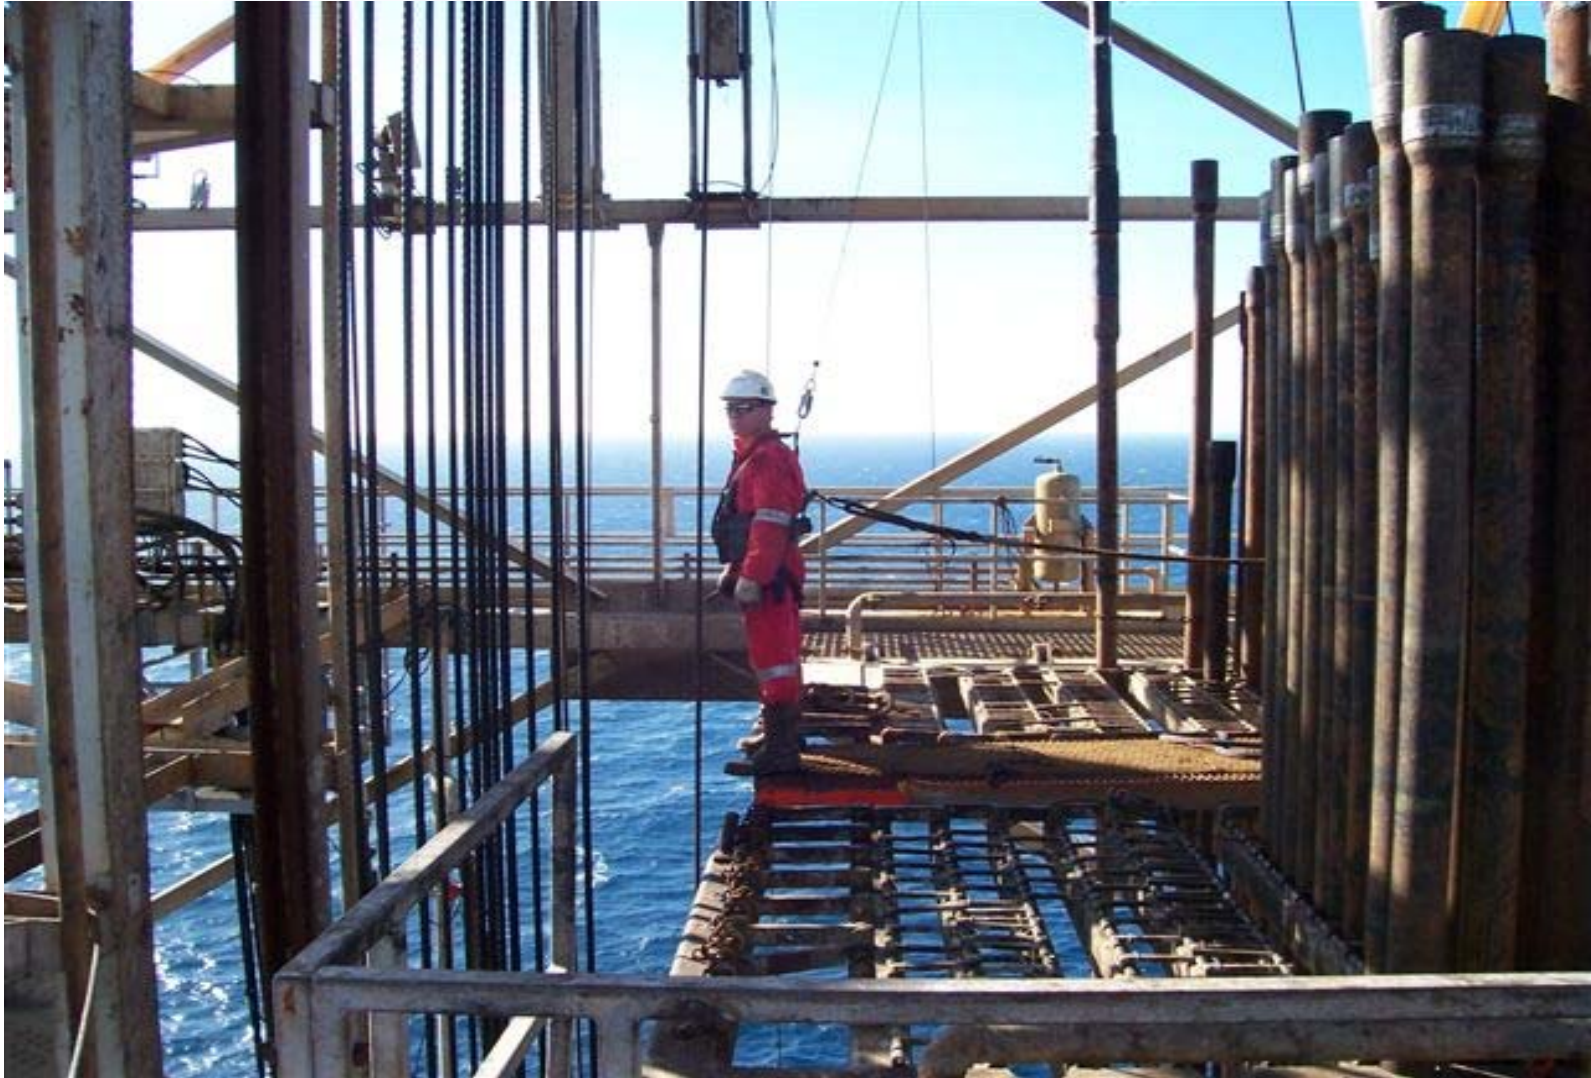
Monkey Board Fall

On the 13.01.06 @ 0630 hrs a Pump man was working on the monkey board lost his balance & fell, ending up 2 feet below the monkey board suspended by his rope tail line & inertia line. The incident was witnessed by the Driller who took immediate action to get men aloft to assist the worker. The work basket was rigged & raised up to bring the pump man down to the rig floor.

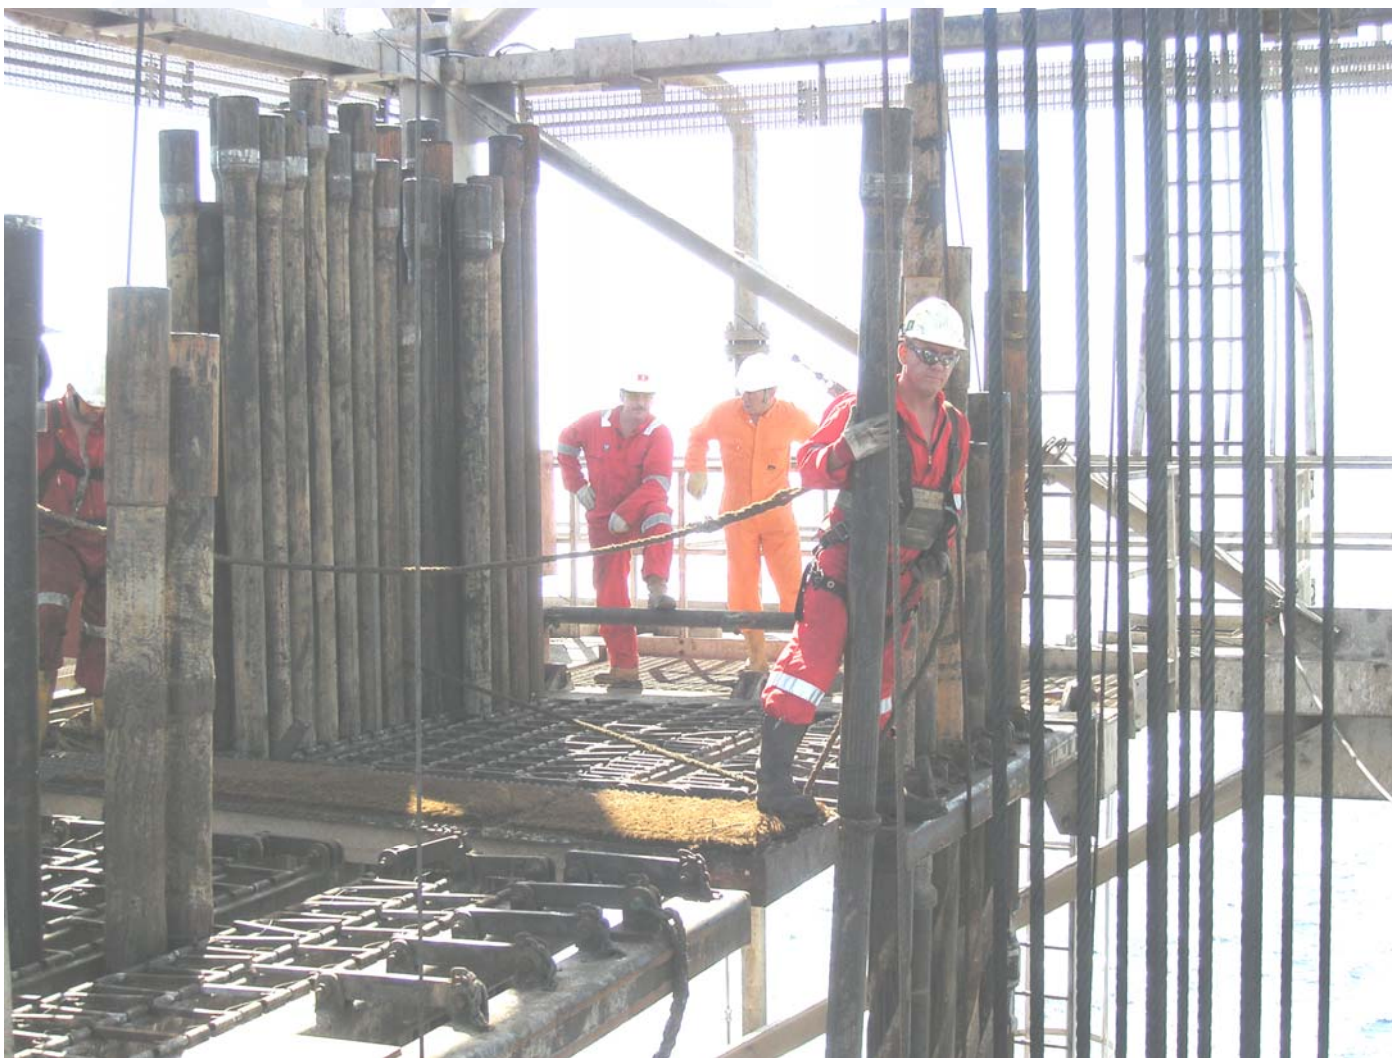
Position of Derrickman prior to fall

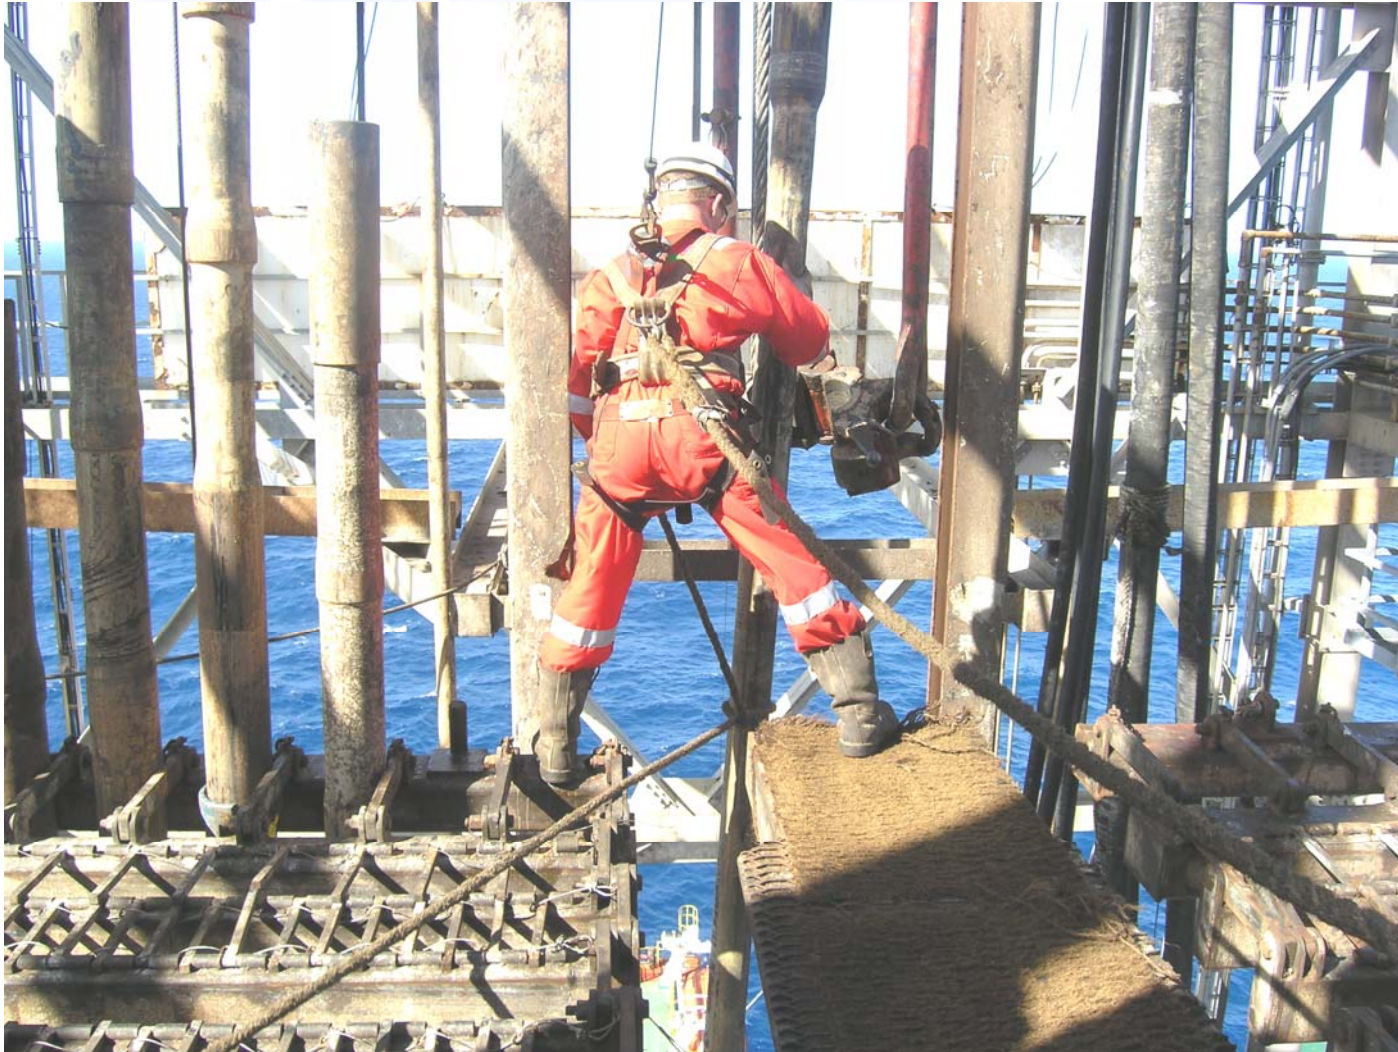
Elevators latched prior to fall

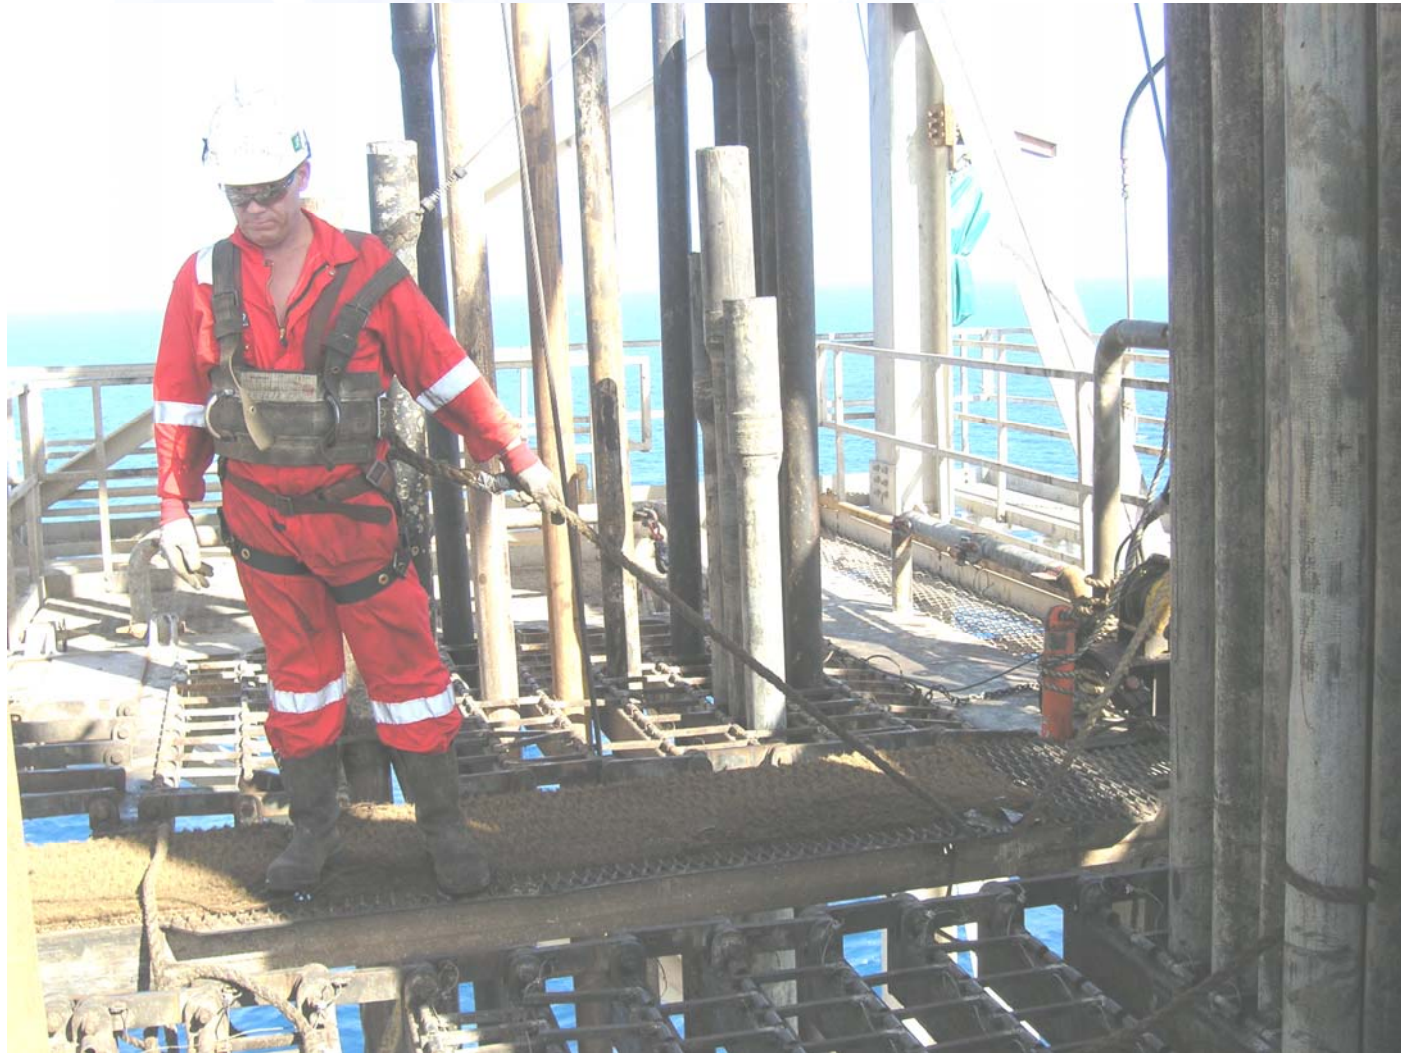
Where he thought the rope may have hung up

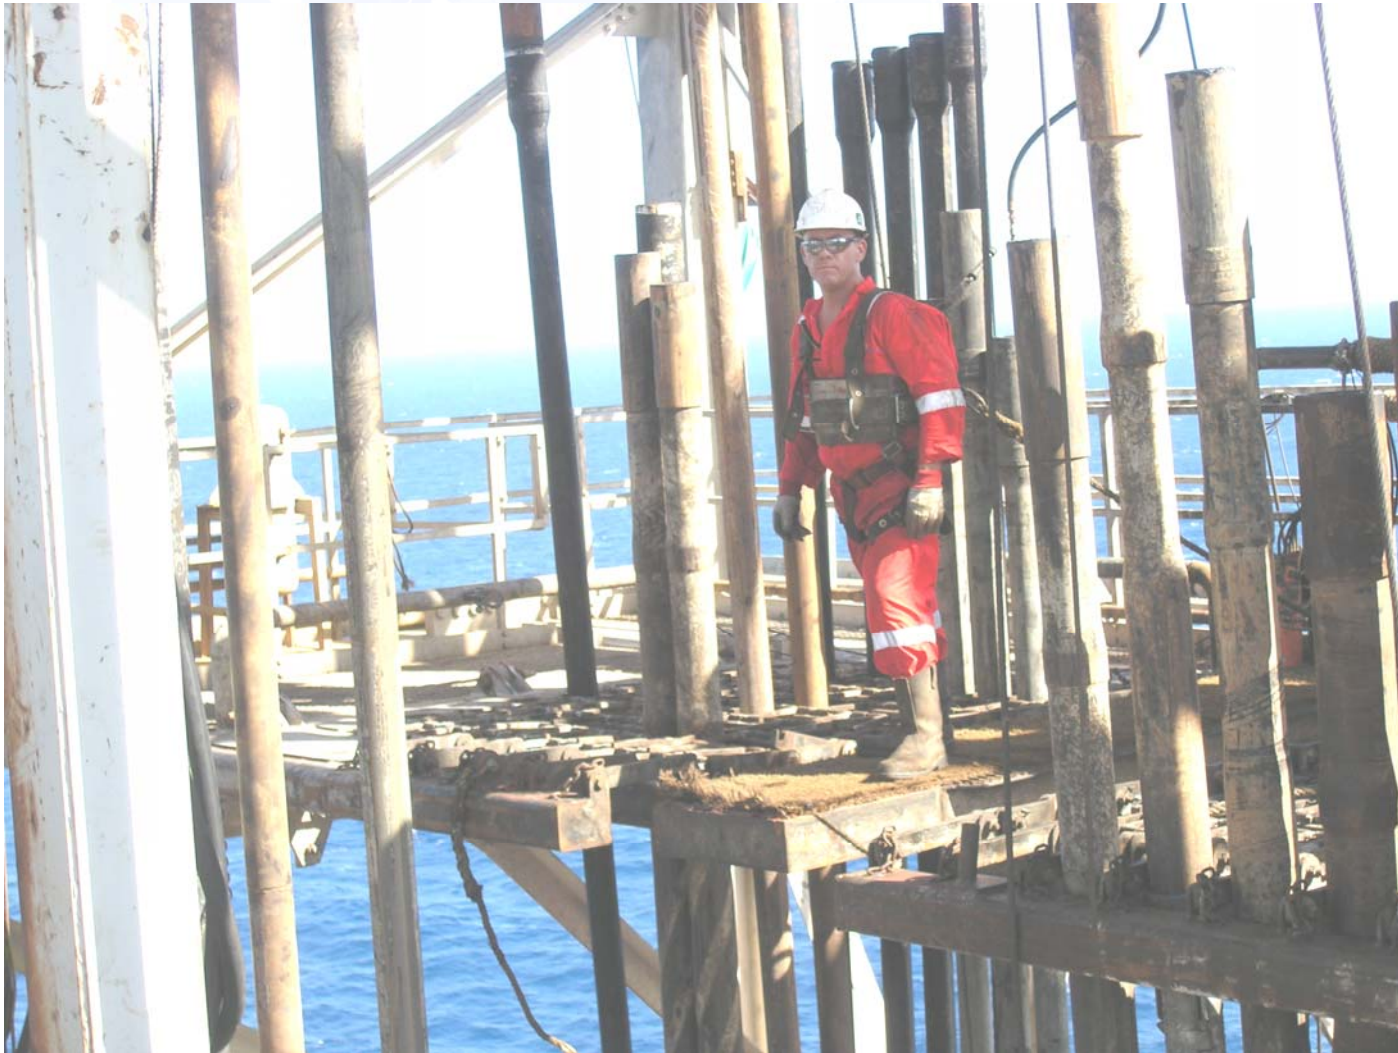
Position on m/board if rope had hung up

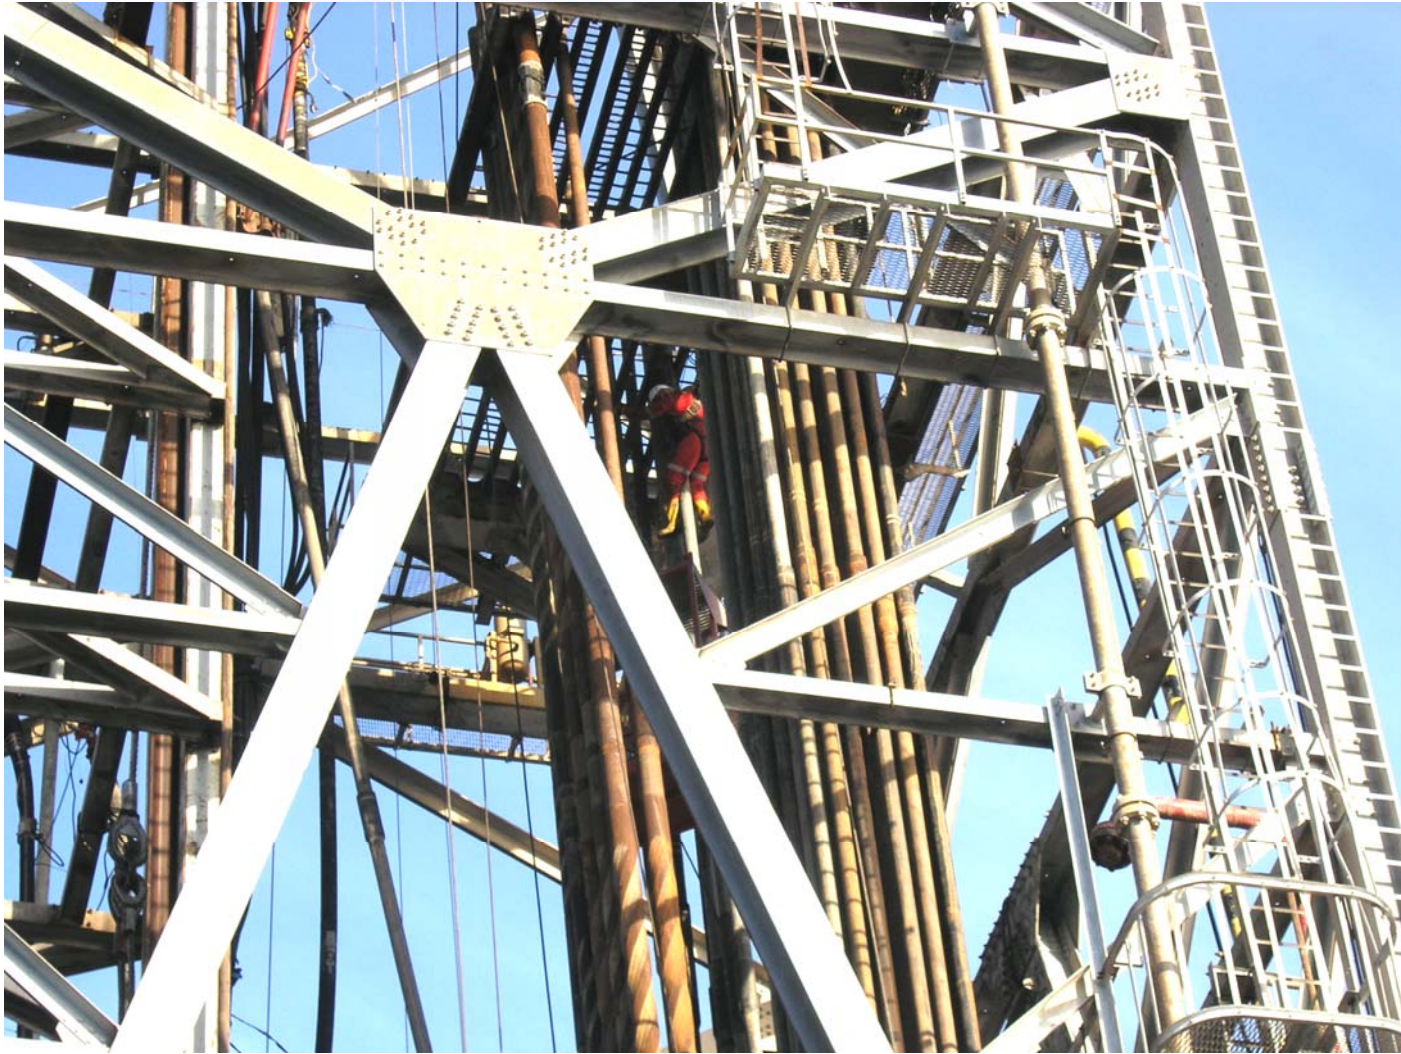
End of fall below the Monkey board

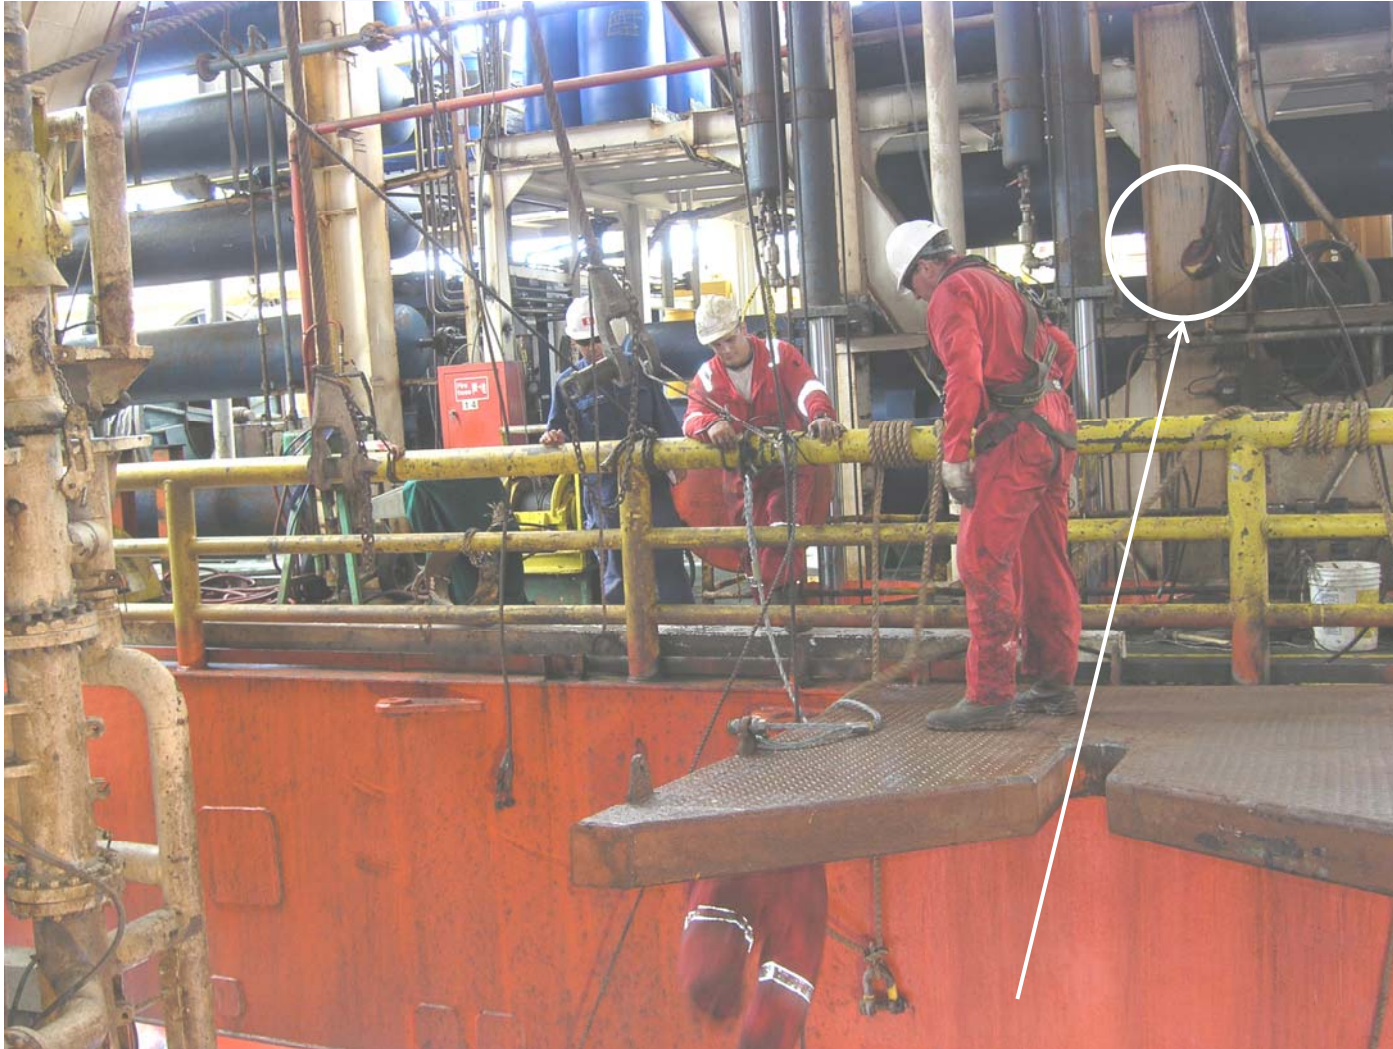
Inertia reel 45 degree

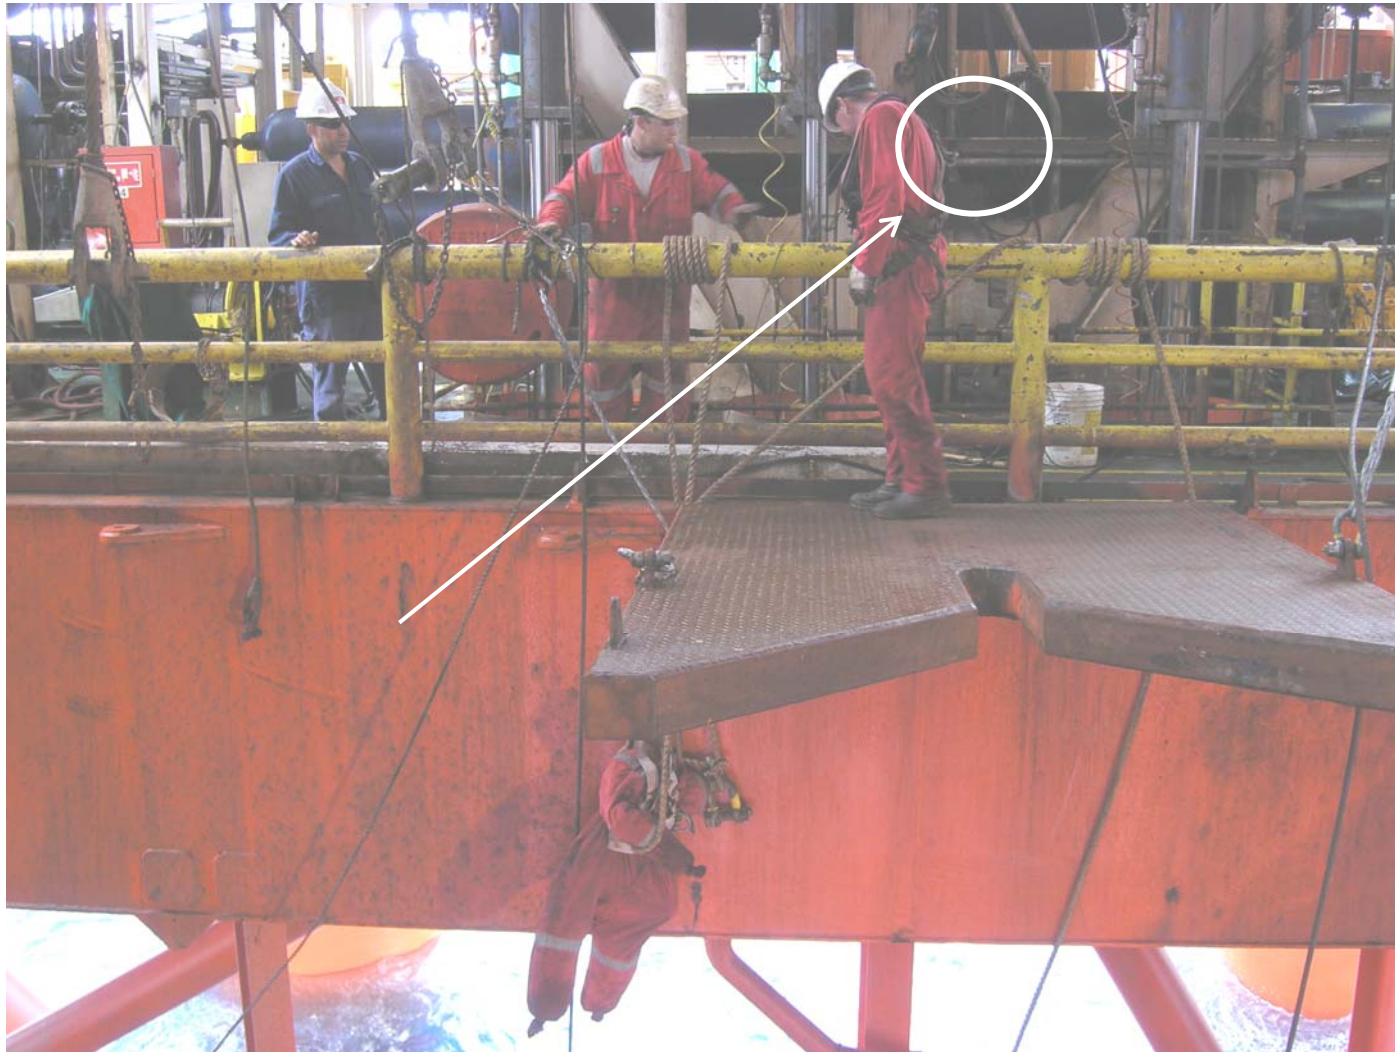
Inertia reel 45 degree

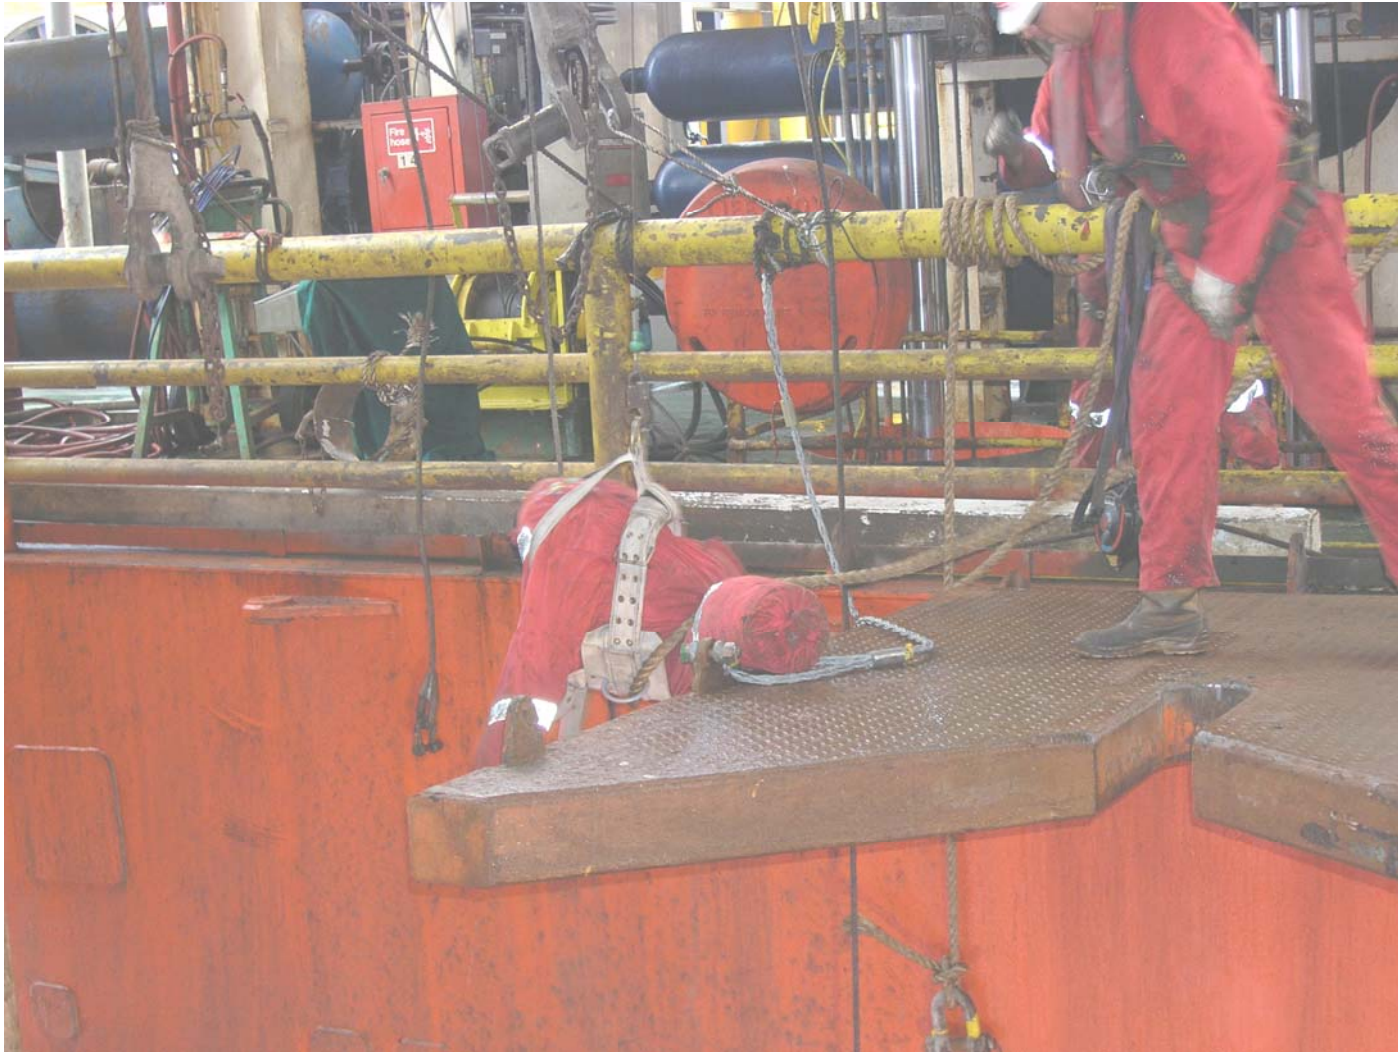
Inertia reel directly above the Victim

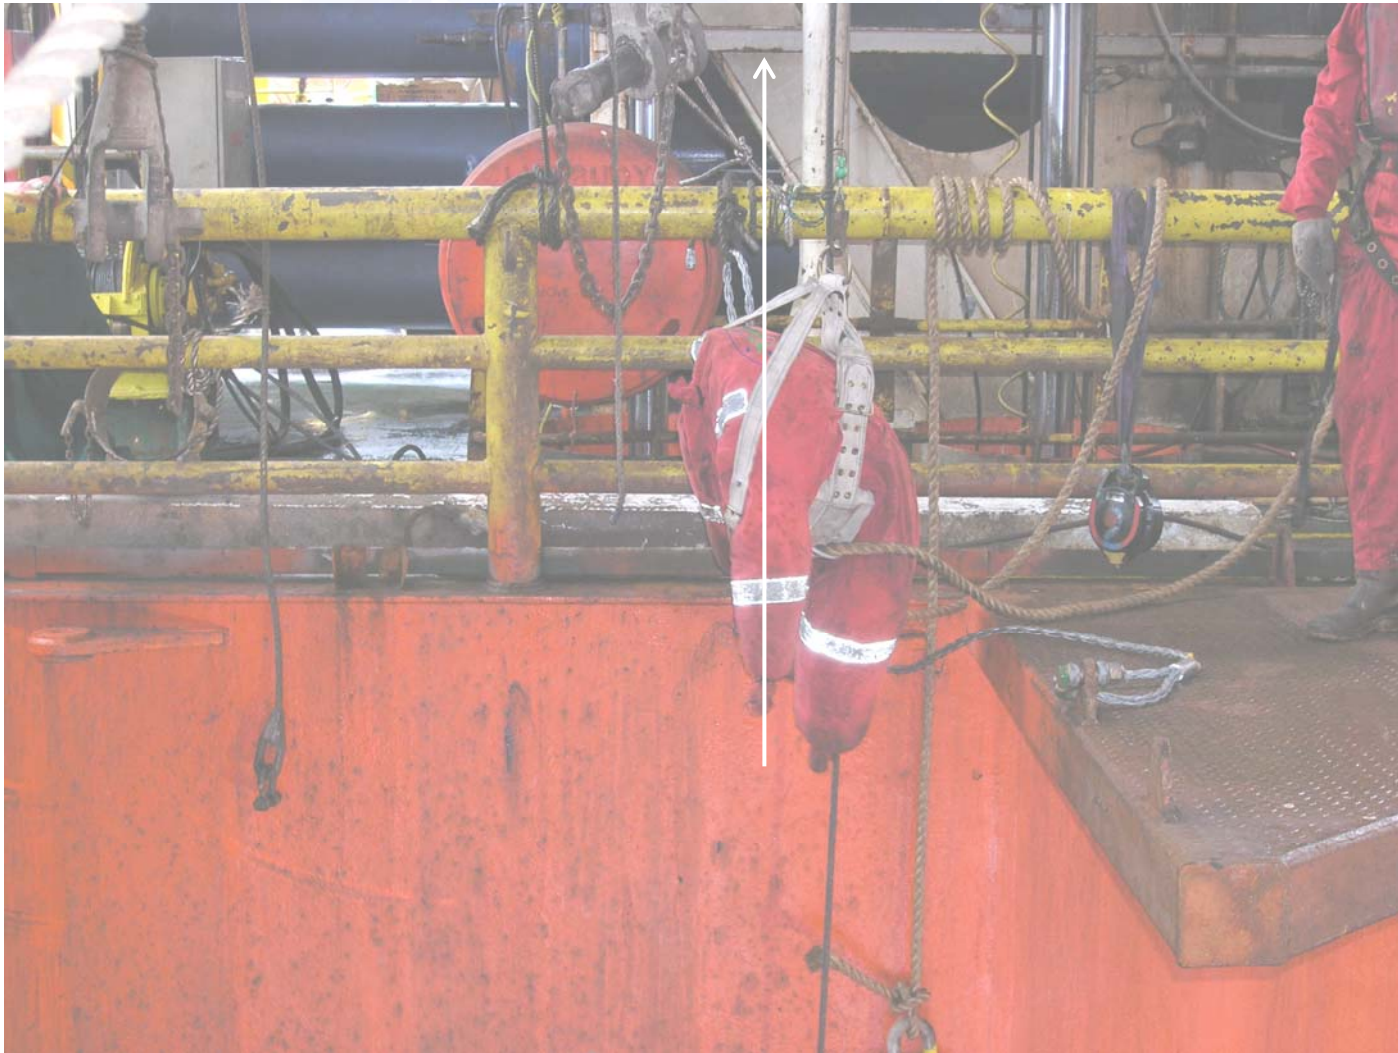
Inertia reel directly above the Victim
