Jack Bates Snub Line SIC

September 3rd 2006

Top-Drive (TDS) maintenance during rig move

Asst. Derrickman Injury to Shoulder & Jaw

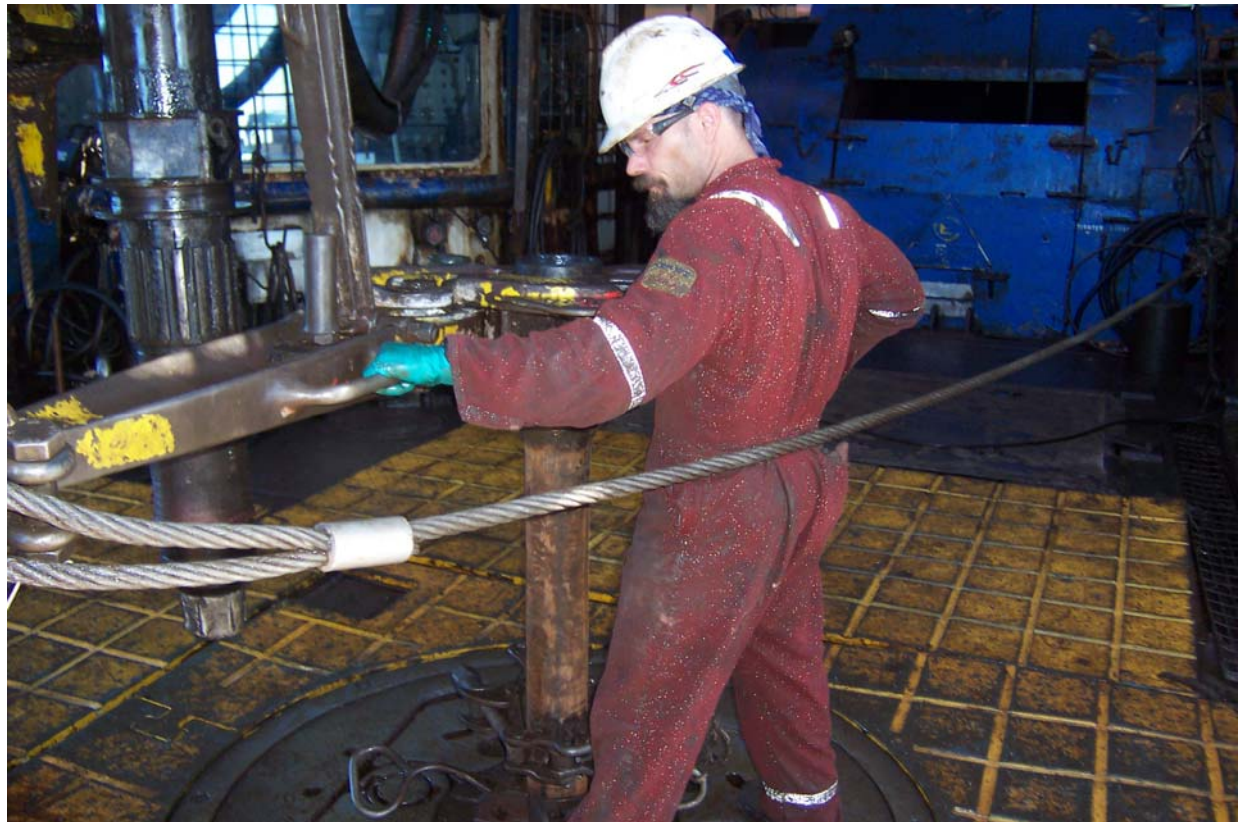
Re-enactment. Note : For illustrative purposes, the tong here is engaged on the stump in the rotary.

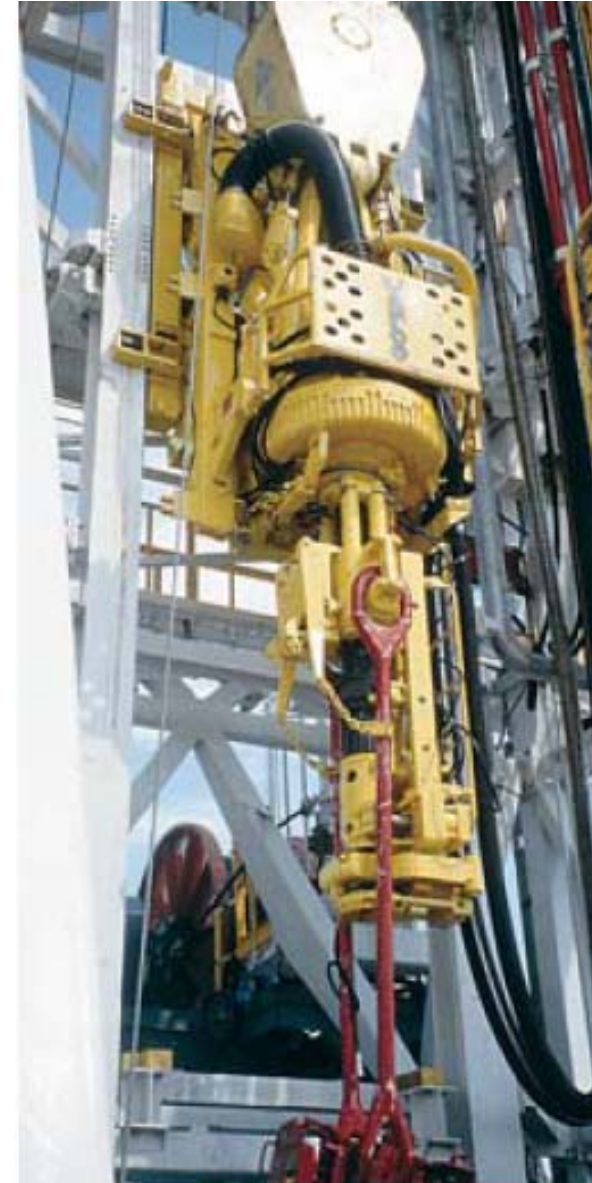
Whilst taking up slack in snub line, IP was caught between tong lever and snub line and was injured as described previously.

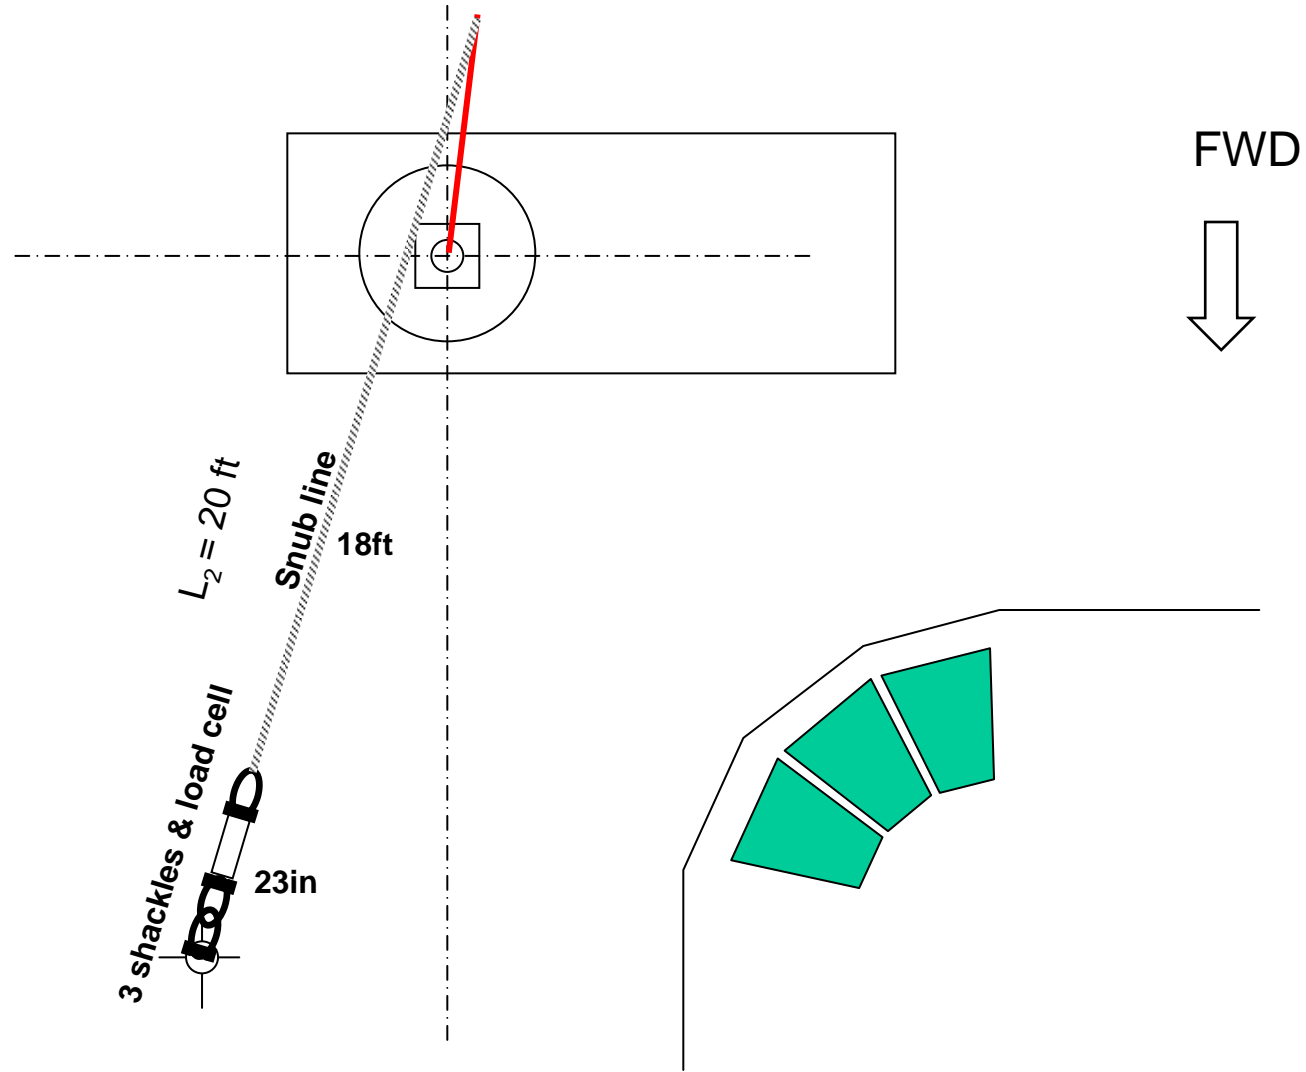
Jack Bates Drill Floor : Actual Setup

Basic snub line length too long

Excess line was habitually wrapped around backup post

Root Cause : Use of wrong length line

Recommendation : Implement a single specification of breakout line suitable for task
