CaCl₂ Brine Incident

#2313

M-I SWACO Broome
Western Australia

CaCl₂ Brine Incident #2313 Summary

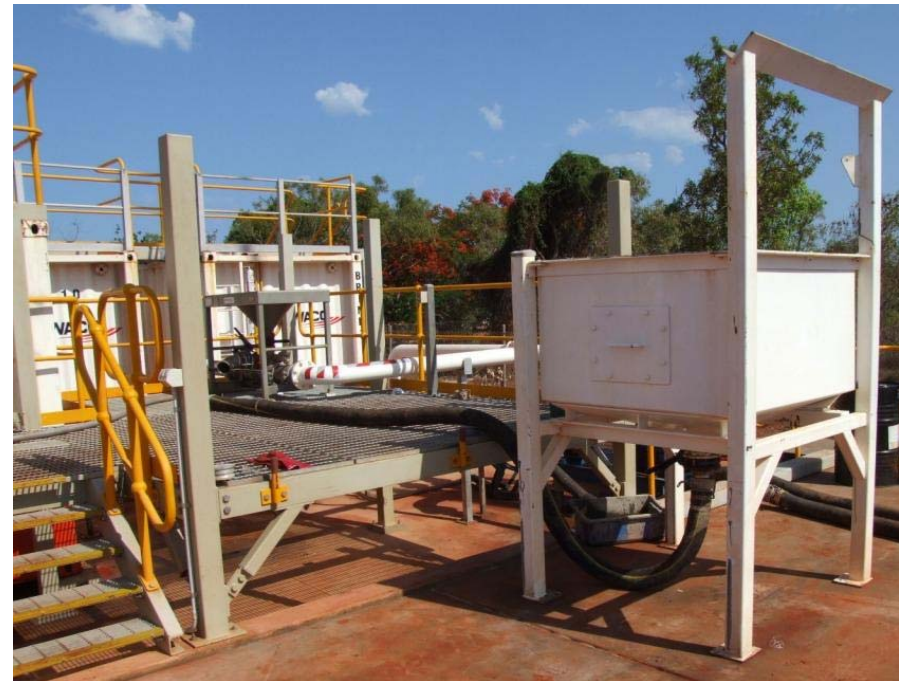
- On Tuesday 27-Nov-07 at approximately 13:00 the Broome facility operational personnel set up the 'Big Bag Hopper' (BBH) in preparation for the following days operations.

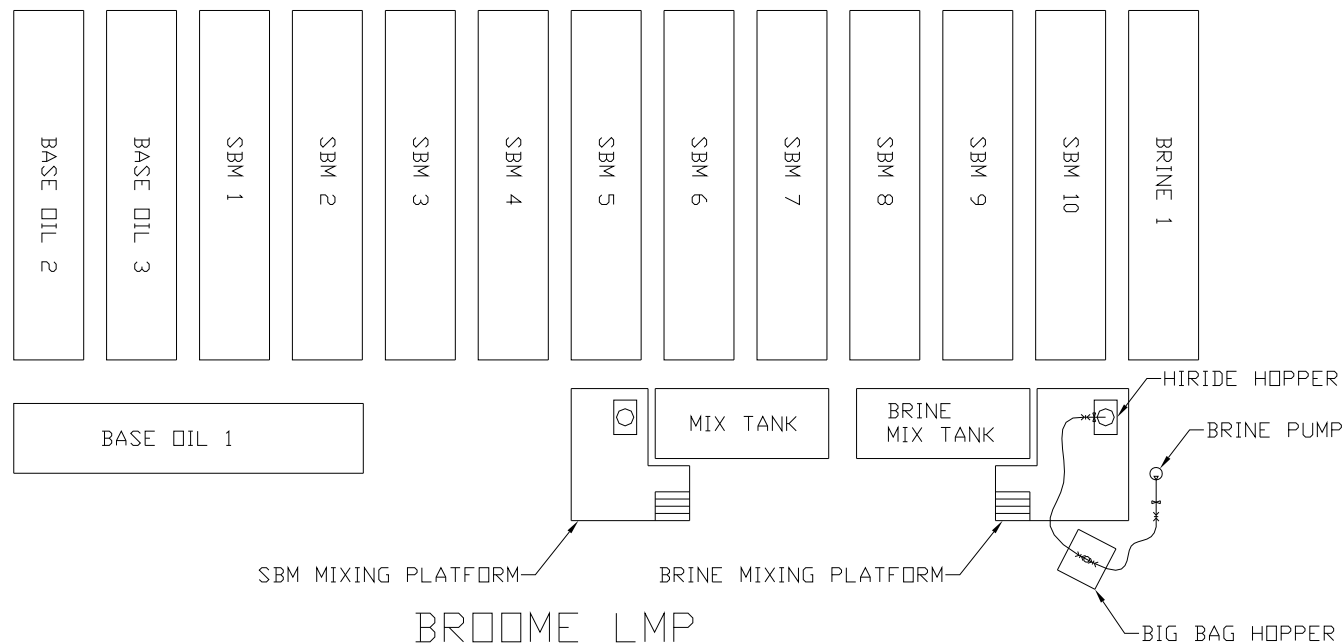
- The BBH was located on the concrete loading bay in front of the Brine mixing platform with the BBH outlet approximately 5m from and 0.5m below the inlet connection on the base of the 'HIRIDE Hopper' (HRH).

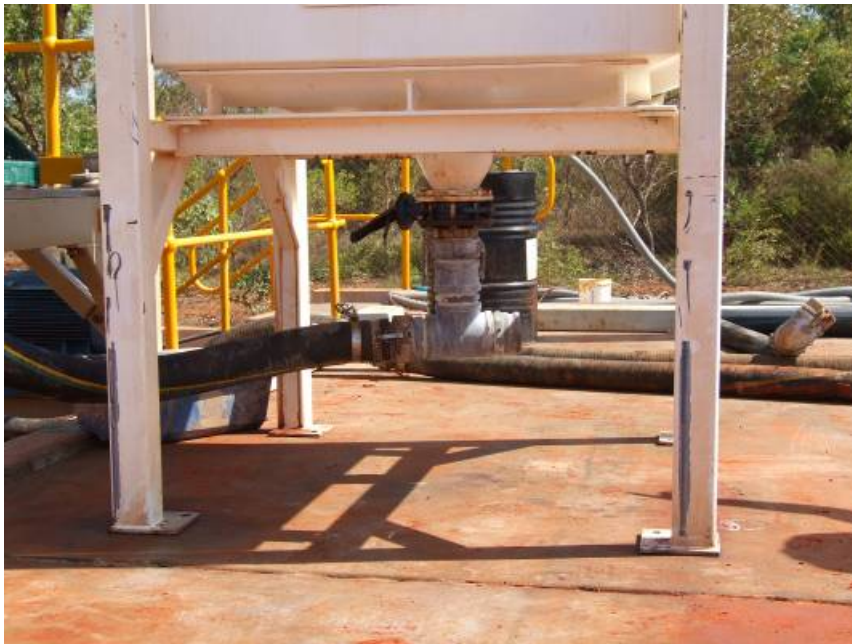
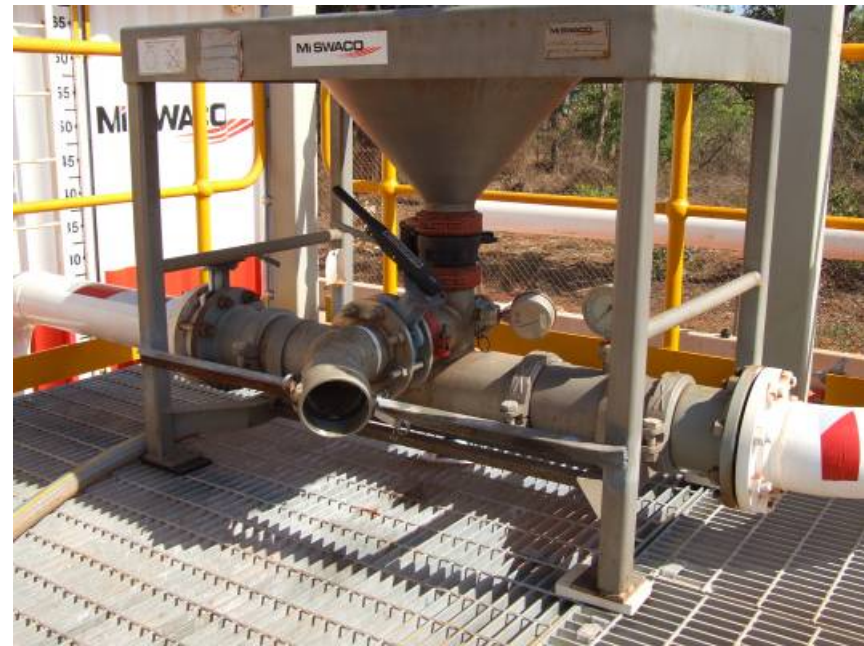
- A 4" 'Tee' piece was used to include the BBH in a fluid circuit from the pressure side of the Brine pump to the inlet connection on the base of the HRH.

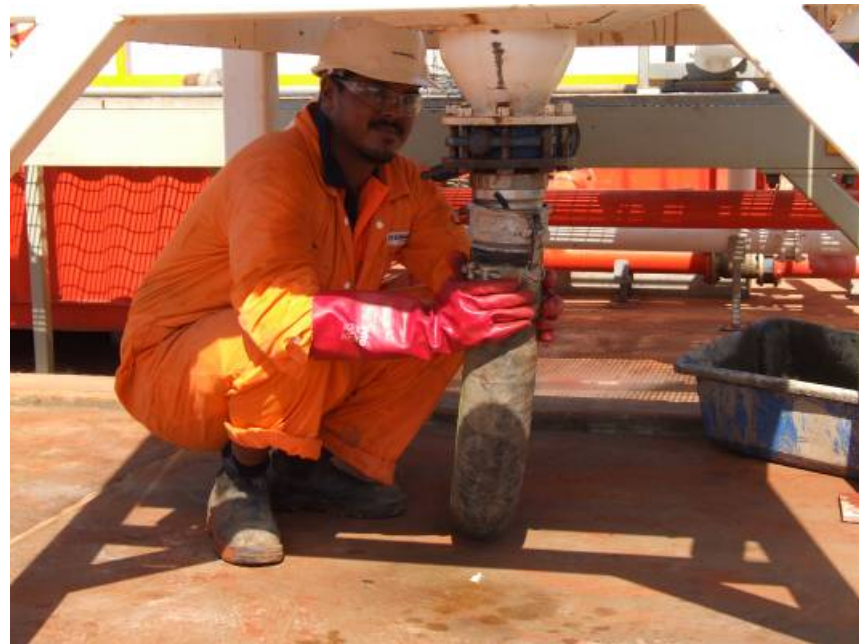
- The IP moved into position crouching under the BBH and removed the wire that had been used to ‘mouse’ the ‘Cam-Lok’ coupling.
- A fire hose was used to cool the general area around the IP.

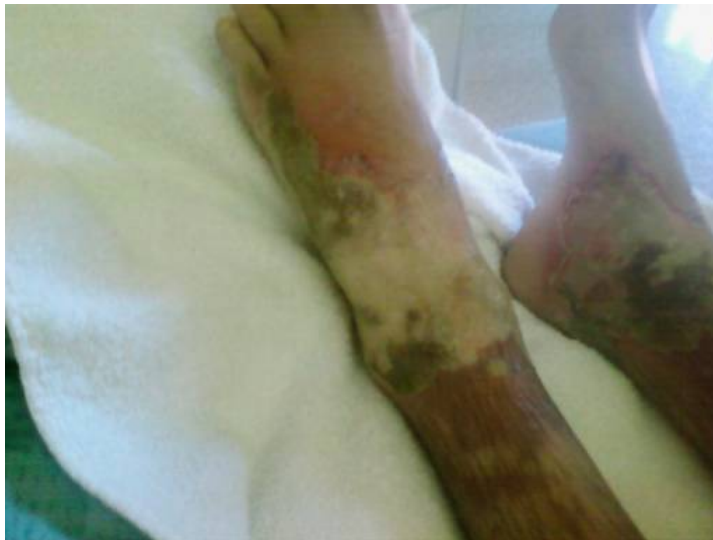
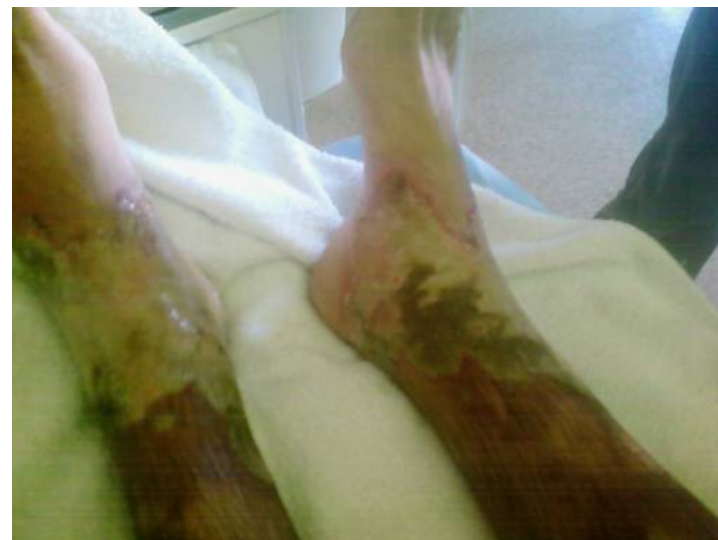
- The IP released the 'Cam-Lok' fitting and manipulated the hose to get it to the coupling to separate.
- As the coupling separated a quantity of fluid was released, some of which spilled onto the lower legs and feet of the IP, fluid also splashed onto his forearms and hands.
