# High Potential Near Miss.

## Atwood Eagle – 15<sup>th</sup> December 2009.

Drillsafe – 3<sup>rd</sup> June 2010  
Adelaide

Steve Ramsey – Operations Manager – Atwood Eagle  
Ben Prain – Regional HS&E Coordinator

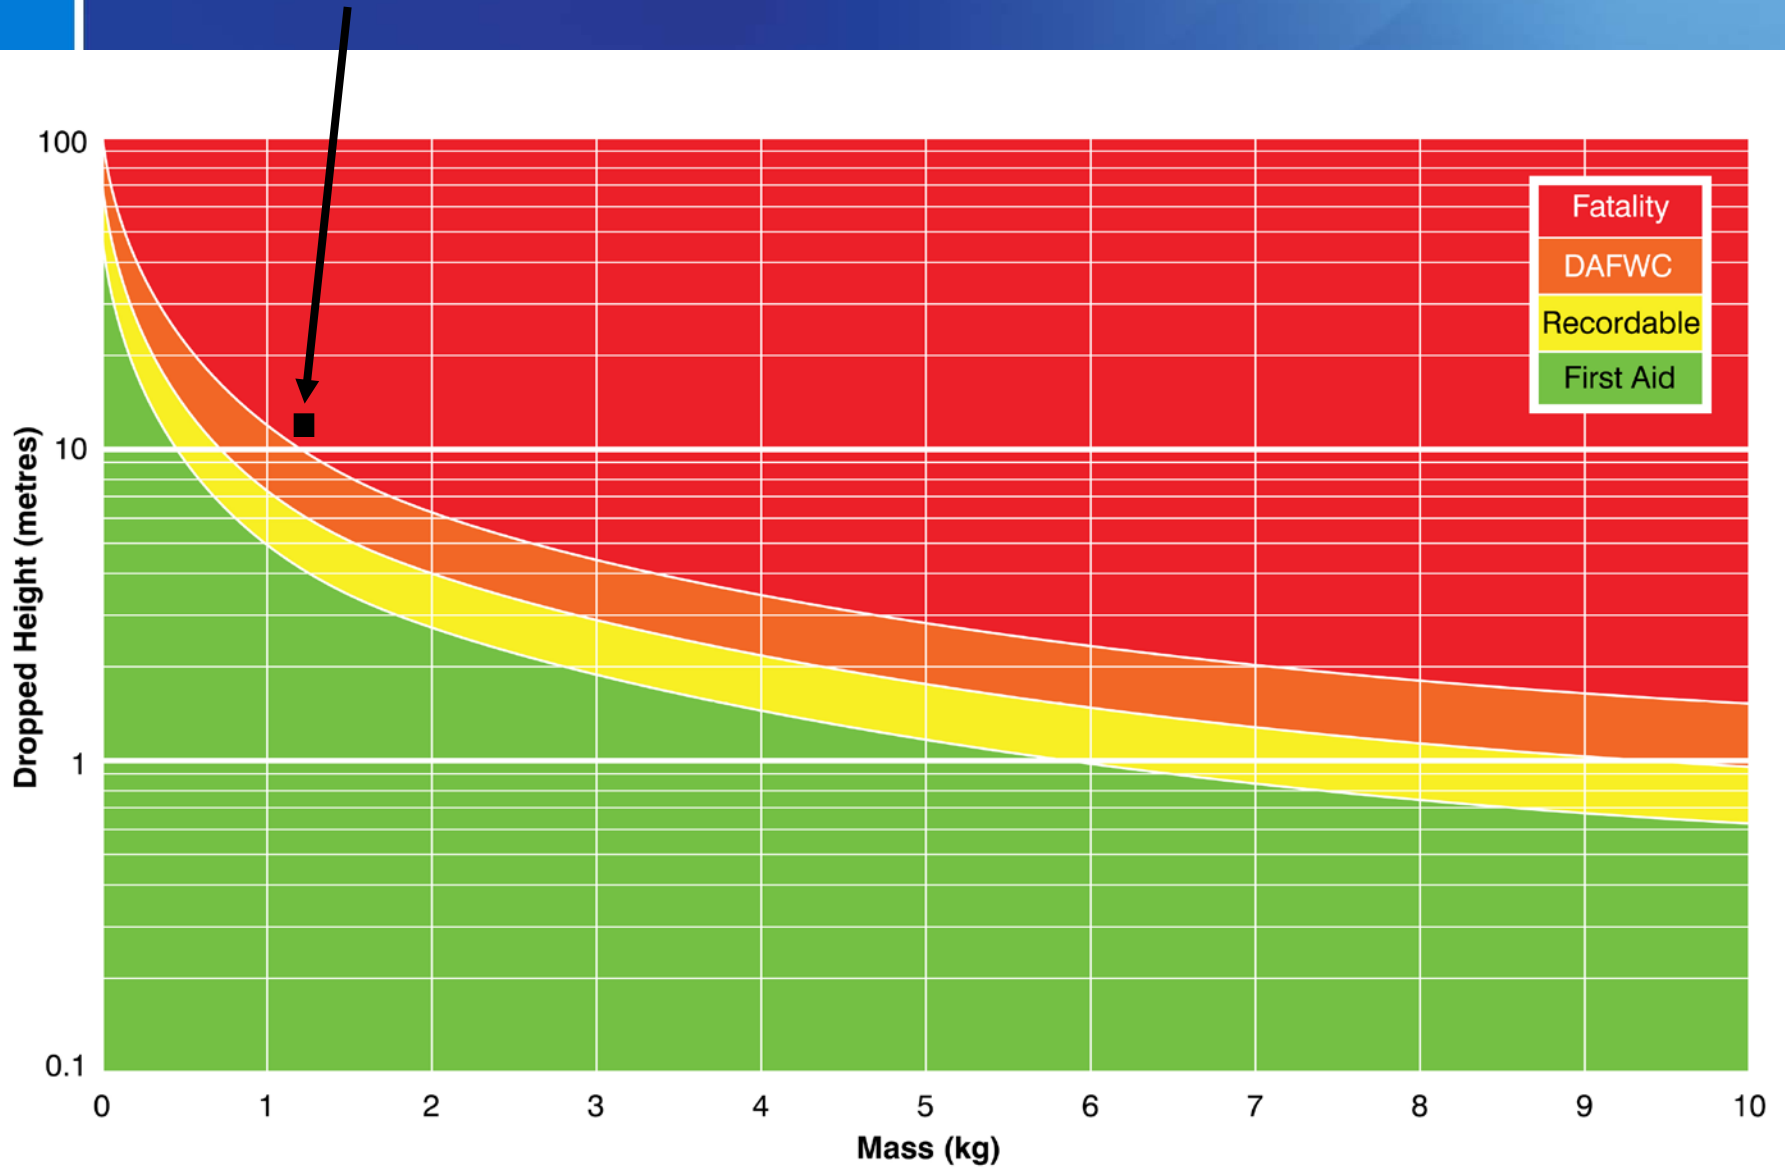
# DROPS Calculator.

- At approximately 22:15 on the 15th of December a Lead Roustabout (Dog-man) was walking along the Pipe Deck, when he noticed a steel inspection plate on the deck.
- The 2.55lb (1.155kg) inspection cover plate had fallen a maximum 11.45m off the forward end of the gantry crane due to corrosion of the retaining bolts.
- This event had the potential to cause a fatality if the plate had struck someone, based on the DROPS calculator.

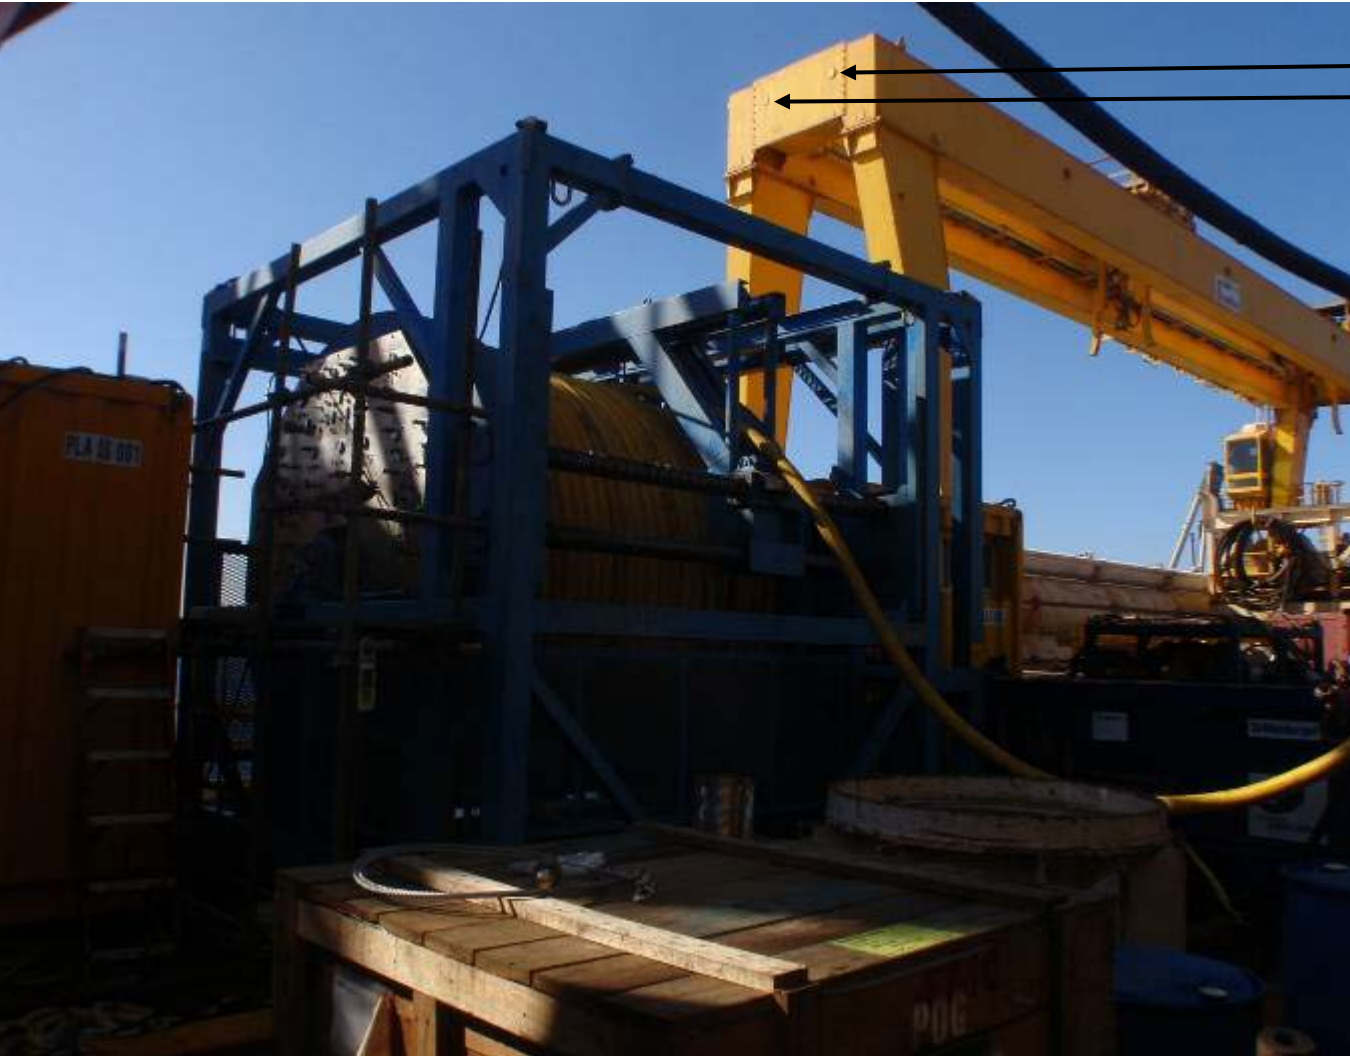
Inspection plates in situ, used for initial assembly of crane structure and then subsequently for inspection of the integrity of the hidden assembly bolts.

The inspection plates are located at both ends of the gantry crane main cross beam.

The inspection plates are held in place with two horizontally spaced 10mm bolts.

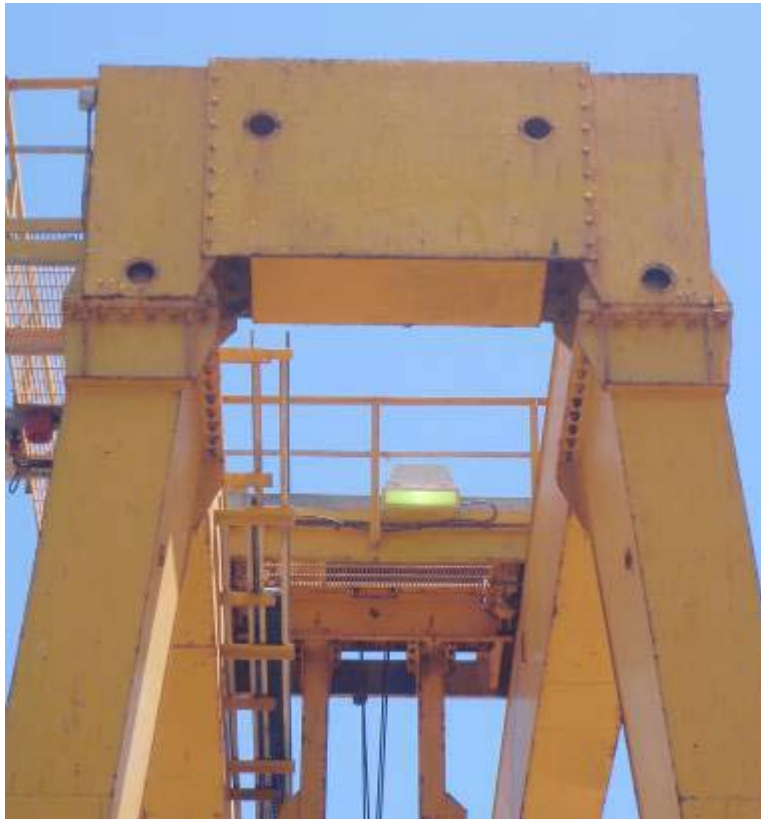
Plates removed from fwd end as safety precaution following incident.

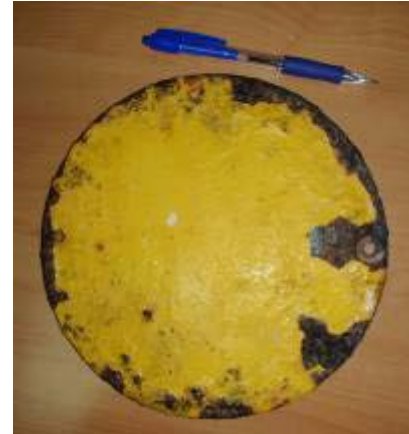
Inspection plate that fell to the deck. (1.15Kg fell 11.45m).

1. Gantry crane segregated and barriered off on rig - COMPLETE.
2. The other cover plates were removed from the forward end of the crane - COMPLETE.
3. Alternative materials for cover plate to be considered and installed including:
  - utilize a gasket sealant between cover plate and crane structure, keeping in mind that it should be easily accessed and fit for purpose in the marine environment.
  - (Note: It is not recommended to use Stainless Steel fasteners in this case) – COMPLETE – Perspex covers installed.
4. Communicate the incident and maintenance expectations with the trades and ask for feedback regarding possible improvements - COMPLETE.
5. Review the incident at Pre-tour and Weekly safety meetings - COMPLETE.

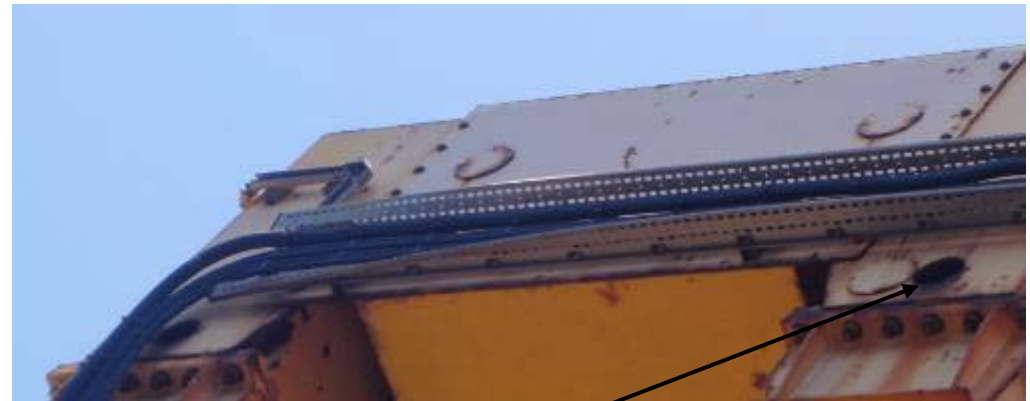
Inspection plates left open, attached by one securing bolt. *(NB. All inspection plates have been removed following the incident).*

- There is an underlying acceptance (hazard not perceived) of leaving the plates secured with one bolt and open.
