Elevator's strike Diving Board

At 4.30am on 14th April 2010''

Drillsafe - Adelaide - 3rd June 2010

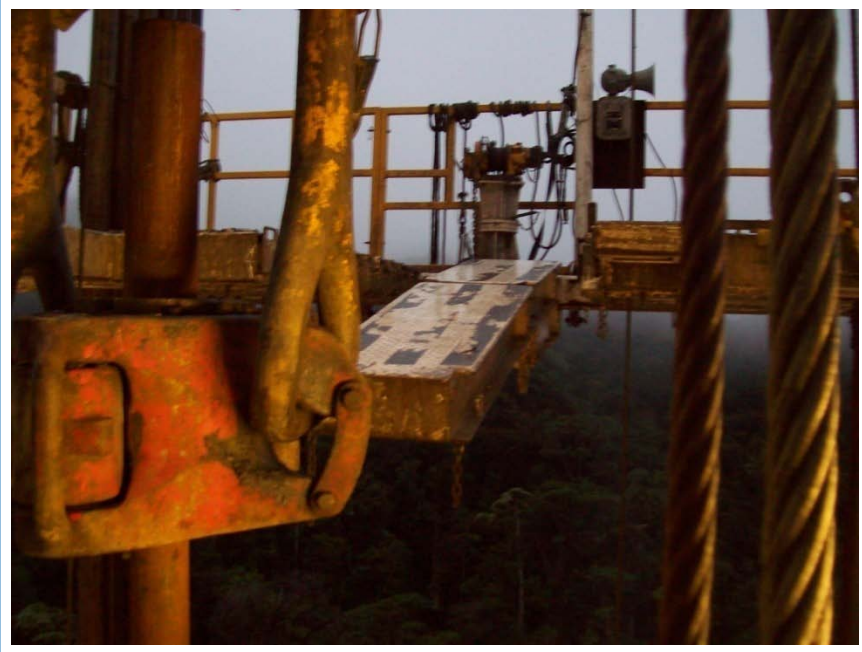
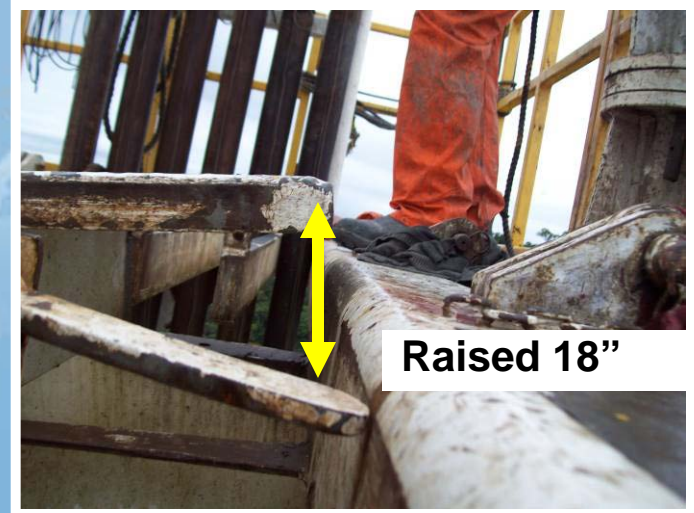
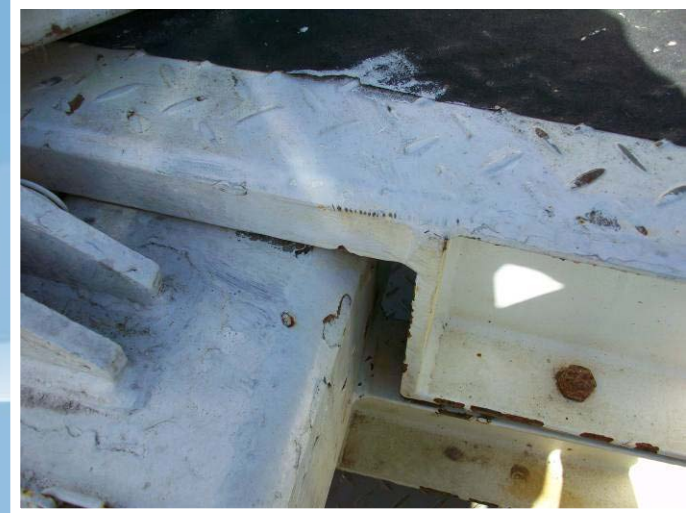
Resultant Damage

- Driller had just completed POOH and laying out drill pipe singles.
- The next task was to start running racked stands in the hole to break and lay out. There were 6 stands of 5 ½ DP, 4" HWDP and 4 ¾ DC's.
- After running 4 stands of HWDP into hole the rig ran out of pipe dope.
- Because there was no pipe dope the Driller decided to use the Mouse hole to break the remaining stands.
- The 1st racked stand to be run into the Mouse hole (5th stand of 4" HWDP) snagged monetarily on the edge of the mouse hole as it was being lowered in.
- As the stand of pipe lowered in the Mouse hole the elevators hit the Diving Board causing significant damage.

Action	Status
Raise an Equipment Failure Report for the repair of the Diving Board/Monkey Board so that repairs are tracked through repair to completion.	EFR raised. Material ordered and received. Waiting on opportunity to repair.
Conduct inspection i.e. MPI of all repairs undertaken to damaged Equipment	Awaiting repairs
Add the inspection of the Jam Nut and Adjusting Screw to all PM inspections.	Completed.
Ensure Jam Nut is fitted prior to rig commencing next contract. Add to Pre Spud Inspection.	In progress
Review "Layout Sideways" JSA and include all learning's from this incident.	Completed.

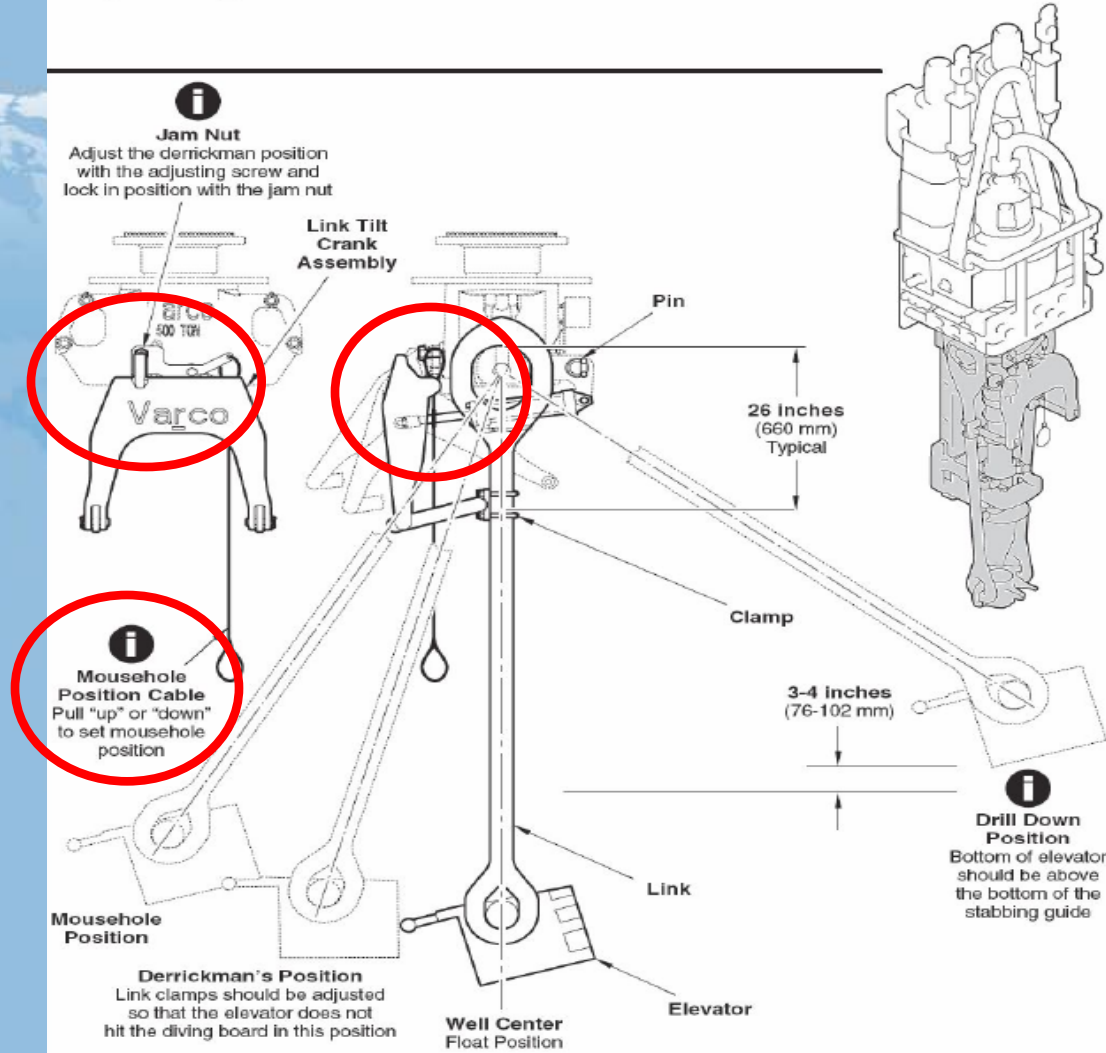
Link Tilt – Jam Nut

- Statements said the bails were not retracted prior to lowering the stand.
- Using the Mouse hole to break HWDP is only performed sometimes and would not be considered a routine task.
- The Adjusting Screw and Jam Nut were not installed on the Link Tilt. The Jam Nut stops the bails from being extended to the Mouse Hole during normal operations
- The Planned Maintenance System inspection does not specifically refer to the Jam Nut or Adjusting Screw in any inspection. The OEM does not indicate it should be part of an inspection routine.

Adjusting the link tilt

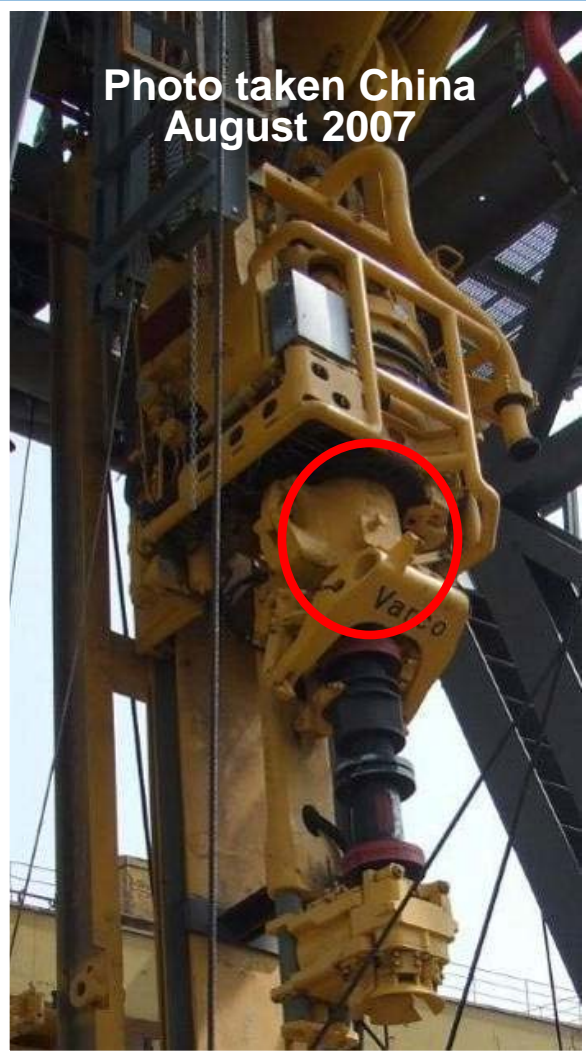
- One of the original Mechanics still with HAES stated that the Jam Nut and Adjusting Screw were intact when the rig was first commissioned late 2007.
- The earliest photo that can be found with the Jam Nut and Adjusting Screw missing was taken 9th January 2009.
- National Oilwell Varco Top Drive Service Manual states “Jam Nut – adjust the Derrick man's position with the adjusting screw and lock into position with the Jam Nut adjusting screw and lock” There is no mention of ongoing inspections.
- NOV Safety Alert dated 21st January 2010 about TDS8 and Jam Nuts breaking off.
- MR was raised for new Jam Nut and Adjusting Screw on the 25th March 2010.

Photo taken China
August 2007

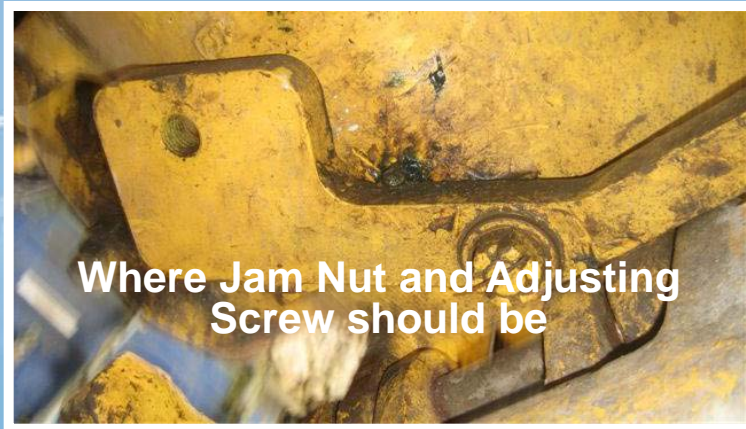
Where Jam Nut and Adjusting
Screw should be

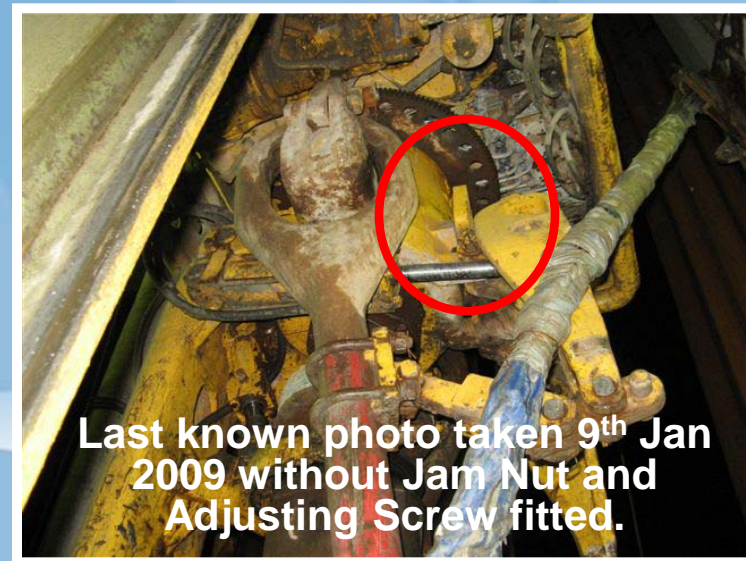
Last known photo taken 9th Jan
2009 without Jam Nut and
Adjusting Screw fitted.

- The Investigation team concluded that the jam nut and adjusting screw had been removed from Rig 103 some time between the first commissioning in December 2007 and prior to the 9th of January 2009 (approximately a 12 month period) and that the rig continued to operate without this safety control in place as a normal practice. The investigation team has been unable to find out any further detail when or why the link tilt jam nut was removed or for what reason.

The team considers the removal of the jam nut/adjusting screw and the acceptance to operate without this control in place is the root cause of the incident.
