# Billy Pugh Incident

Maersk Discoverer

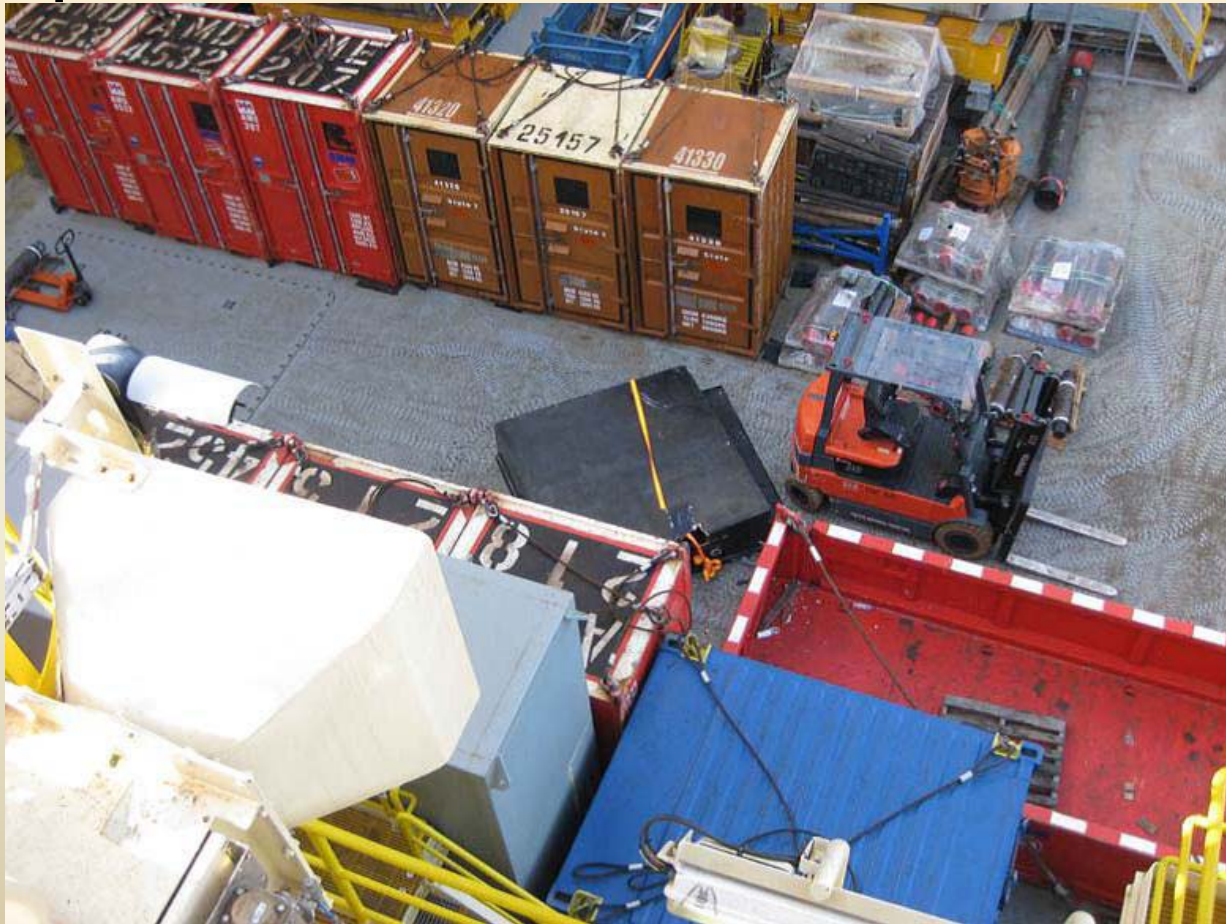
## Final position of box

- 30<sup>th</sup> December 2009 – around 10:00
- Helicopter approaches for landing
- Box and Billy Pugh (200kg) blown from Emergency Generator Roof
- No injuries were sustained

- All items surrounding heli-deck removed or secured
- Crews notified of incident and instructed to watch for ANY items around heli-deck
- SJA and USP revised to include this hazard
- Billy Pugh moved to different location

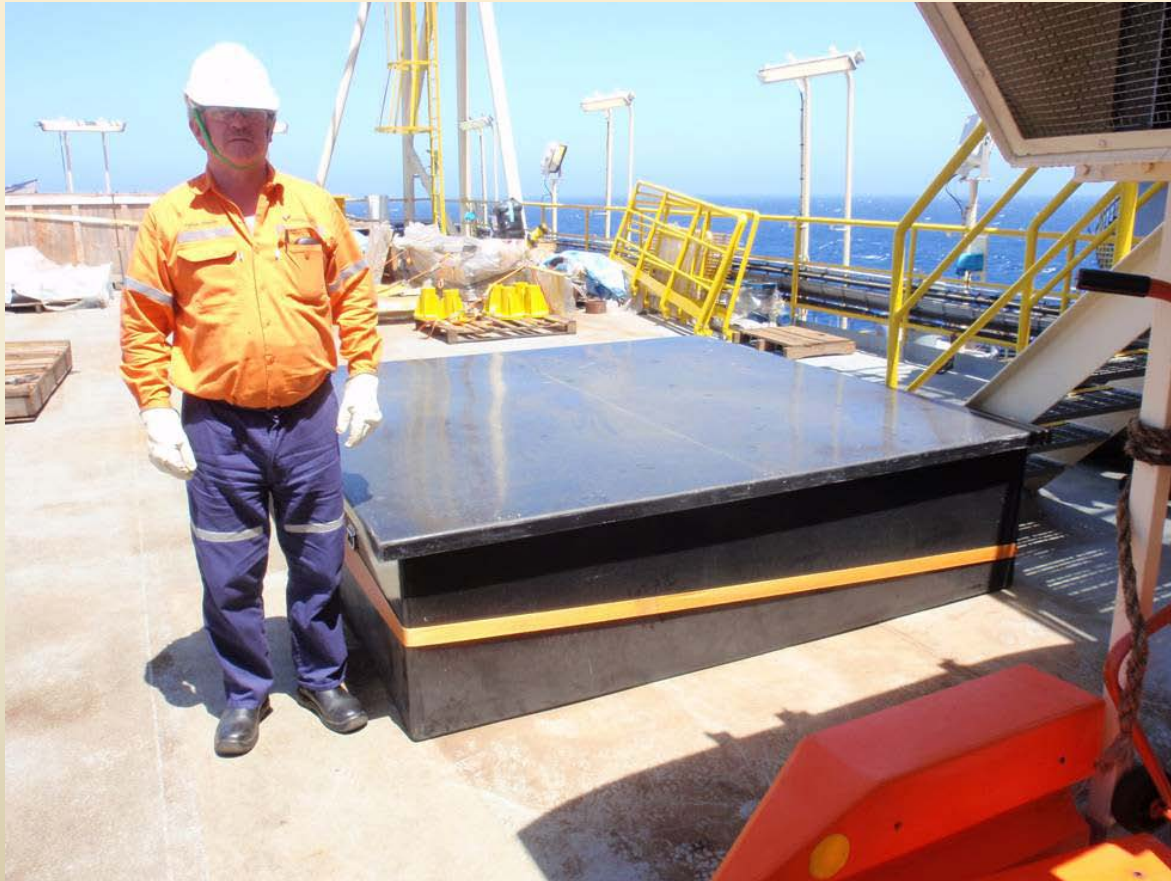
## Dimensions of box

- Box Placement – deliberate for easy access
- 2" Dunnage – created an air gap
- Restraint – not secured to deck
  - Lid was secured using AD strap
- Large surface area of box
- Down-wash from helicopter higher than usual (EC225) – *7 previous landings*
- Wind direction of the day

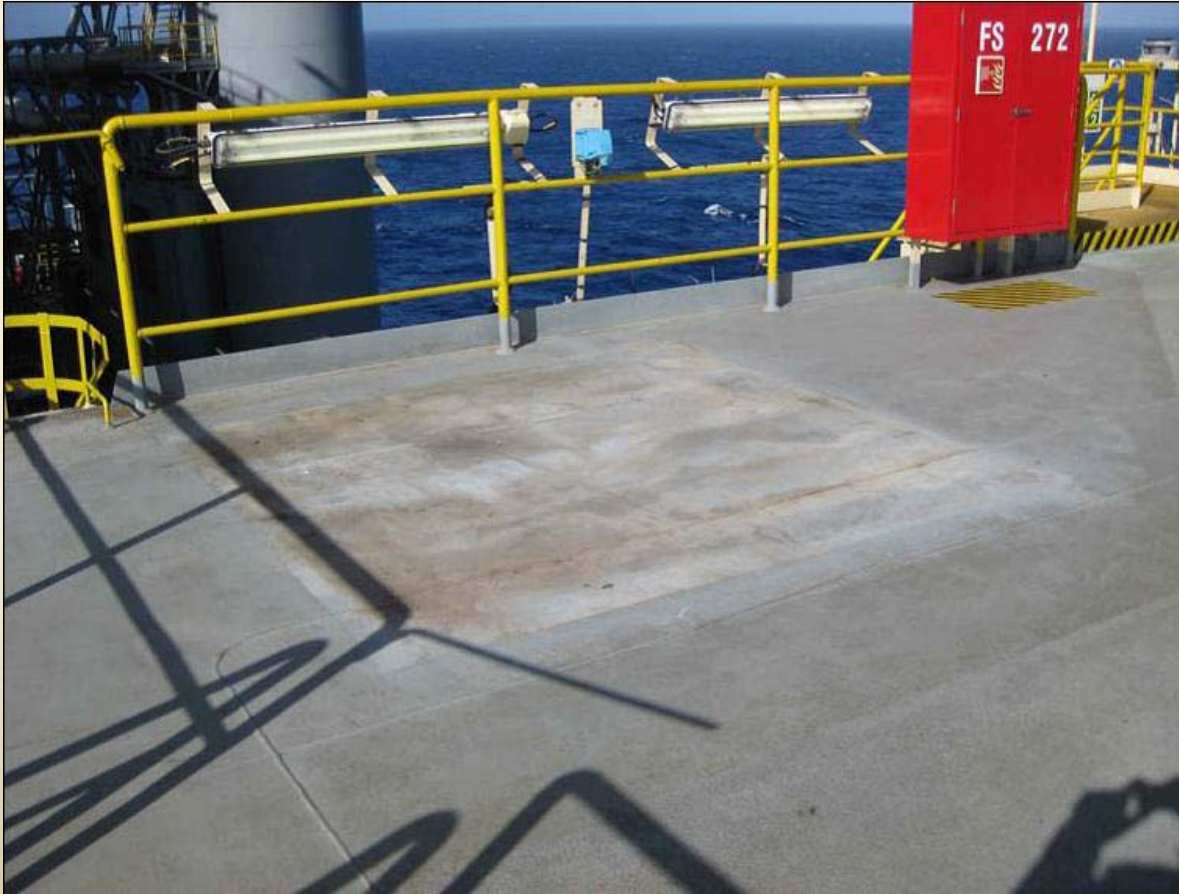
## Original position of box

- Heli-ops major focus
  - Box in position for 5 months prior
  - Several audits conducted on risks in area
  - Extensive inspection by WEL Aviation Dept
  - Valid helideck certificate was in place (HCA)
- Despite this close scrutiny, hazard was not identified
