Drill Press Incident Review OCEAN EPOCH

July 2007

G·E·M·S
GLOBAL EXCELLENCE
MANAGEMENT SYSTEM

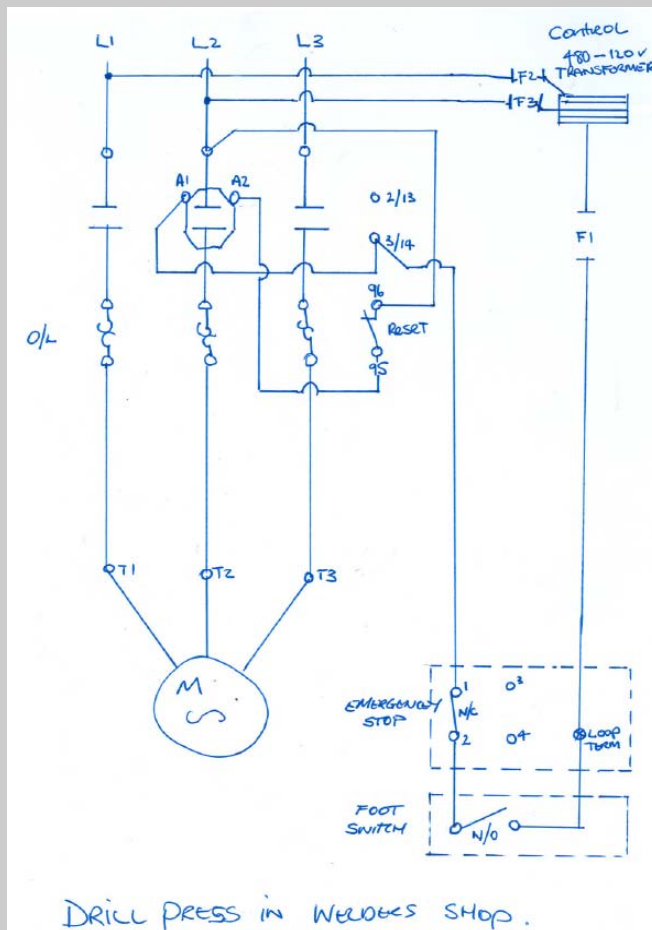
< OLD

- **The foot switch had been replaced approximately 24hrs before the incident at the request of the relief welder which was on days off at the time of the incident. The original pedal functioned in such a way that the operator would press the pedal and release it for the machine to start, the machine would then run until the operator pressed and released the pedal again (to start - press and release, to stop - press and release). This pedal did not have a guard over the top of it to prevent it being functioned if something dropped on it or if it was stood on accidentally with the ES button disengaged. It also was not uniform with the pedals on the other equipment in the workshop (pedestal grinder, cutting saw). These issues were brought to the attention of the electrician whom in turn went and ordered a new pedal in an effort to improve safety and obtain uniformity with the other pedals in the workshop. Through the ordering process it was realized there was a new pedal in stock which was then installed.**

- Re-configure wiring to incorporate an interlock system, where as the activation of the machine requires a two step sequential method to start the machine (1, depress the foot switch. 2, press the start button) see attached procedures. This will be applied to all machinery with a foot switch.
