Ocean Bounty Dropped Riser Stand Incident

Incident Number OB 144-03-07

Well Location: AP-4

16th January 2007 @ 02:40

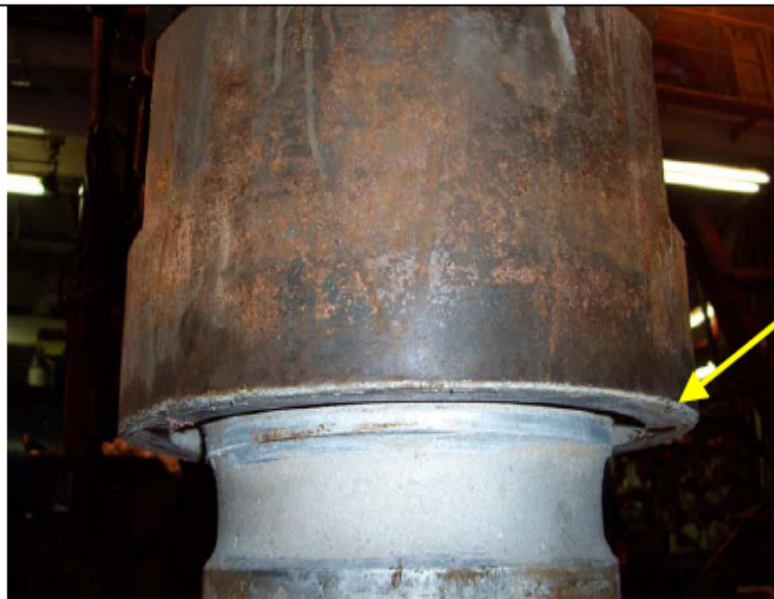
This is the lifting collar on the stand of production riser. Note the 2" lip above where the elevators would have latched.

Below, you can see where the joint's lifting collar caught on the VARCO front guard which caused the joint to lift up and land on IP's foot. Remember, by habit of running drill pipe/collars, the Derrickhand took the stand out of the rack/finger and the stand leaned into the upcoming top drive because there is not a lot of space between the top drive and stabbing area.

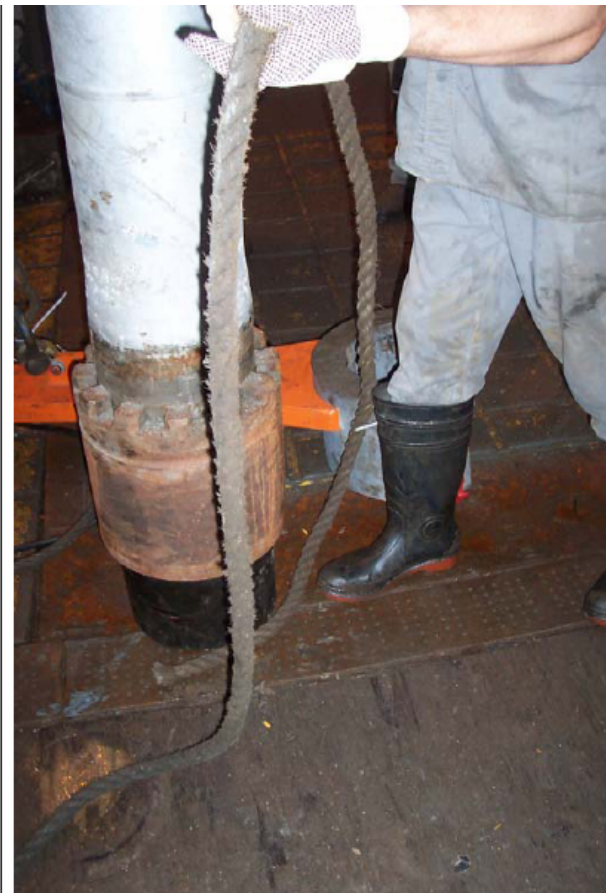
This is the best approximation of where his foot would have been from the perspective of the other hands on the rig floor at the time. His position is between the stand and the stump in the rotary.

Note: the joint was not in this exact position when the actual event occurred, but where the joint finally stopped after the incident.
