# Dropped Block Incident

Learning's from a high potential incident where the consequences could have been catastrophic

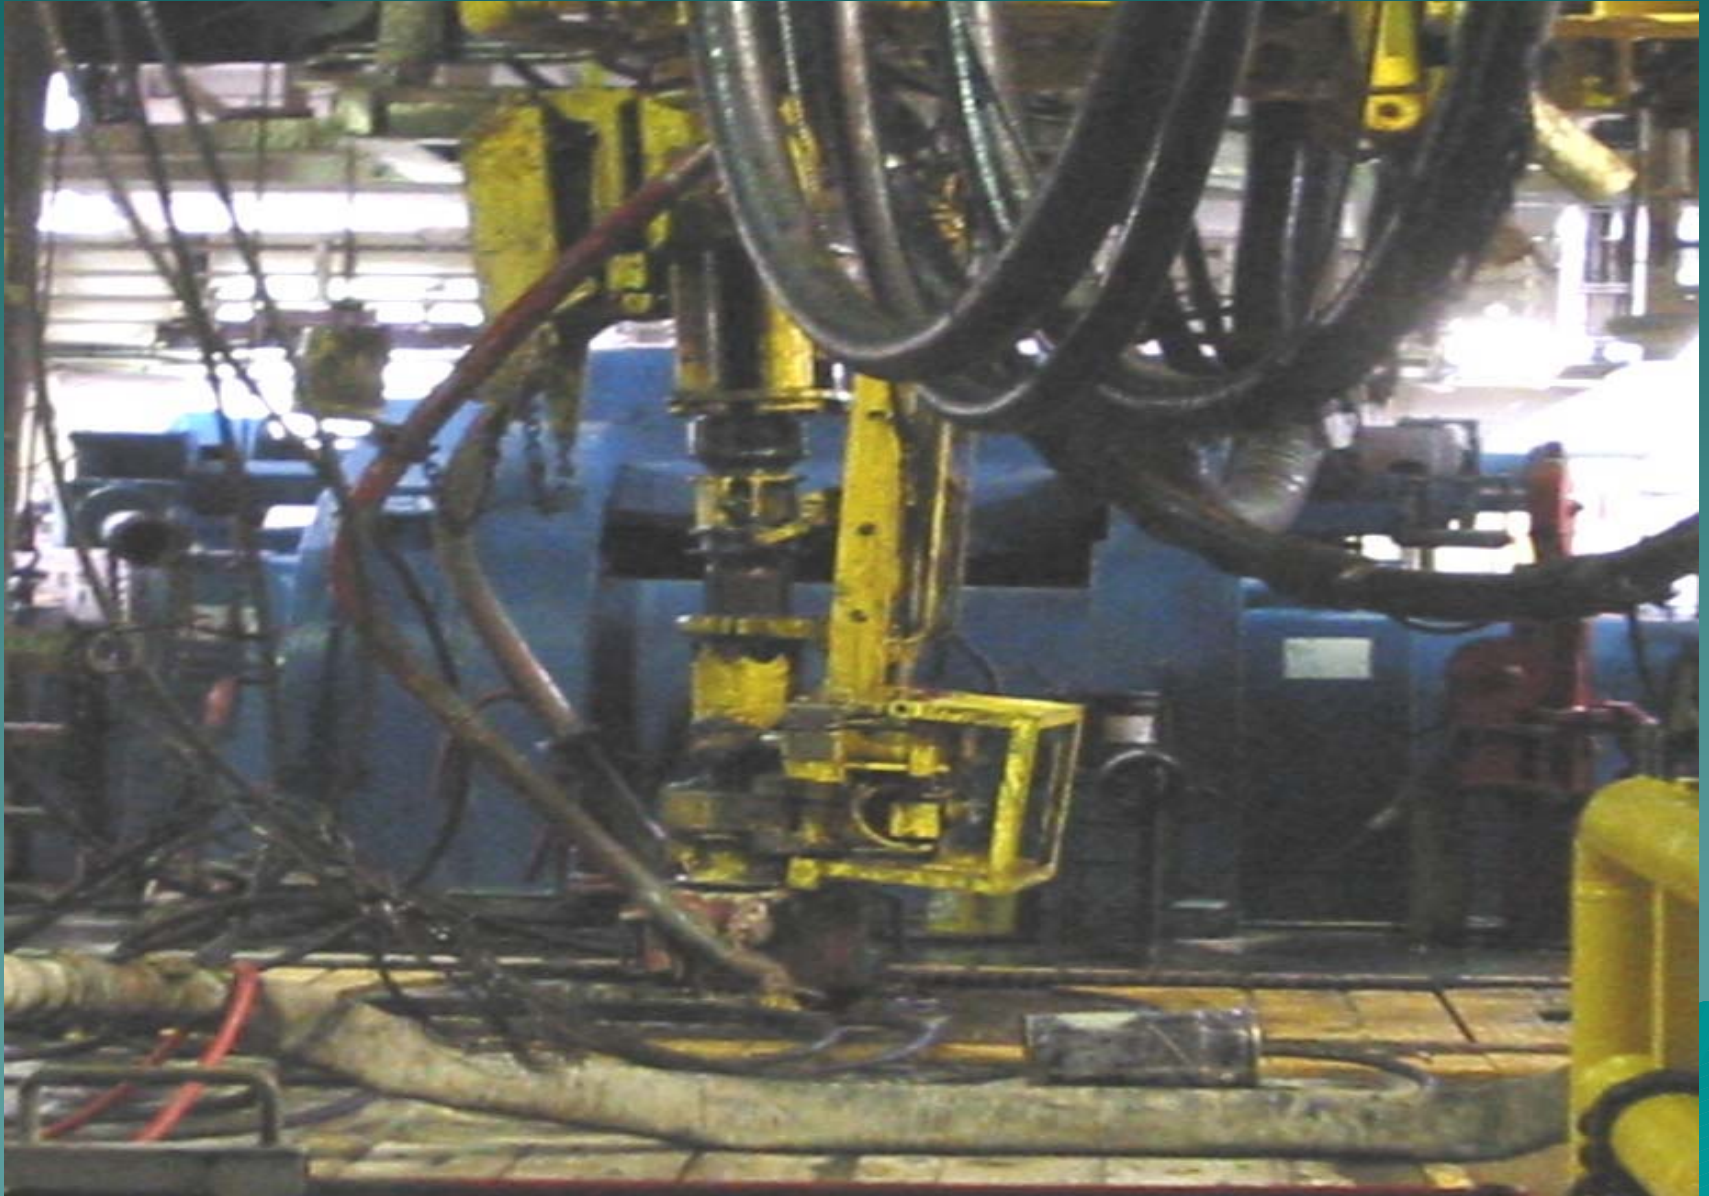
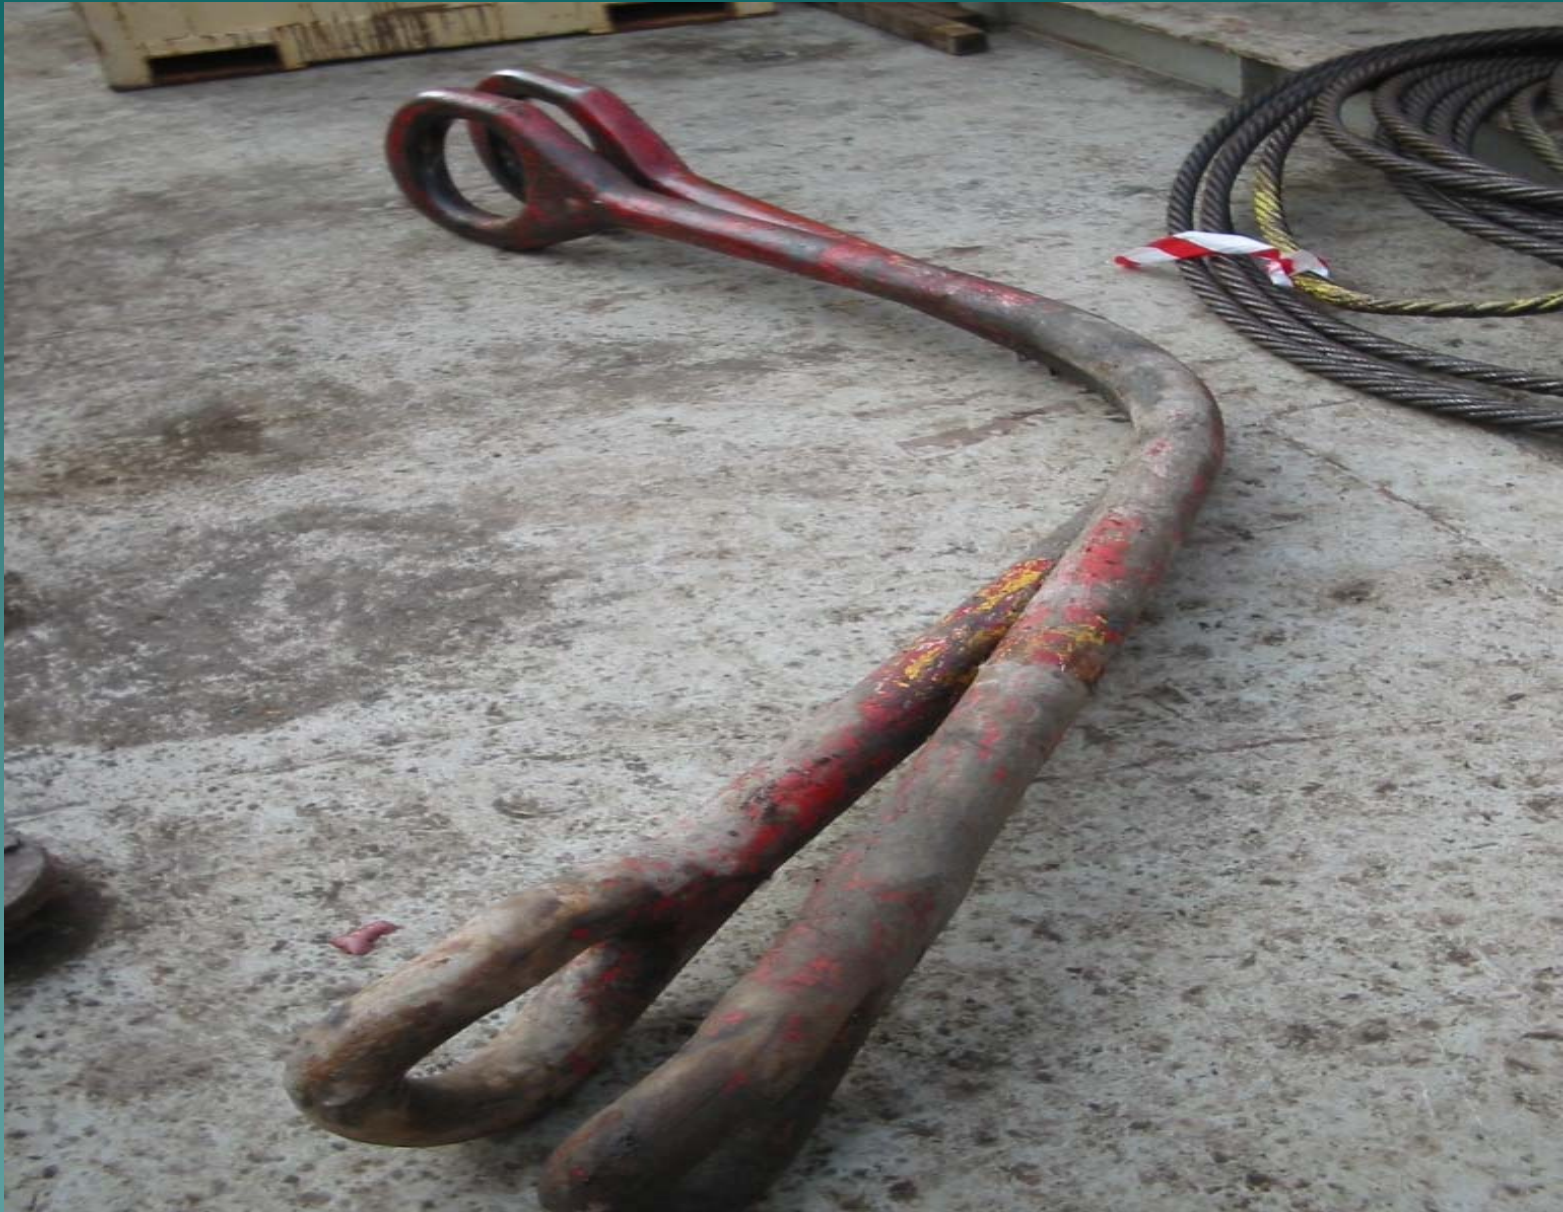
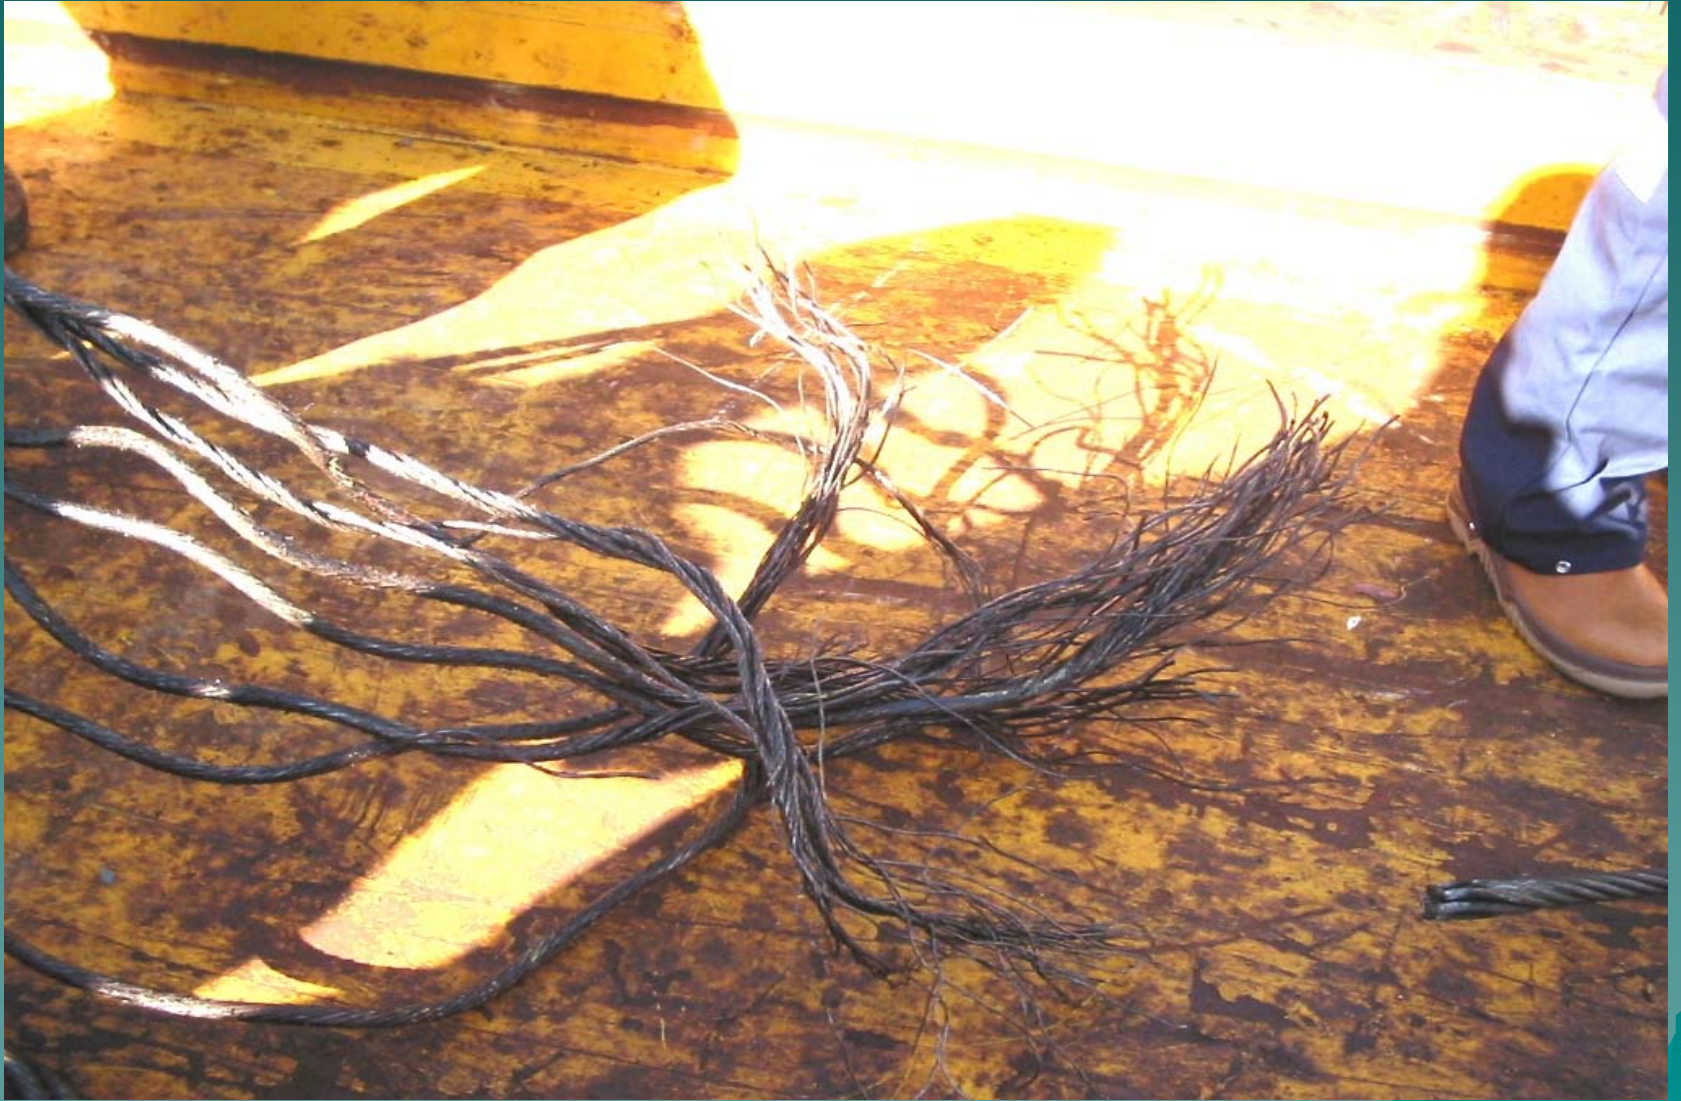
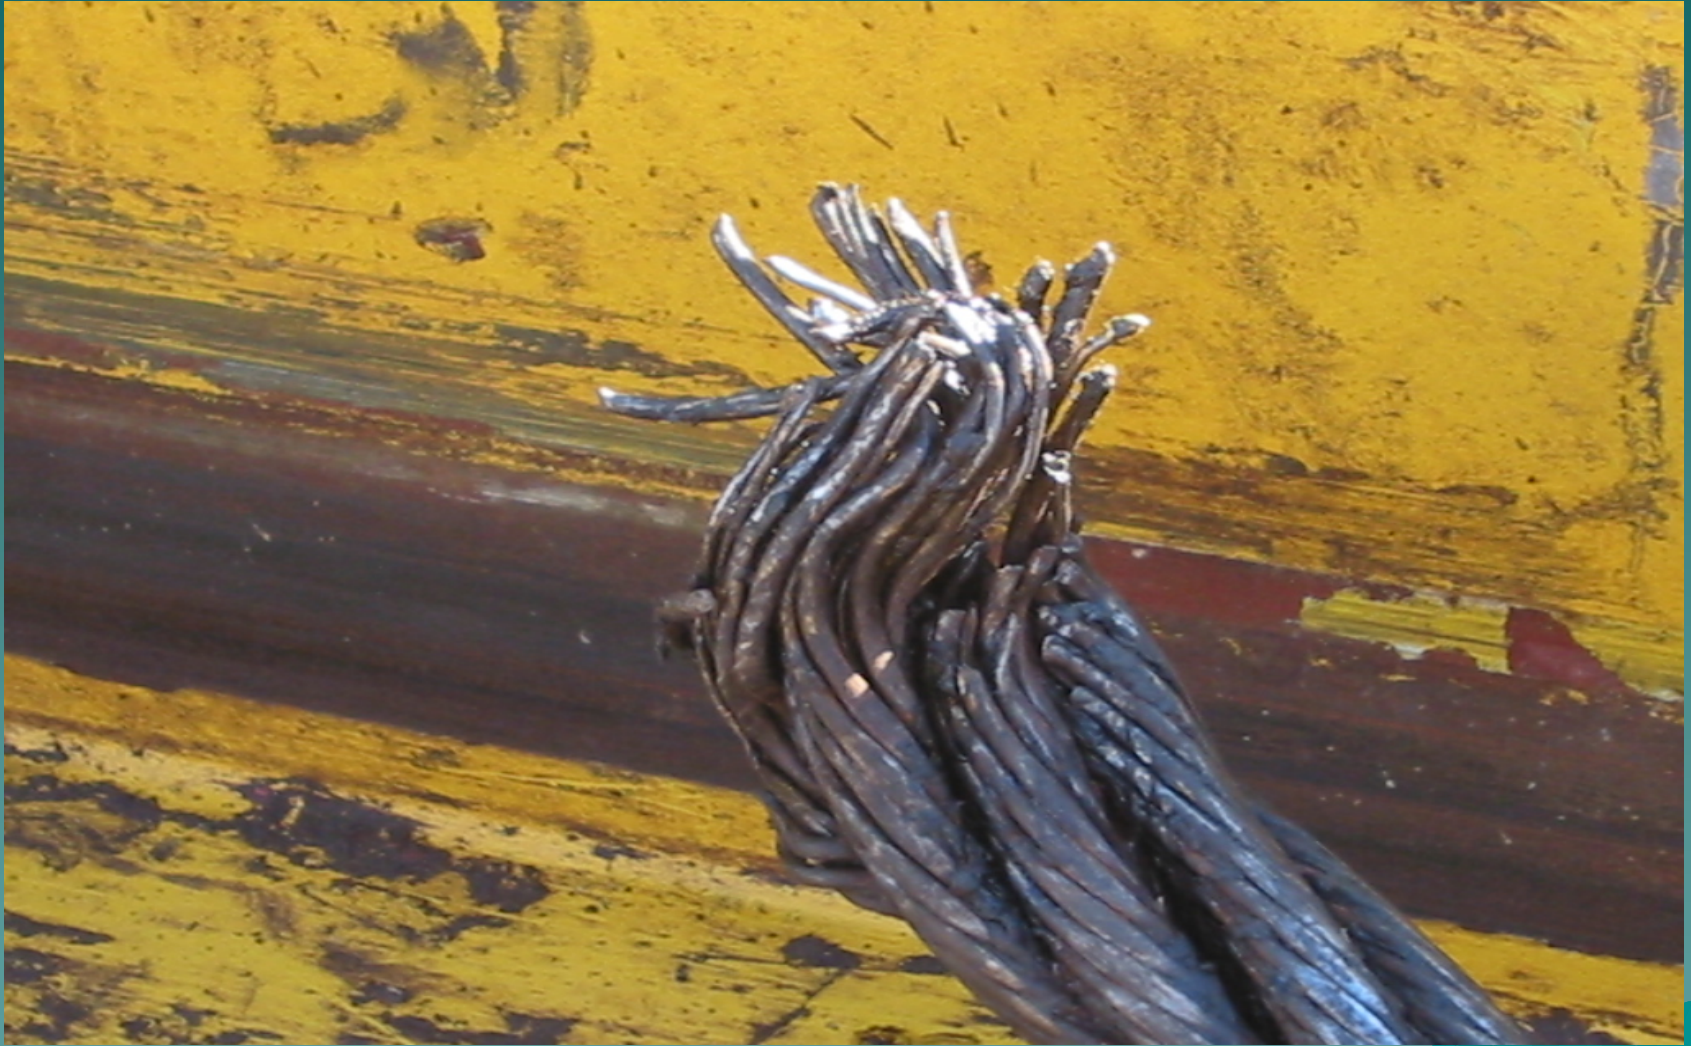
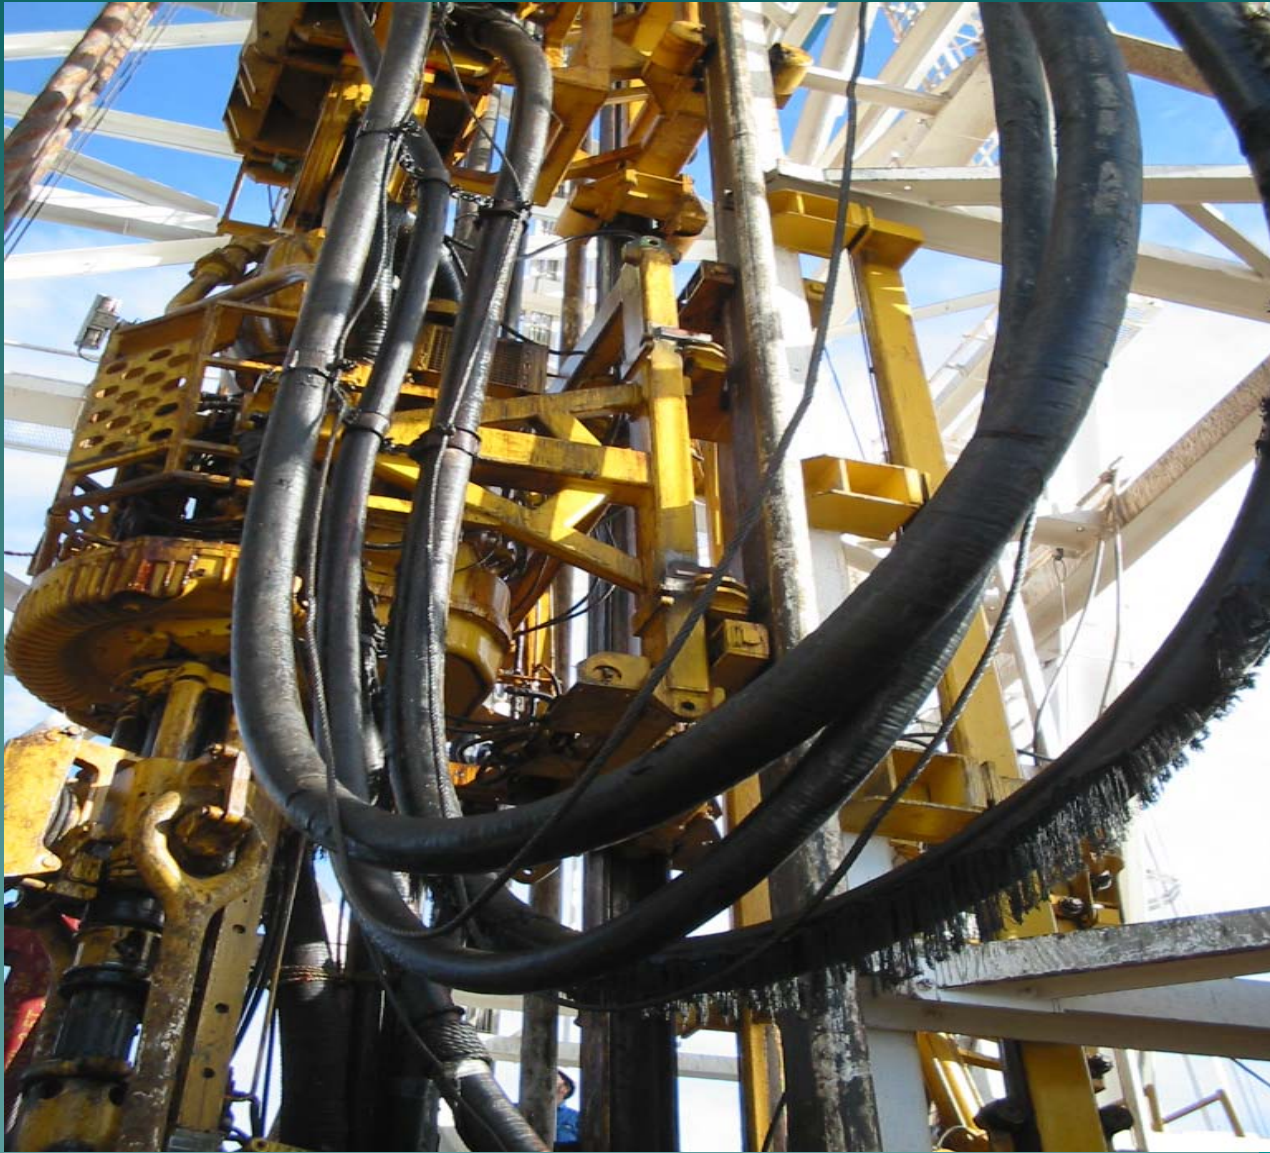
- ◆ Action resulted in the blocks uncontrollably impacting with the drill floor
- ◆ Drill line paid out rapidly from the draw-works where the line severed at the entrance to the drum, with approx 60 metres of 1.5" drill line going through fast line sheave before falling to the drill floor.
- ◆ Luckily no one was hurt

- ◆ Incident investigation team consisted of Operator and contractor personnel along with DOIR observing.
- ◆ A number of personnel on the rig reported hearing 2 'bangs'
- ◆ Investigation revealed operator error

- ◆ Rewrite procedure for Drilling with 'heaves'
- ◆ Manufacturer conducted thorough inspection of all components including MPI by third party company
- ◆ Write a guideline to how supervisors be informed of prevailing weather and what to expect – Include in JSA
- ◆ Council appropriate personnel as per guidelines
- ◆ Installation of Kinetic Energy Monitoring Systems (KEMS)
