# DRILLSAFE

AUSTRALIA'S DRILLING INDUSTRY  
QUARTERLY HSE FORUMS

## Rig Positioning ENSCO 56 Adjacent To Ocean Legend

# Incident

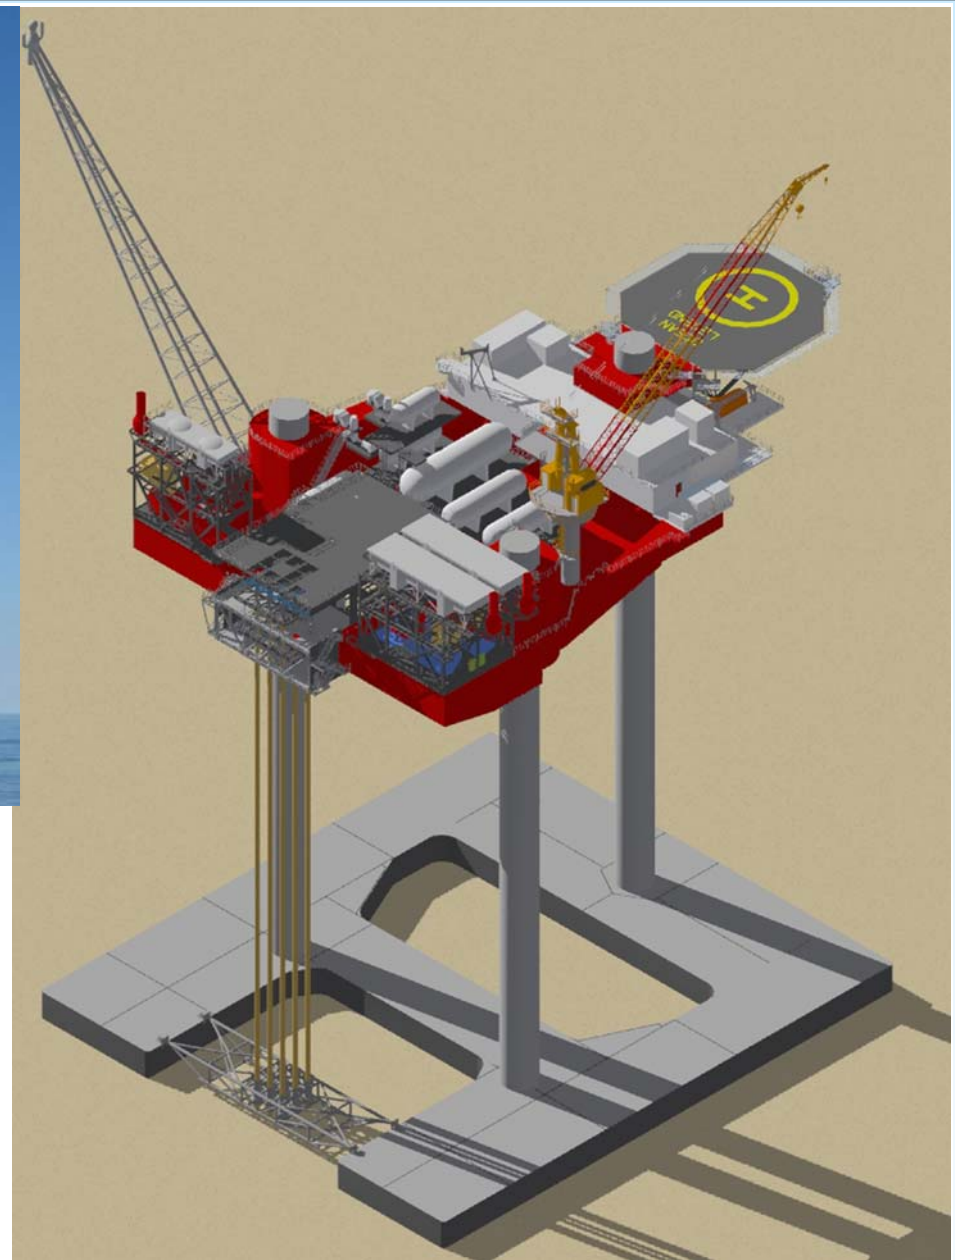
Ocean Legend as seen on approach and a 3D rendering of the platform.

Note that the mat extends beyond the edge of the hull as seen at surface

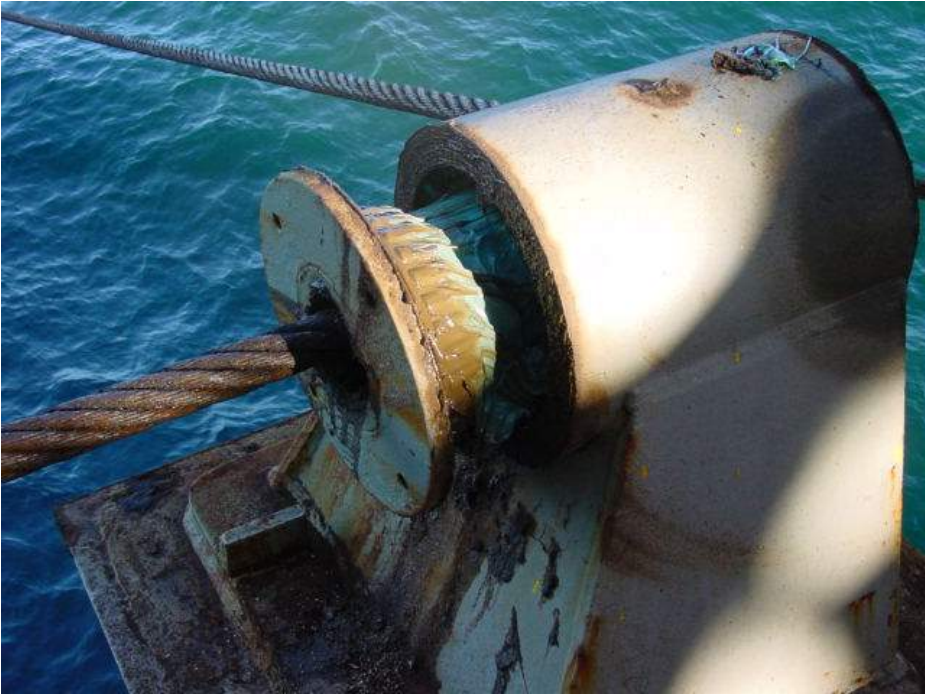
Port Fairlead Post Incident

- Attempted to position rig but port fairlead failed when the rig was close to final location
- Minor contact occurred between rig spudcan and platform mat before the could be pulled away from platform
- Pulled rig off to a holding point and pinned
- Replaced both fairleads and port anchor wire
- Positioned rig within tolerance

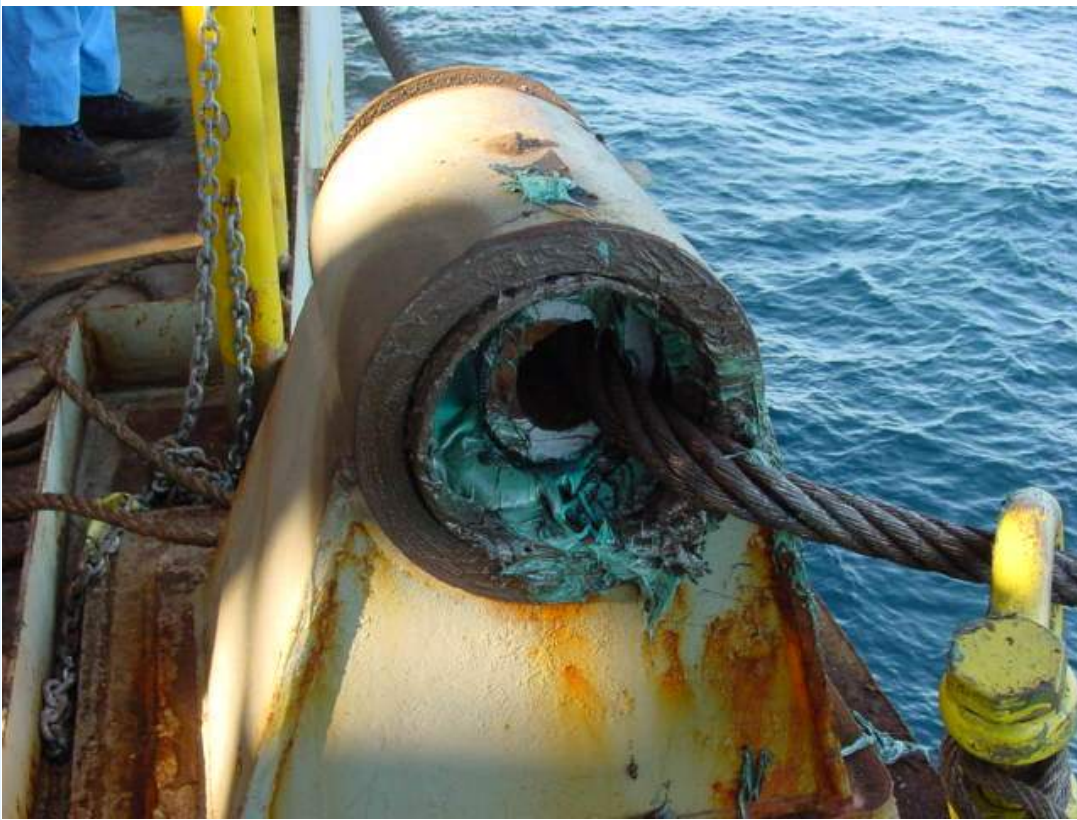
The port fairlead:

- Failure point was the shaft or barrel
- Anchor wire did not part
- Anchor wire was replaced

- **Anchor wire failure** – No excuse for this. The failure point was near the end, hard to reach and lubricate and not adequately checked. Many people could have identified a problem but nobody did.
- **Fairlead failure** –The fairlead was the weak link in the mooring system. It was tested with a proof load of 40 tons but the exact manufacturers SWL was unknown. There was some evidence of a pre existing crack in the fairlead shaft that broke. Rig inspections failed to identify the fairleads as weak points in the system. A fracture of the shaft would only have been identified if the fairlead was stripped down for inspection. The fairleads may not be original equipment but may have been replaced by previous owners. There is no document trail to cover pre Ensco equipment modifications.
- **Minor contact with Ocean Legend mat** – Spudcan to mat contact was minimal but not intended.

- Equipment failures – Ensco have re engineered the equipment specification and replaced the fairleads
- Maintenance – Ensco has increased the maintenance requirements in their preventative maintenance system for mooring system components
- A detailed incident report was issued

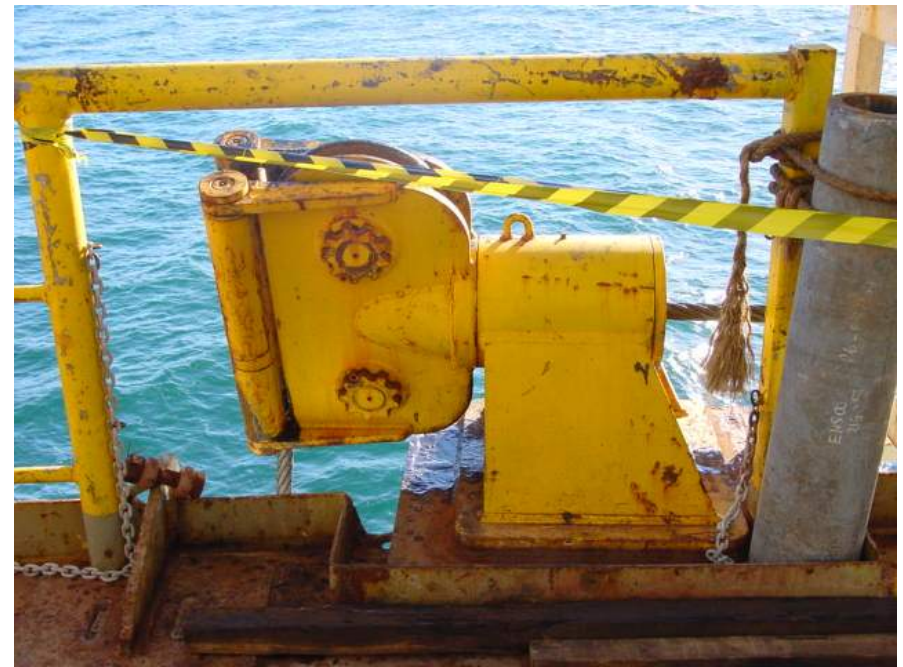
The Starboard fairlead:

- Did not fail in service
- Was replaced post incident
- Anchor wire was not replaced but only 6 months old
