# Nan Hai VI Fire 23 July 2006

# Investigation

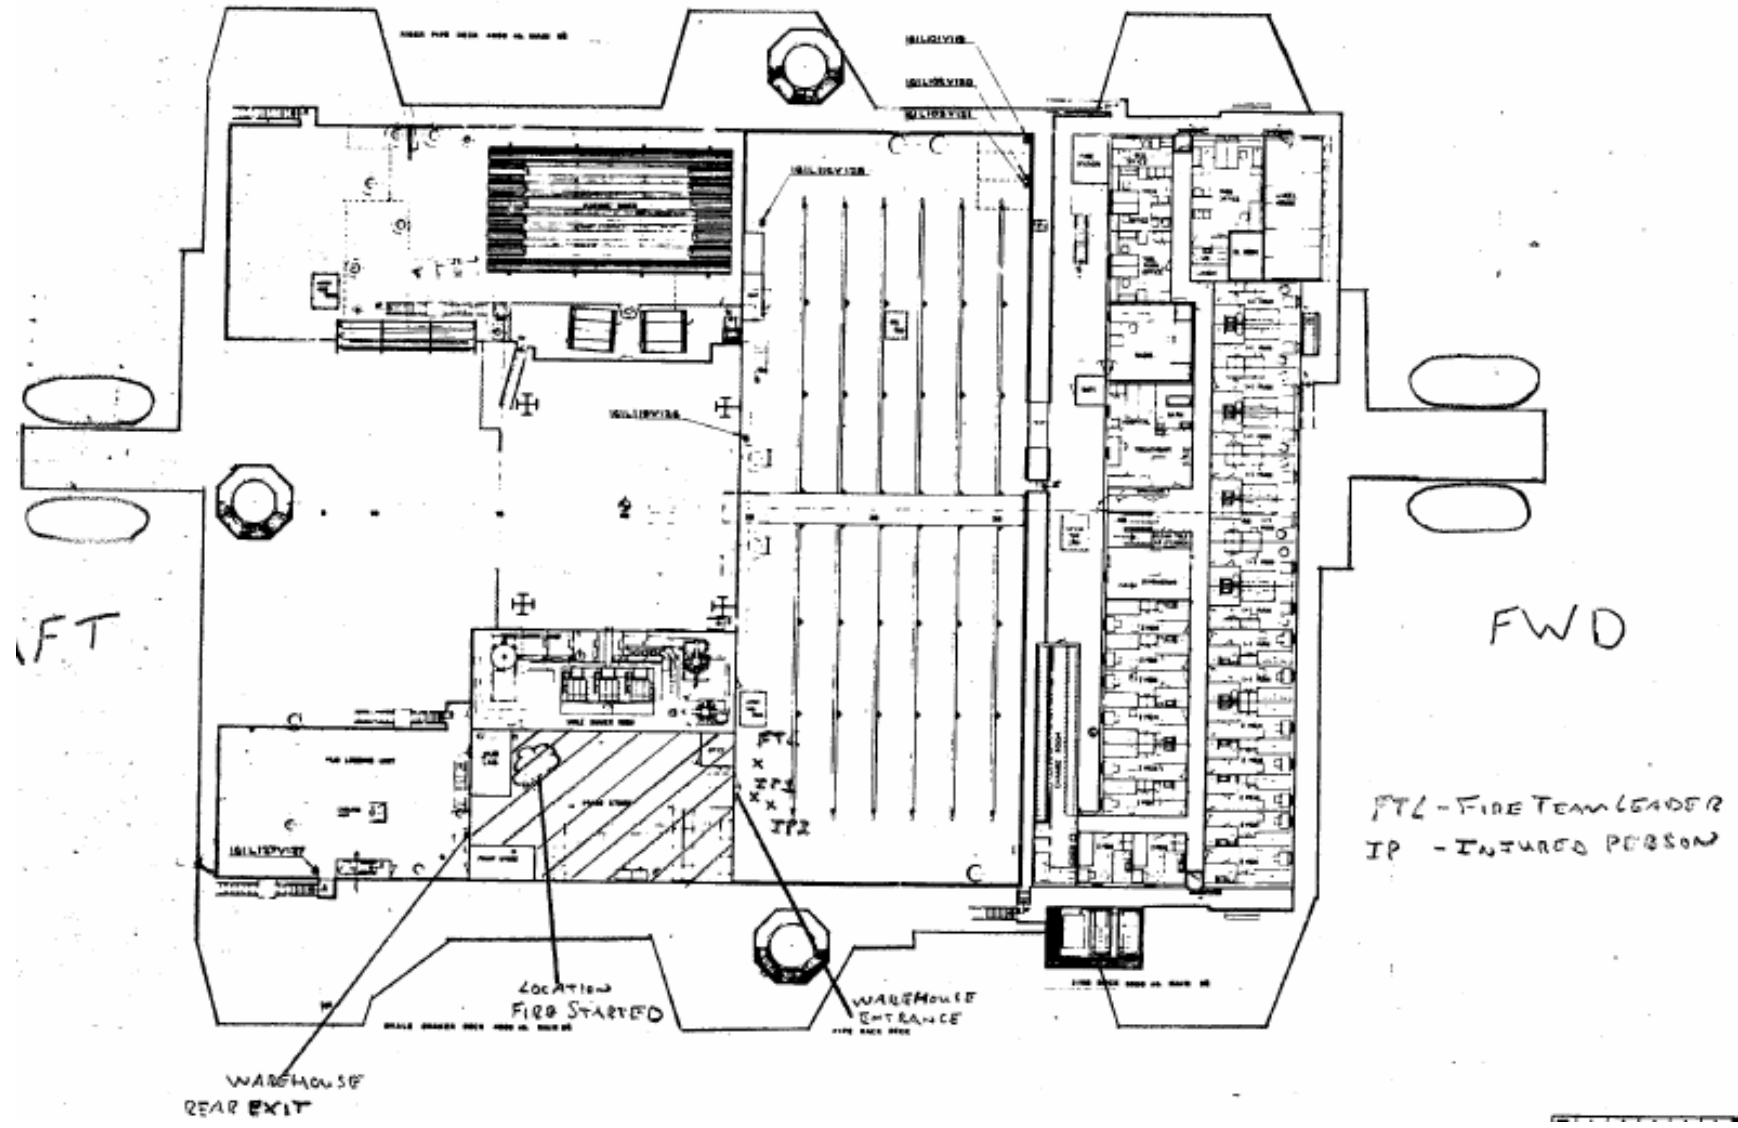
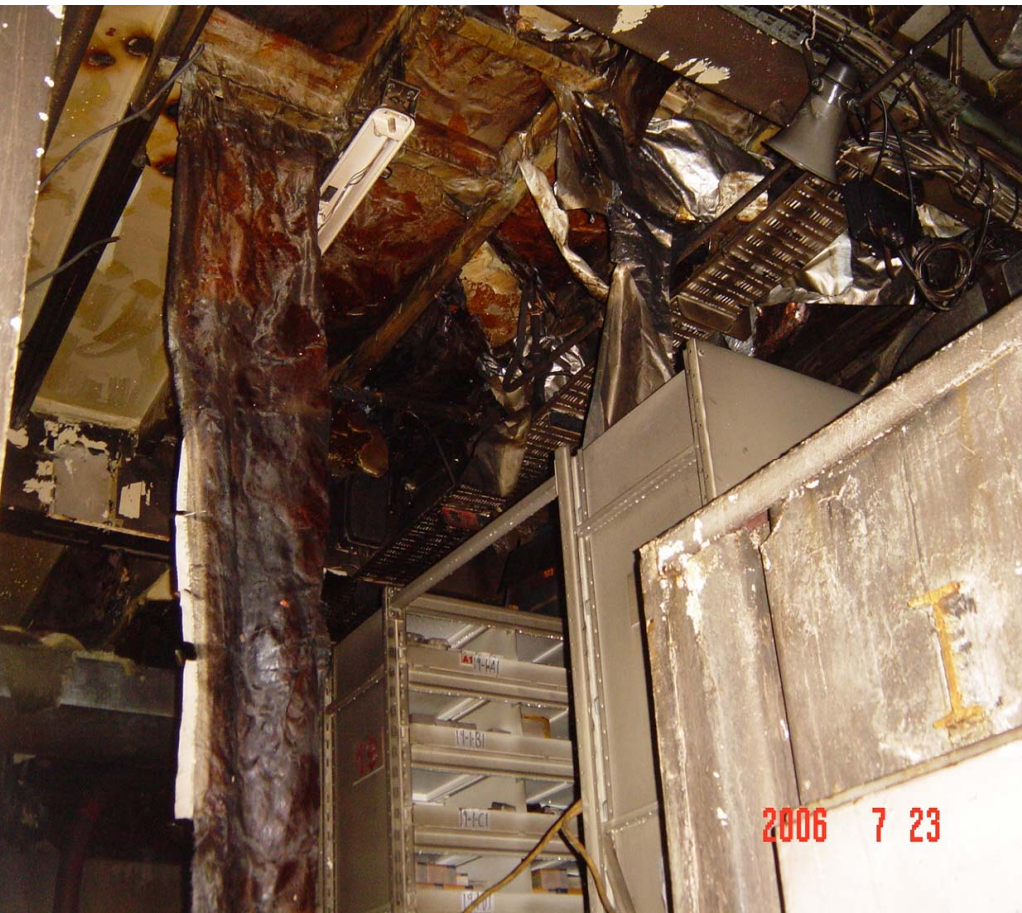
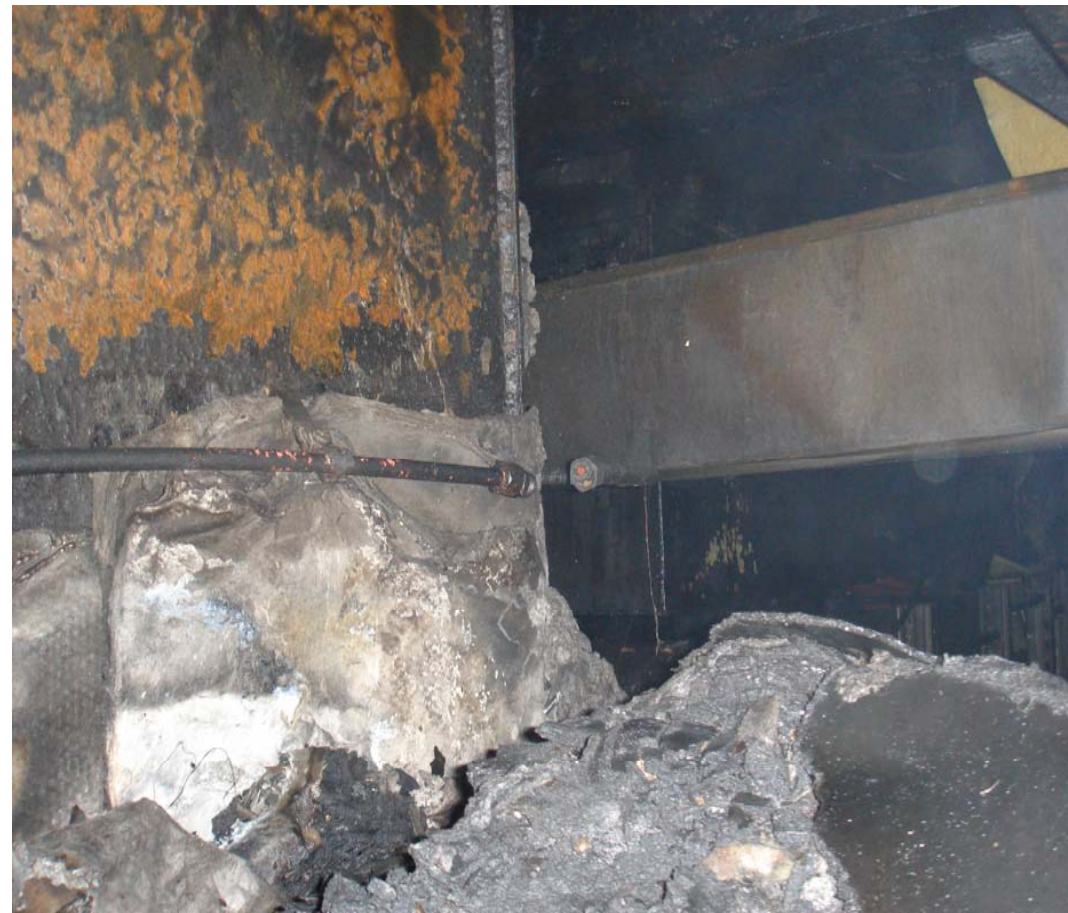
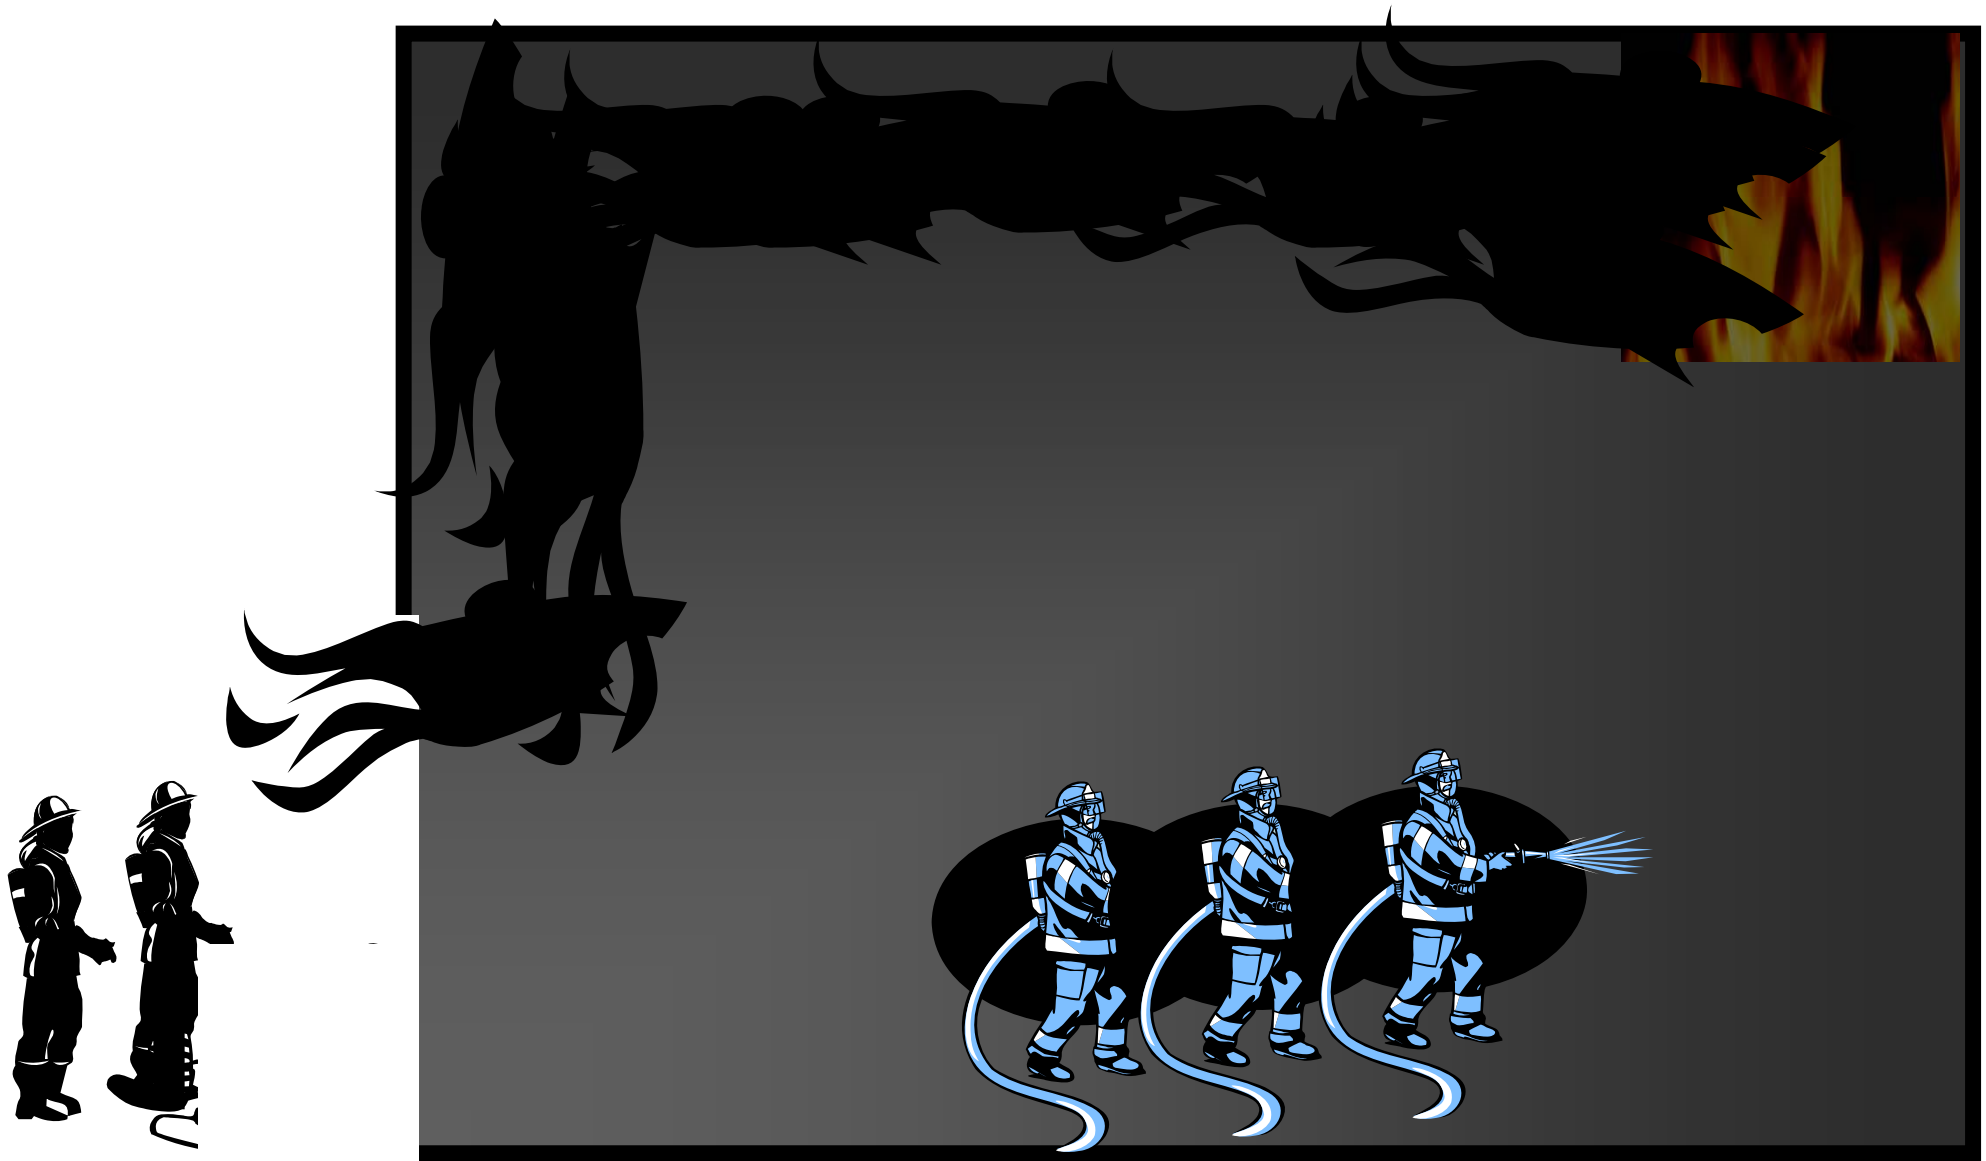
- Investigation team to the rig from 25<sup>th</sup> to 29<sup>th</sup> July
- Findings: Direct Causes
  - Heat transfer from oxy/acetylene cutting on deck on top of main store
  - Combustible material inside store caught fire
  - No fire watch inside store
  - Explosion due to flashover/backdraft caused by rupture to air line in the area of the fire.
  - Two people injured standing in doorway with inadequate FFPPE.
