Transocean
India Operations
Drillship
FATALITY REVIEW

Drillsafe Forum
September 6th 2006

Incident Summary

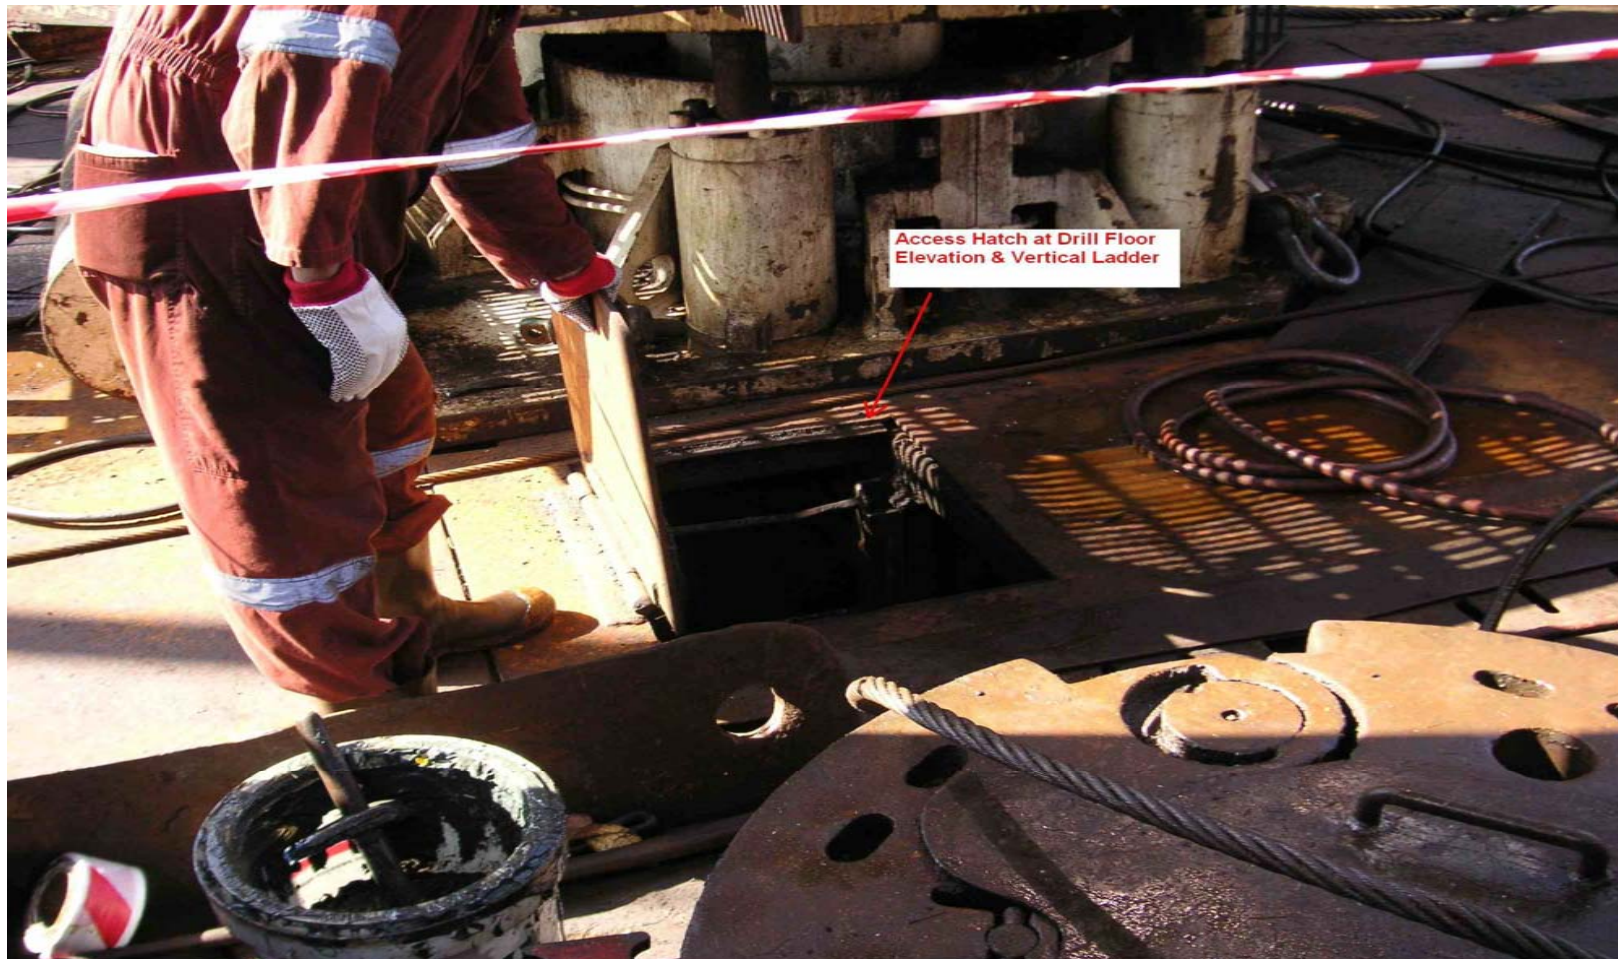
Hatch on Drill Floor Giving Access to the Diverter Housing and RTR

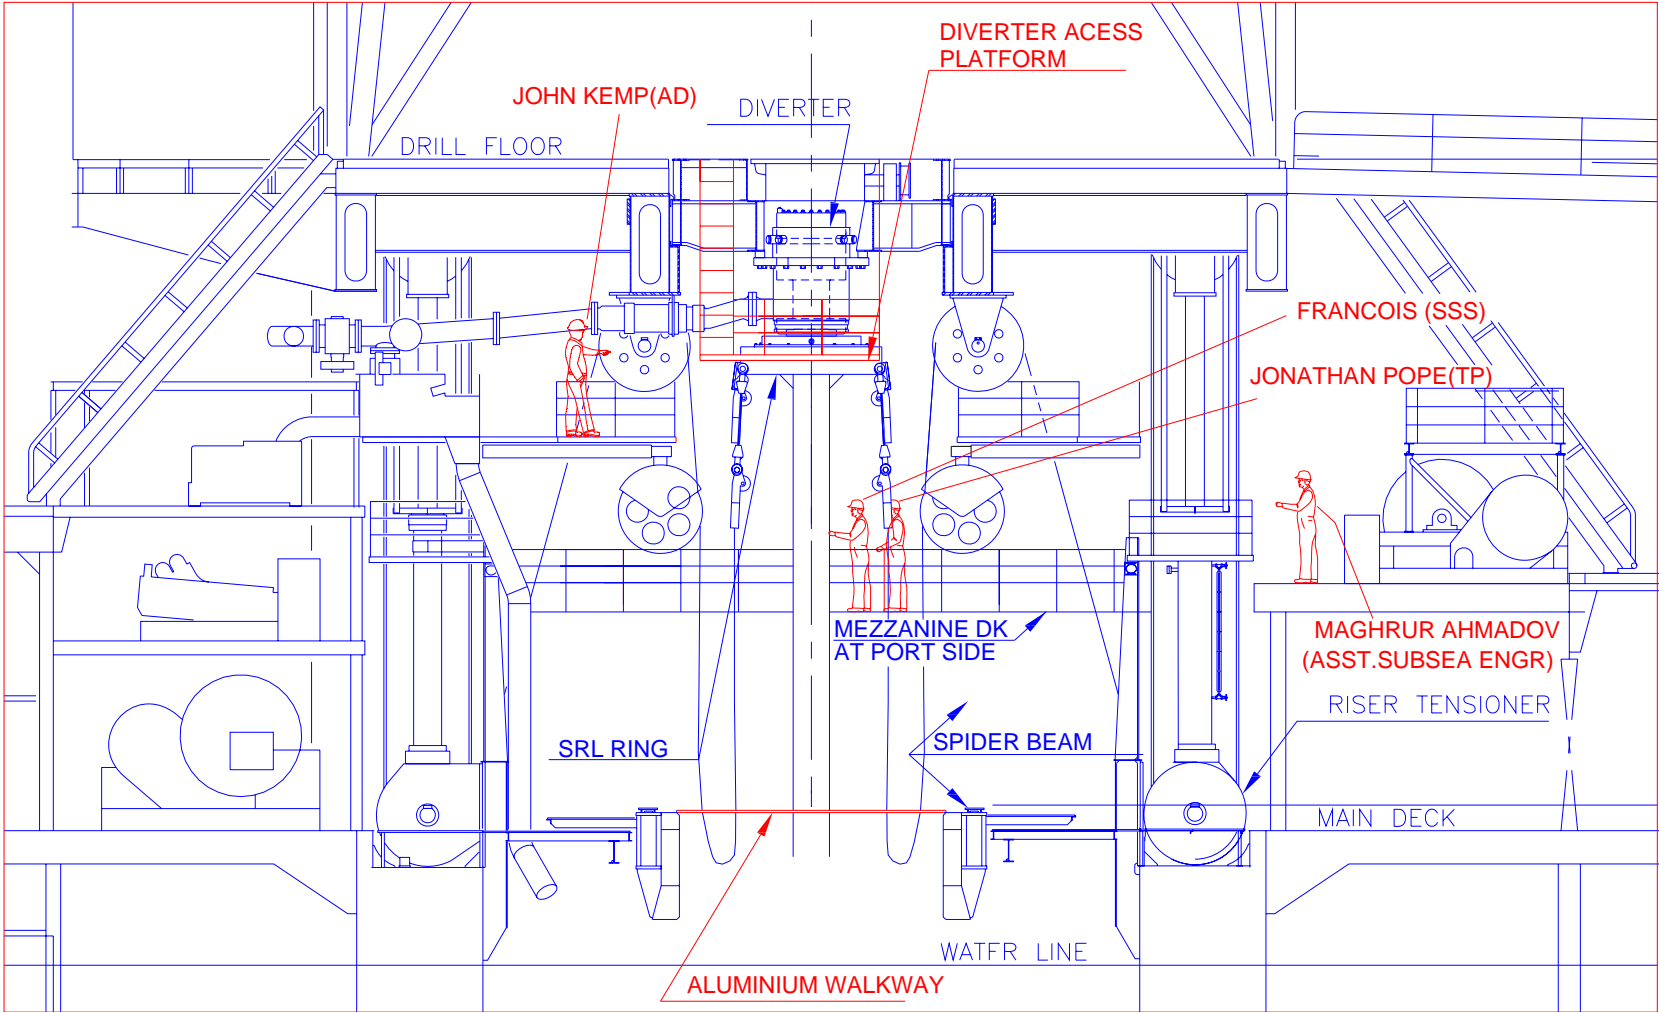
Side View of the Area Beneath the Drill Floor

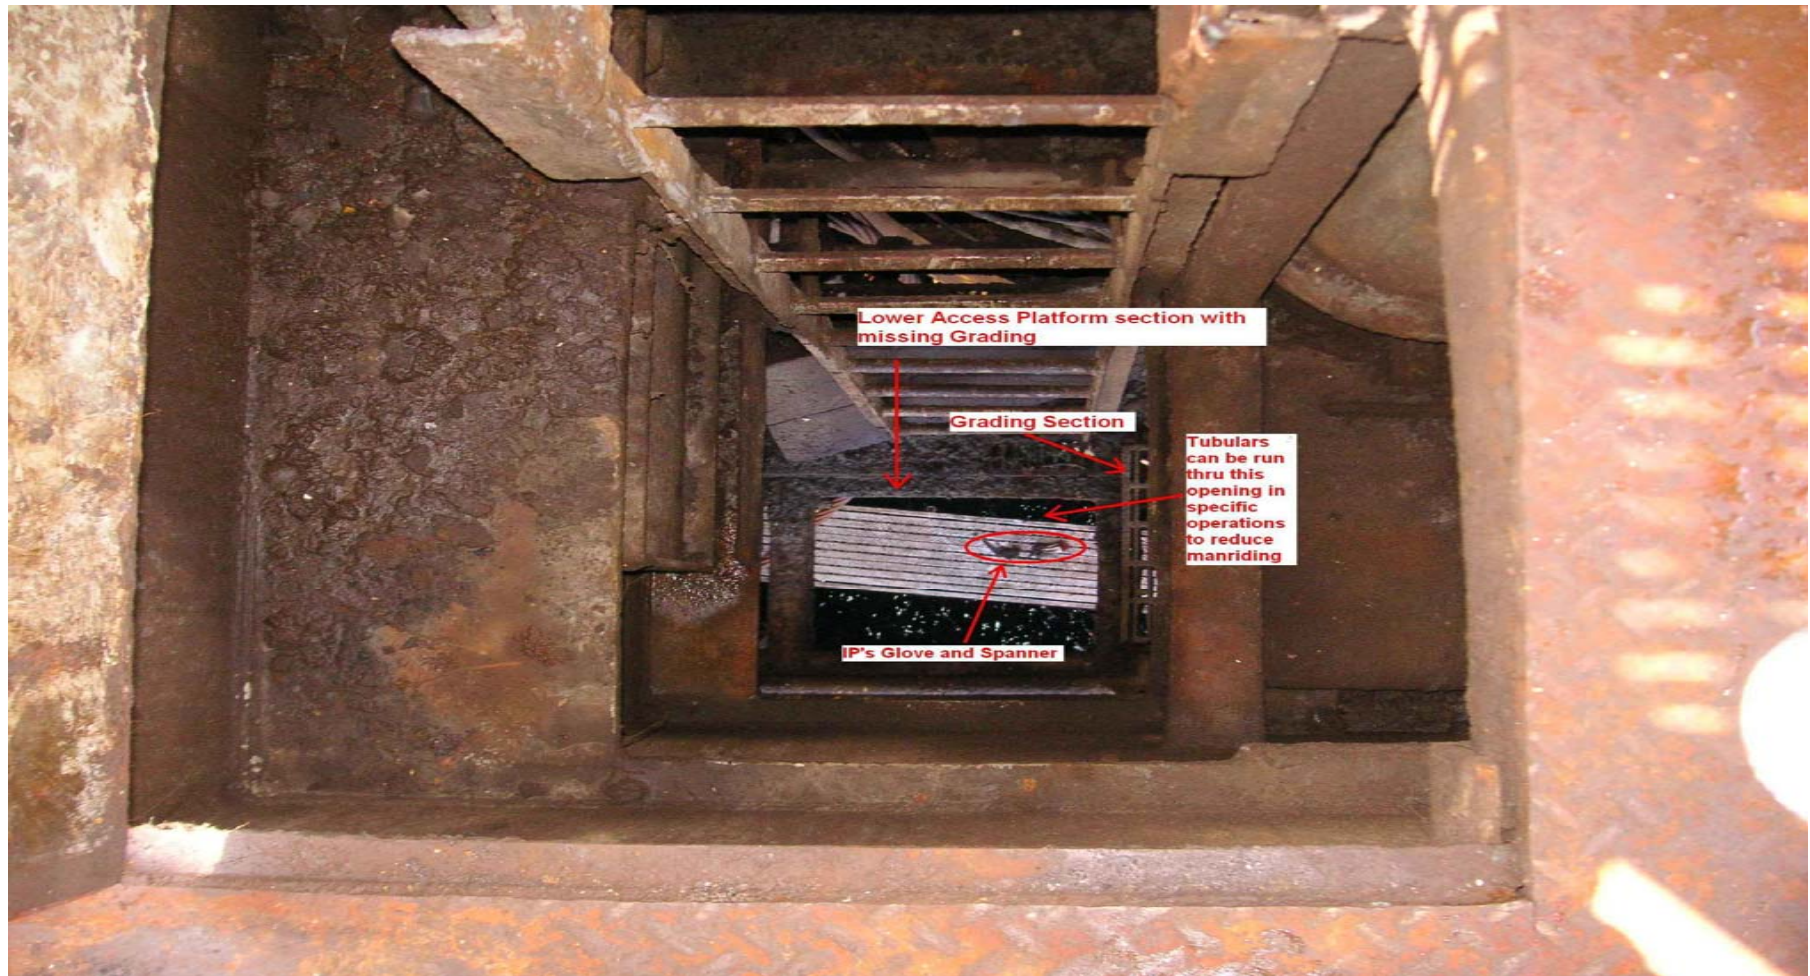
View Looking Down Through Hatch on Drill Floor

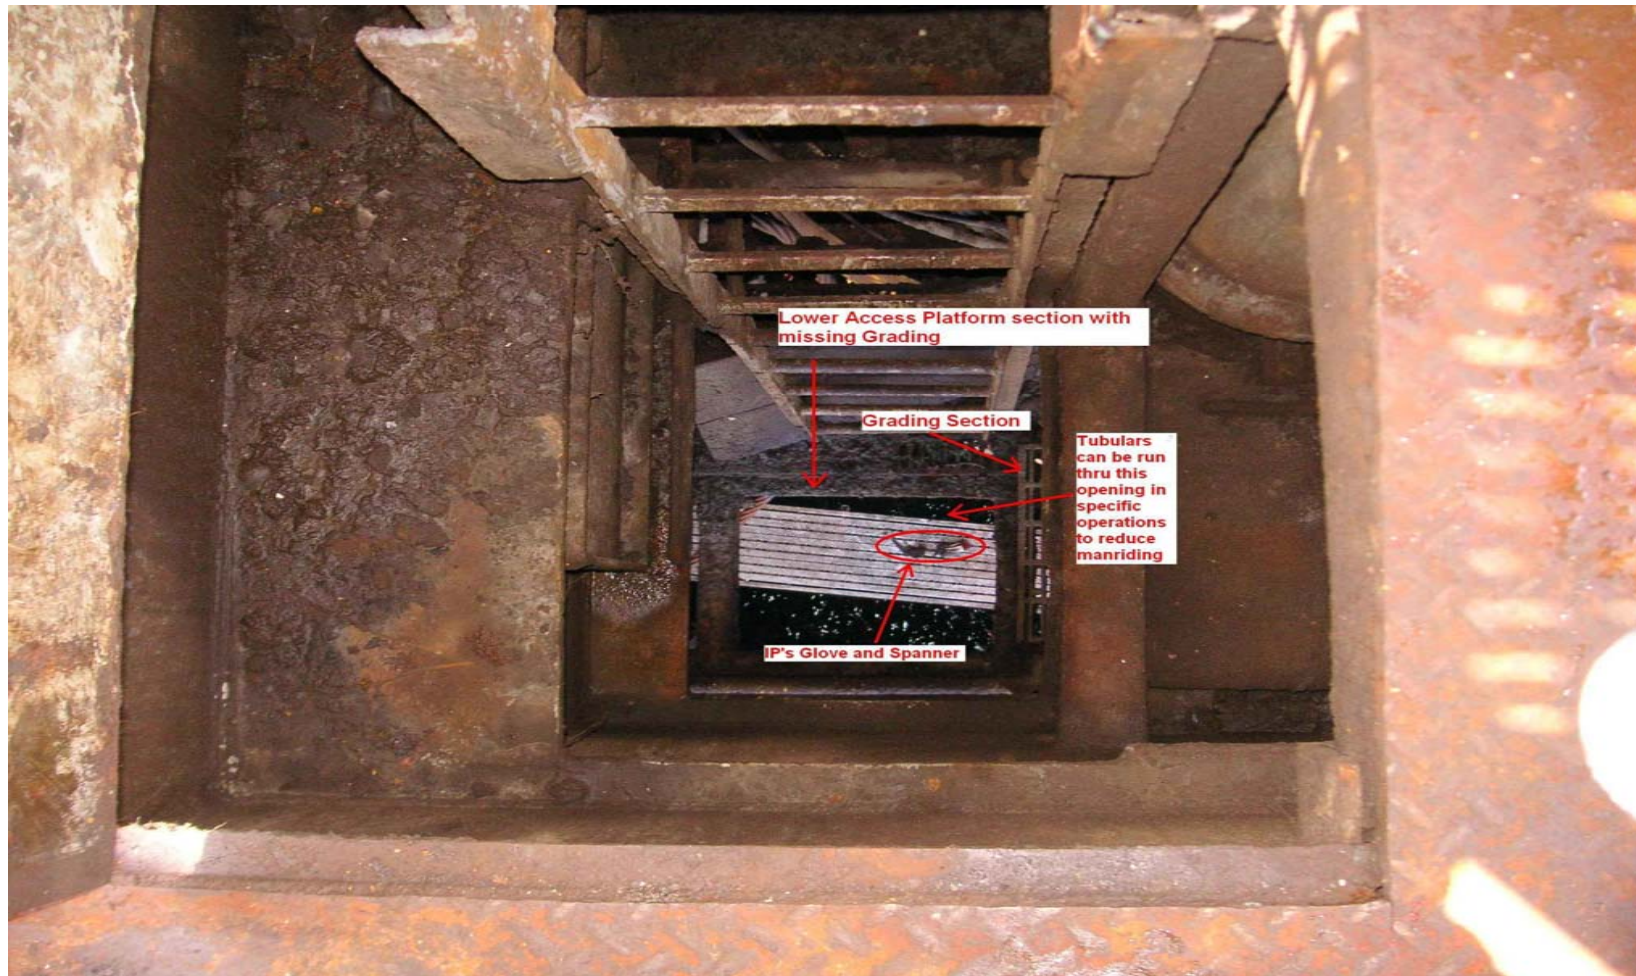
- **Praveen descended the ladder from the drill floor without securing the lanyards.**
- **While descending the ladder, Praveen slipped and fell about 40 feet into the water in the moonpool.**
- **An aluminum walkway across the spider beams was directly below the opening in the grating. It is possible Praveen may have hit this and other objects.**
- **Floorhands raised the alarm and the Senior Sub-Sea Supervisor (SSS) and Toolpusher (TP) rushed to the Moonpool.**
- **SSS and TP saw him briefly at the surface before he submerged. He was not seen thereafter.**
- **Search and rescue operations commenced with the Man Overboard Alarm but were unsuccessful.**

View Looking Down Through Hatch on Drill Floor

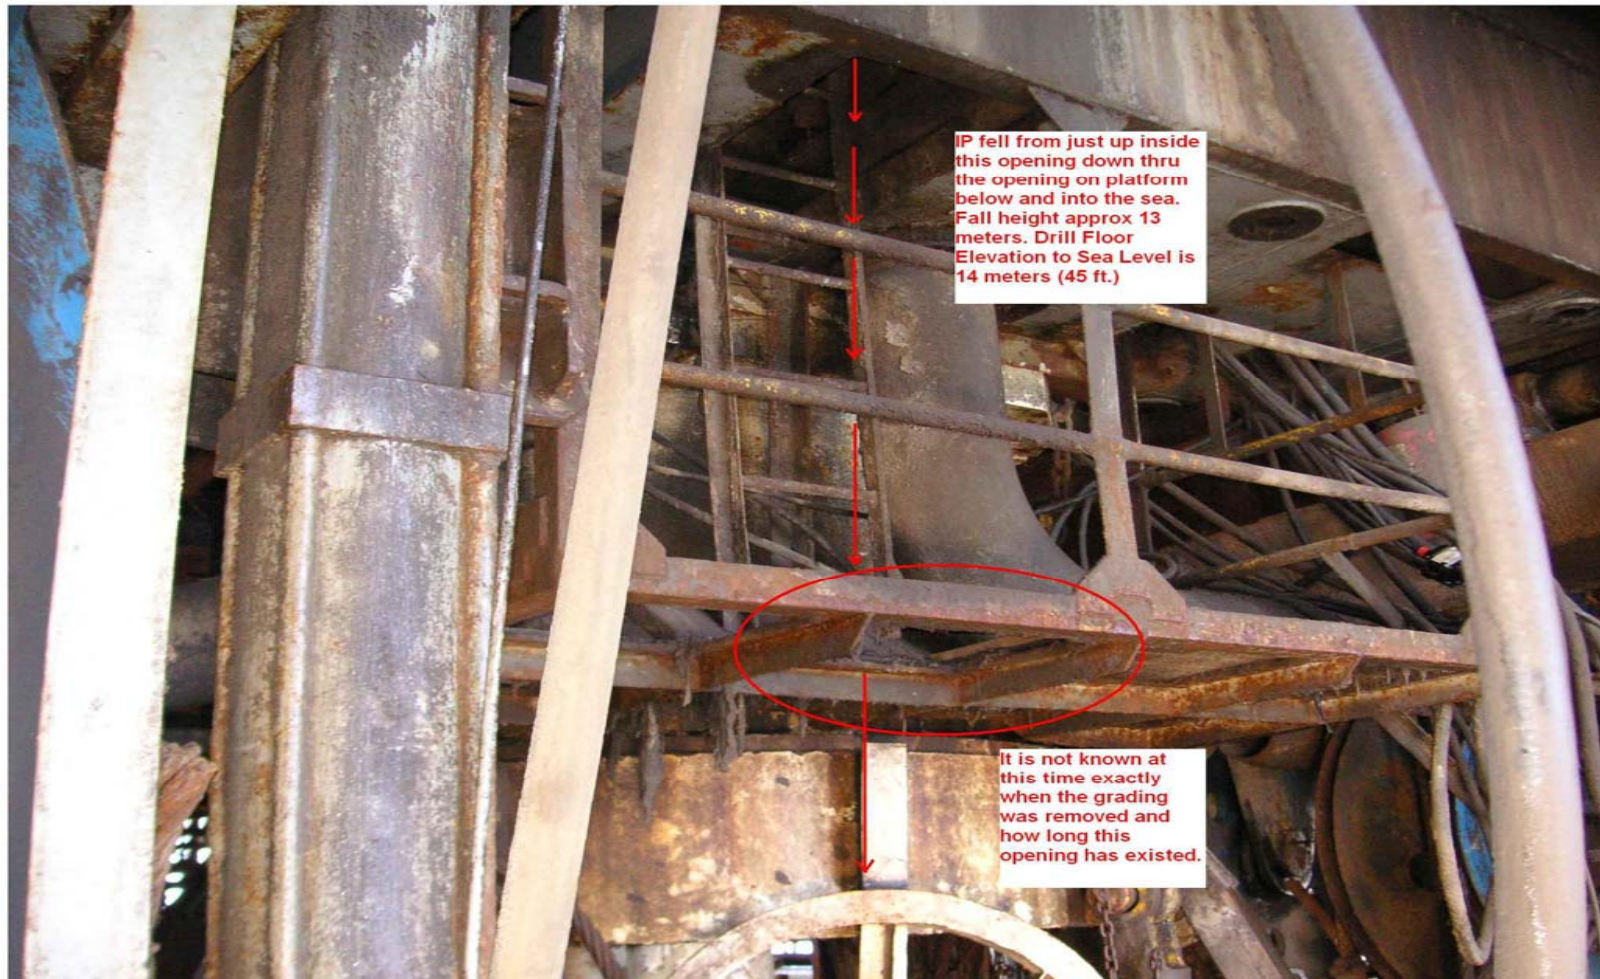
Side View of Diverter Housing Platform Underneath the Drill Floor

- **The platform grating had been previously removed to use the hatch as a “mousehole” for cement stands, allowing hoses to be connected at floor level.**
- **There was no specific THINK Plan or Task Specific Think Procedure for this task.**
- **No fall protection equipment or flotation device was used by Praveen to descend the 10 foot ladder.**
- **The floorhands identified and discussed the hazard of the missing grating, but failed to apply any additional control measures.**
- **Deck and access ladder were wet with water and hydraulic oil.**
- **First five rungs of the ladder were constructed with square steel stock and the second five with round steel stock.**
