Top Drive Rig Up Incident - 9 August 2005

Jingemia 6 - North Perth Basin

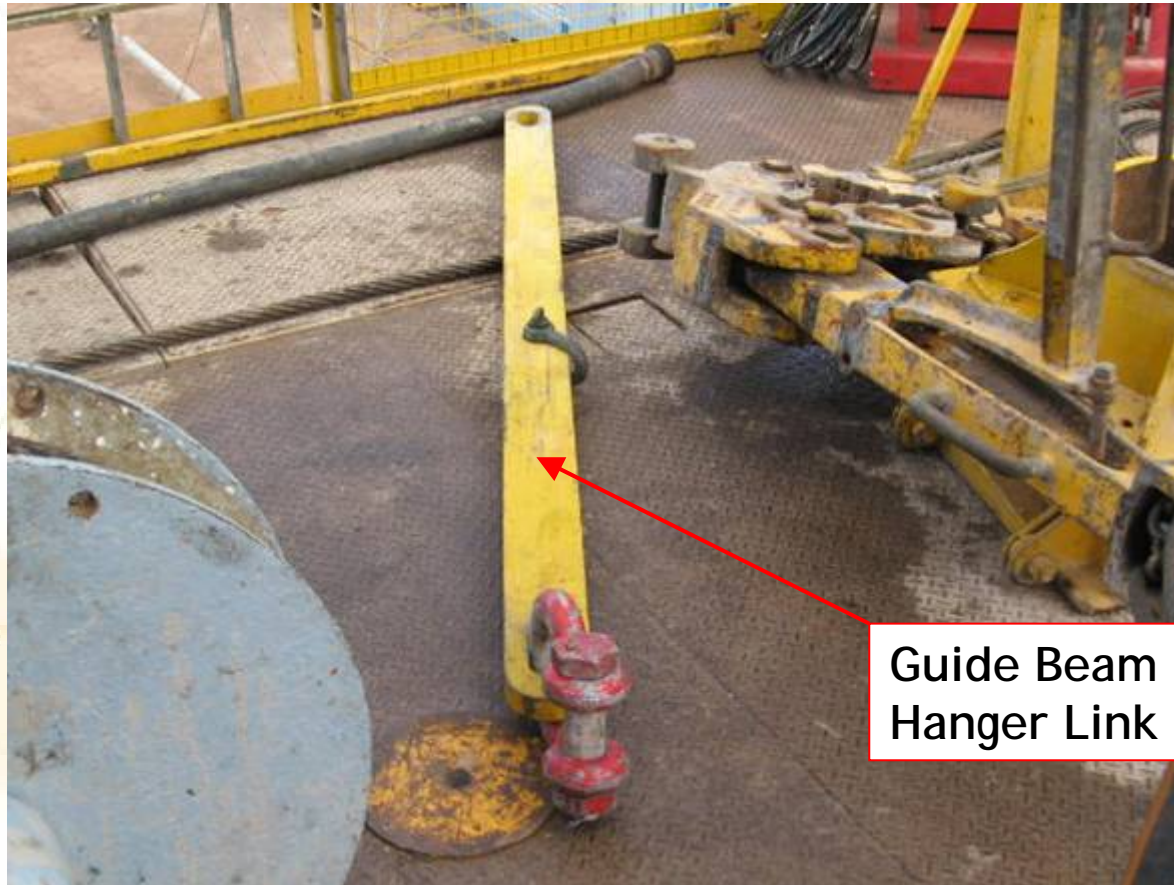
Guide Beam
Hanger Link

- 08:30 hrs Work Permit issued
- Top drive picked up to floor
- Guide beam picked up
- Experienced difficulties with top drive clearance when attempting to connect the hanger link
- Approx. 18:10 hrs decide to change out short hanger link for long version
 - Varco operator (IP) standing on top cross brace below crown
 - Varco operator with radio on monkey board with line of sight to operator near crown and Supervisor on floor
 - Varco Supervisor with radio and one operator next to Ensign crewman operating winch

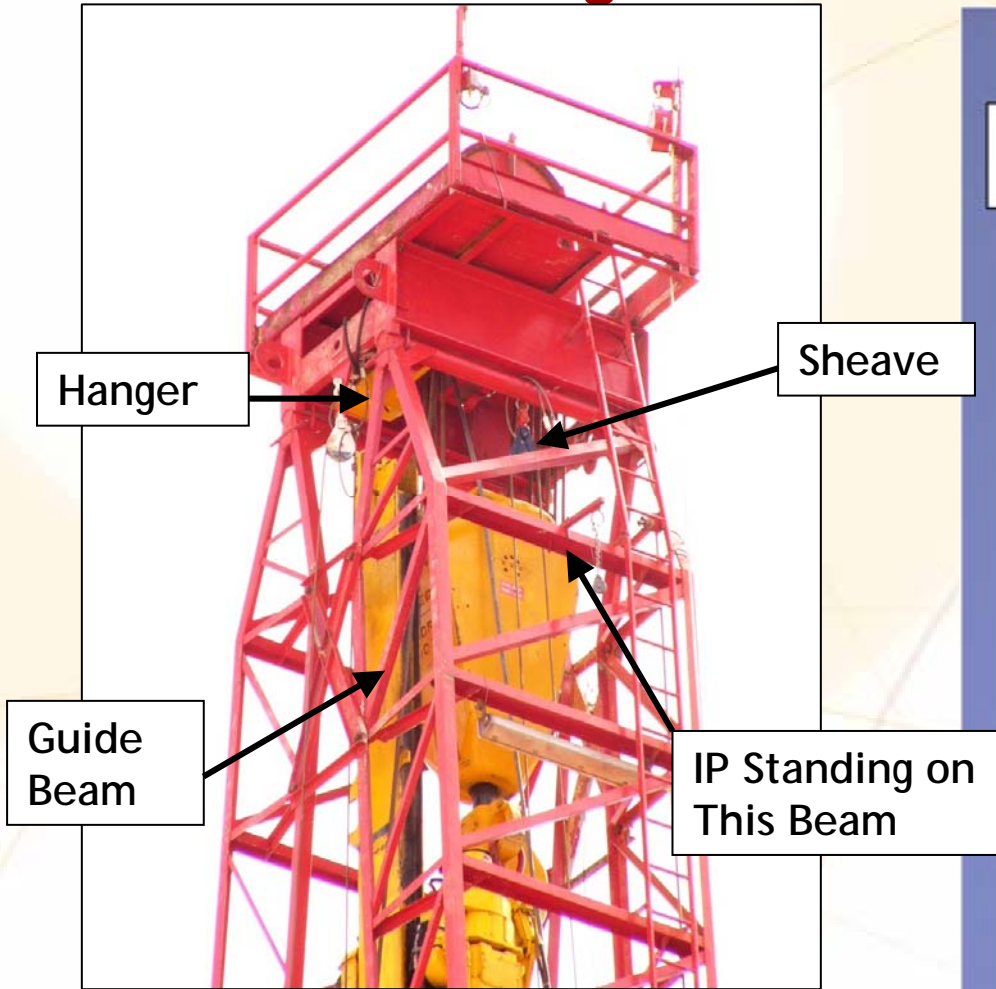
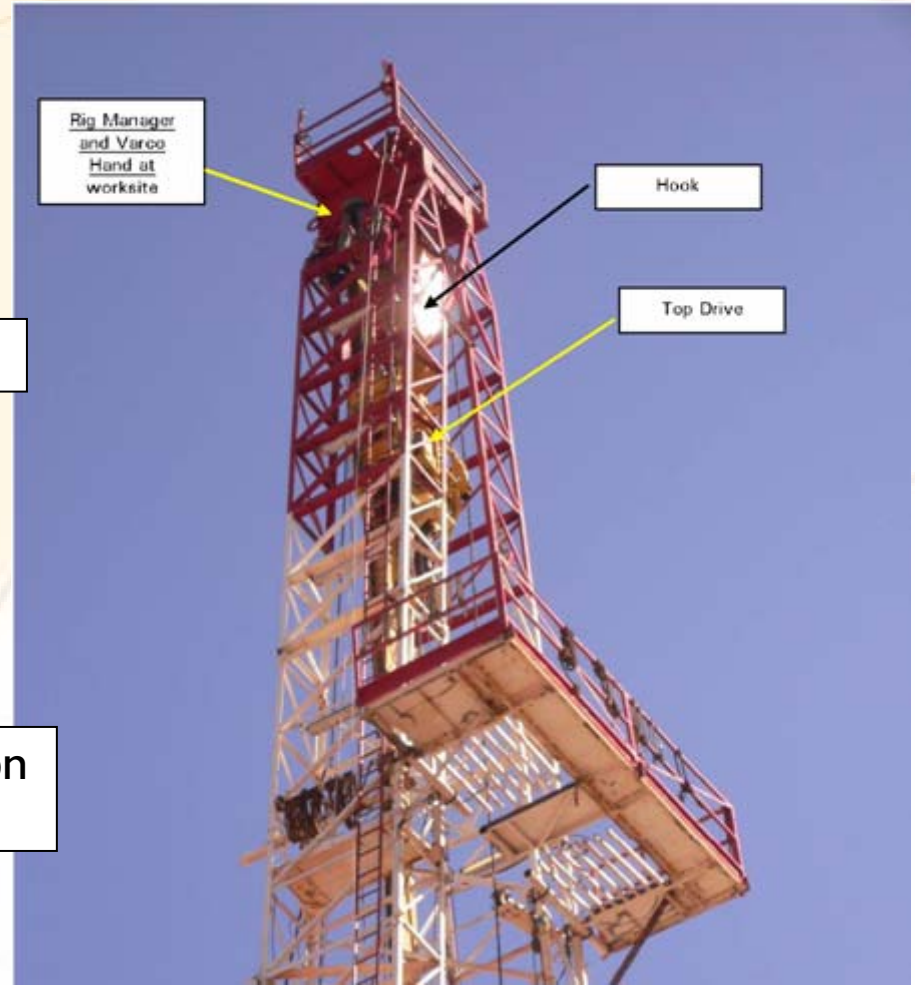
- Removed short link and lowered to floor with main winch
- Picked up long link and raised to near monkey board with main winch
- Stopped winch and manoeuvred link past top drive & monkey board fingers
- Varco operator on monkey board called to operator at crown for clearance to recommence hoisting
- On receipt of clearance he called the Varco Supervisor on the floor who passed the instruction to the winch operator
- Load raised approx. 1/2m before a scream heard from the IP at the crown at approx. 18:30 hrs

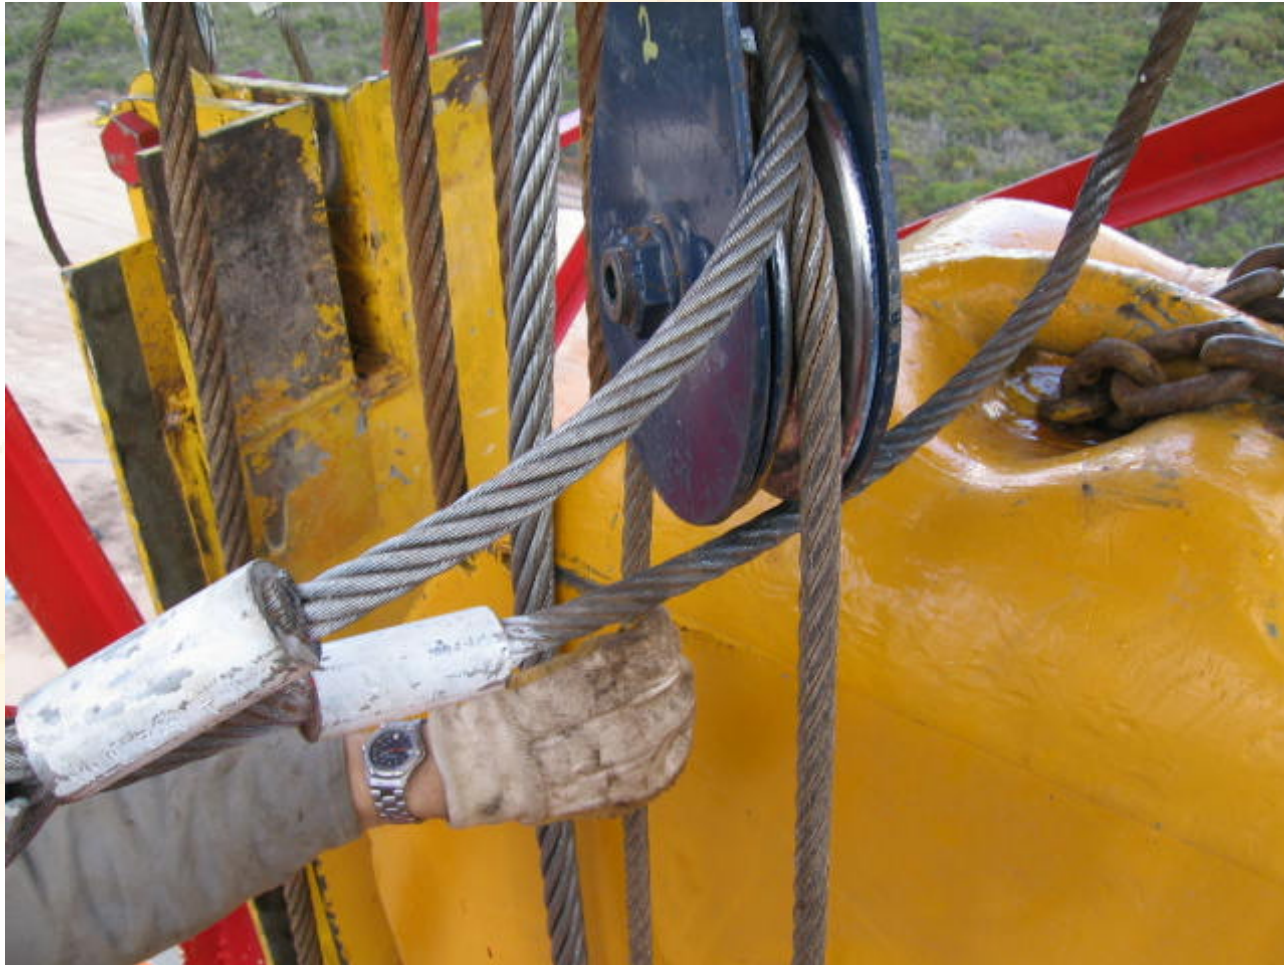
- IP incurred a 'de-gloving' injury with substantial damage to forearm tendons
- Subsequently had four fingers of left hand amputated at first knuckle from palm plus surgery to forearm to address tendon damage
- Total 89 days lost time

- IP stated that he was excessively cold and could not feel his hands
- Lack of awareness of requirement for warm clothing
- IP was not trying to manoeuvre the load when the incident happened
- IP was tired and rested his hand on the line as a convenient support
- IP acknowledged giving the OK to hoist not realising that his hand was resting on the winch line
- Mast lighting immediately below the crown is poor
- Sheave was open wheel type

- Review procedures to include specific climatic conditions where appropriate in work orders
- Investigate use of enclosed safety becket type sheaves for all applications
- Investigate use of controlled descent device to facilitate retrieval of injured personnel from mast
- Include fatigue management in future Ice Breakers
- Develop training program for Wellsite Permit to Work users
