# Caught between results in LTI crush injury

26<sup>th</sup> June 2008

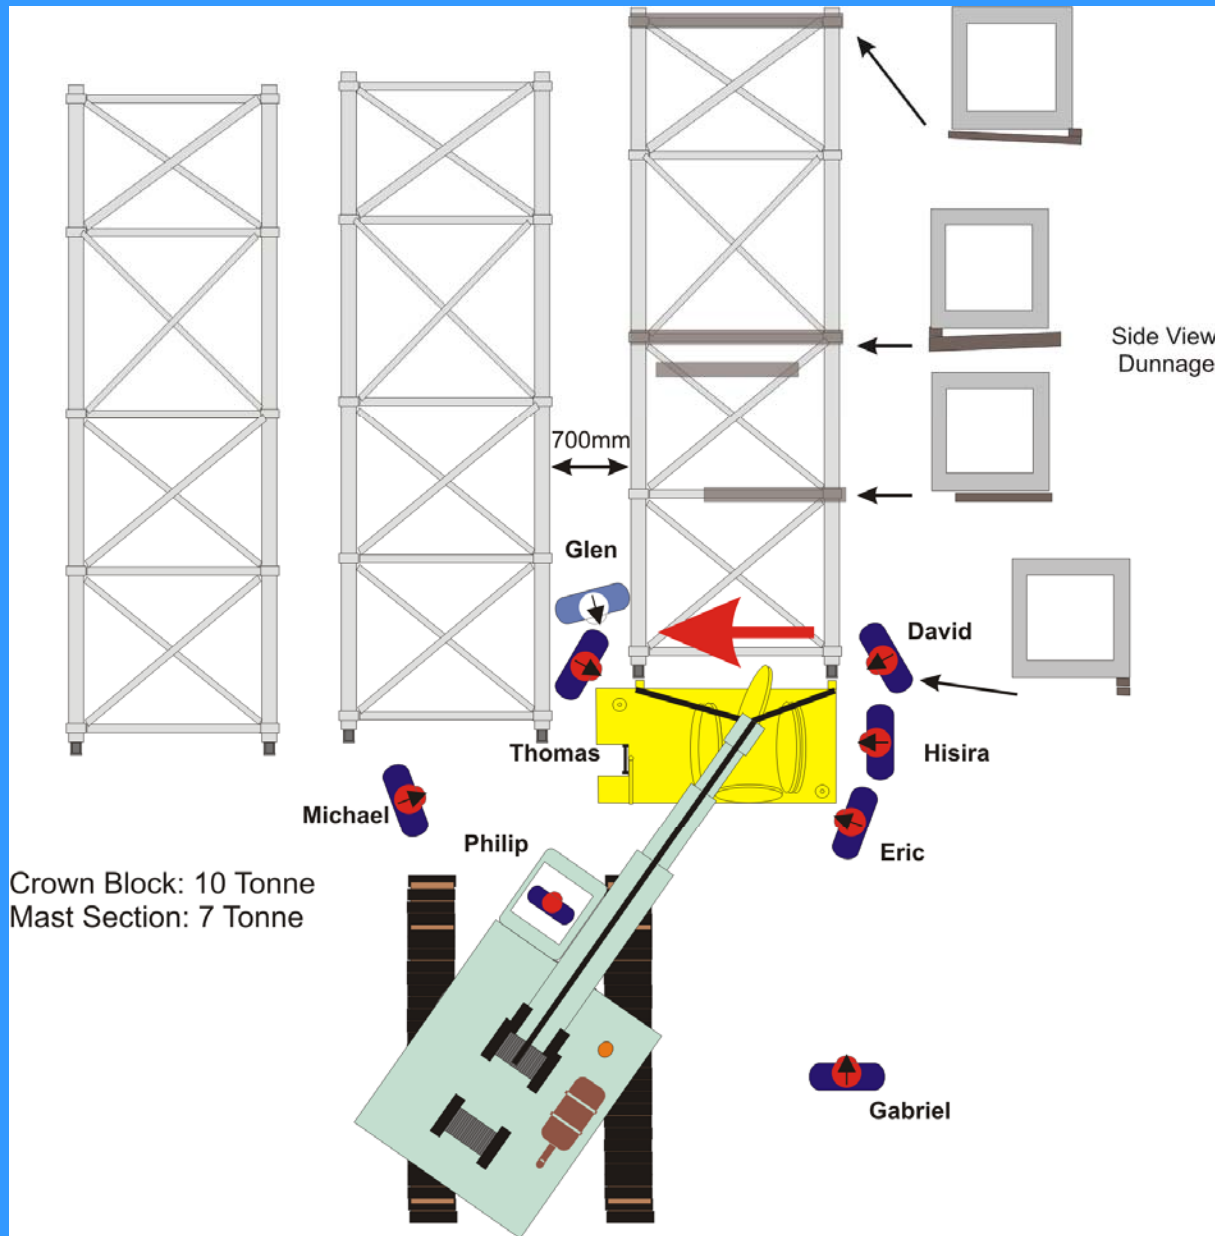
Event Description	Time Period (hours and seconds are approximate times)
Roustabouts stood by on either side with sledge hammers to drive pins in.	0930
On the first attempt the lugs and sockets did not line up. Backed off with crane by minimal movement.	
Second attempt made – better alignment. Driller signalled slow movement down	
Lugs were lowered into the sockets	
As the crown was lowered the weight of the mast was now being taken up by the mast.	
Mast and crown moved sideways toward Supervisor and IP	
Lug came out of their sockets and crane section continue to move towards IP	
<b>INCIDENT – IP CAUGHT BETWEEN CROWN HANDRAIL AND OTHER SECTION ALONGSIDE THAT ONE BEING PINNED.</b>	0950

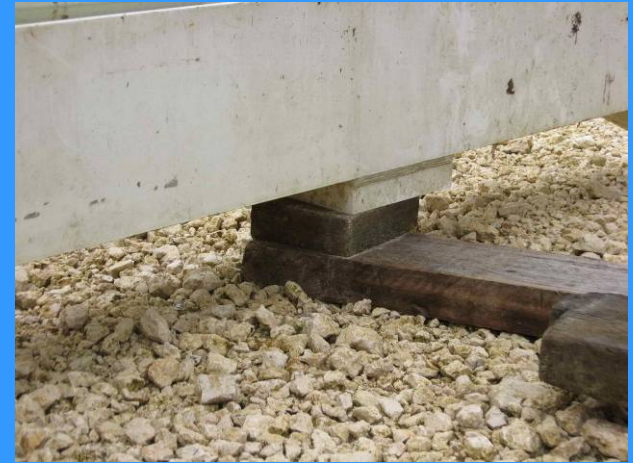
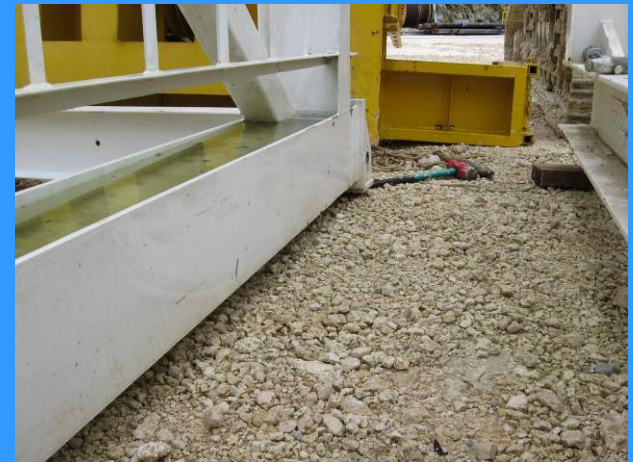
- Dunnage boards under the mast failed
  - Dunnage under the mast section were of poor size and inadequate.
  - Size and placement showed little thought when stacking
  - Inadequate dunnage not recognised in pre job
- Weight applied down on the mast
  - Dunnage were not consistent and no boards under the mast end where the incident happened. The load bearing down on the socket without dunnage moved the combined load sideways.

No.	Action	By whom	By when	Remarks
1	A set of purpose built stands to be fabricated for supporting the mast off the ground during the rig up activity and storage.	Field Supt	31Aug	Two prototypes complete. A total of 8 required.
2	Develop a procedure and dedicated JSA for assembling the mast sections	LF Toolpusher	31Jul	Two different procedures available with rig from China. Both conflict.
3	Drillers and above to received supervisory safety training in <ul style="list-style-type: none"> <li>• JSA production and implementation</li> <li>• Use of procedures</li> <li>• Roles and responsibilities of supervisors</li> <li>• Job planning and leadership</li> </ul>	Training Manager	To be completed by 31Dec08	Initial meetings held with EDN. Plan is to start in September.
4	All HAES personnel to participate in training of lifting and rigging by a certified training establishment to Aust Standards.	Training Manager	To be completed by 31Dec08

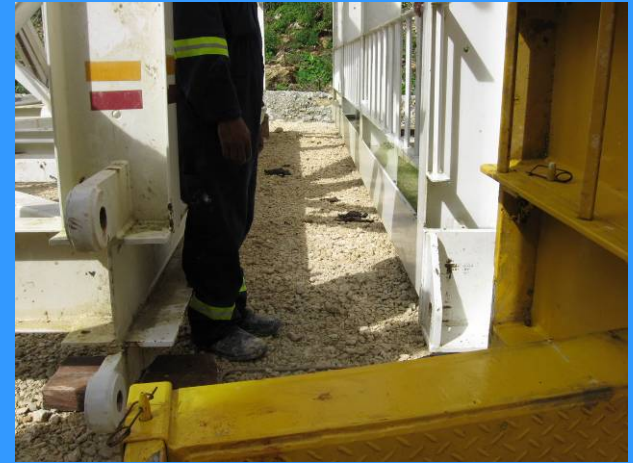
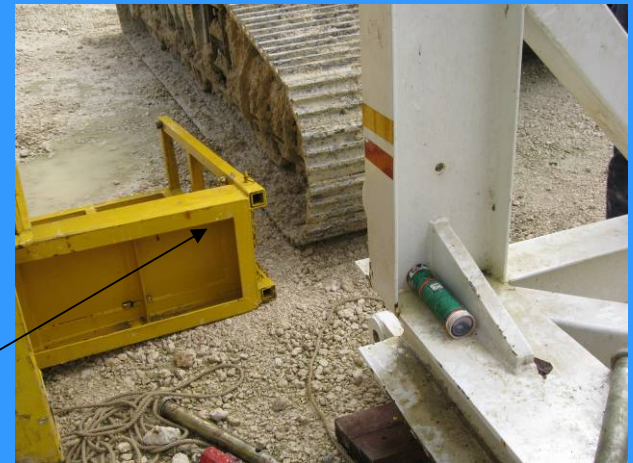
Handrail that trapped IP

- Restricted work space.
  - Supervisor and IP stood in the restricted area.
  - No escape route.
  - Other equipment too closed
  - Overall lease space limited because of Civil works ongoing work
- Insufficient Planning
  - Pre job did not address the hazards. Focus on the job at hand
  - No JSA in place
  - Pre job was verbal and not recorded
