Atwood Eagle

Crushed Finger – 14th October 2006

Crushed Finger Incident Summary

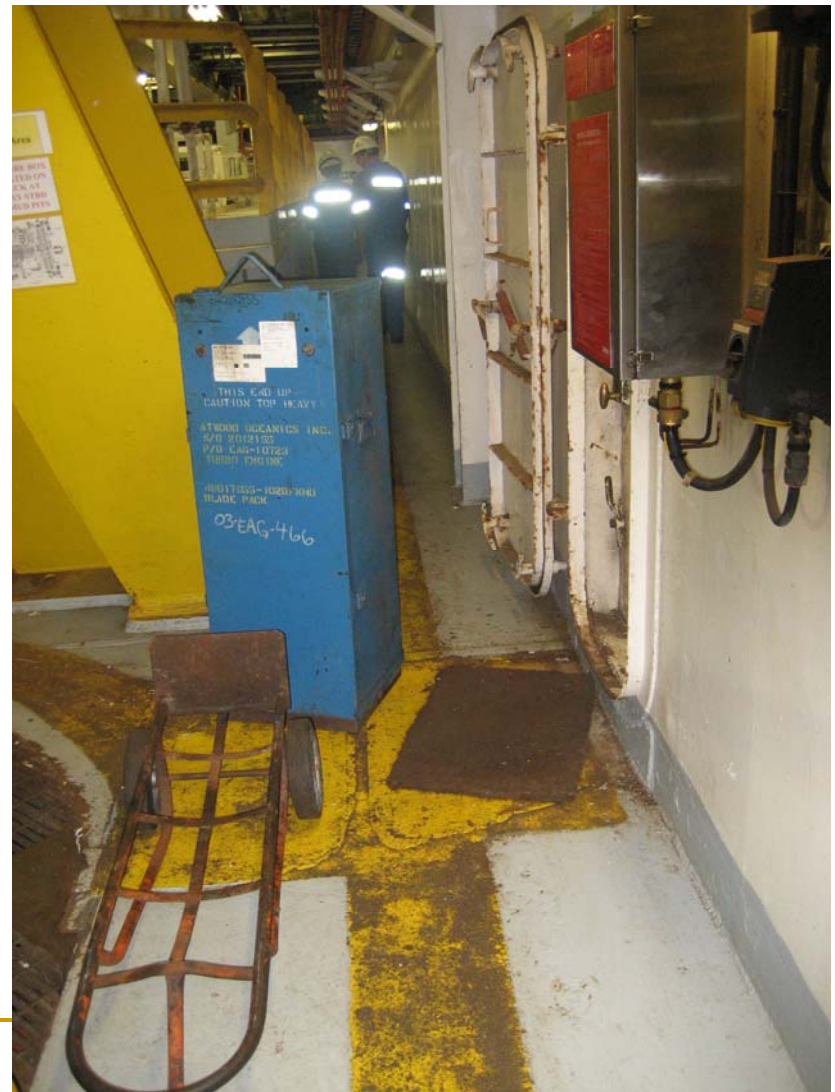
Top View of Incident

- With the power pack and trolley now outside the engine room, a roustabout (IP) promptly took hold of the trolley and lifted the power pack back on the trolley
 - At this point the IP was unable to control the load and it continued coming down past the point of equilibrium
 - The IP attempted to catch the load and prevent it from falling and in doing so caught his right hand little finger between the trolley handle and deck resulting in a compound fracture
-

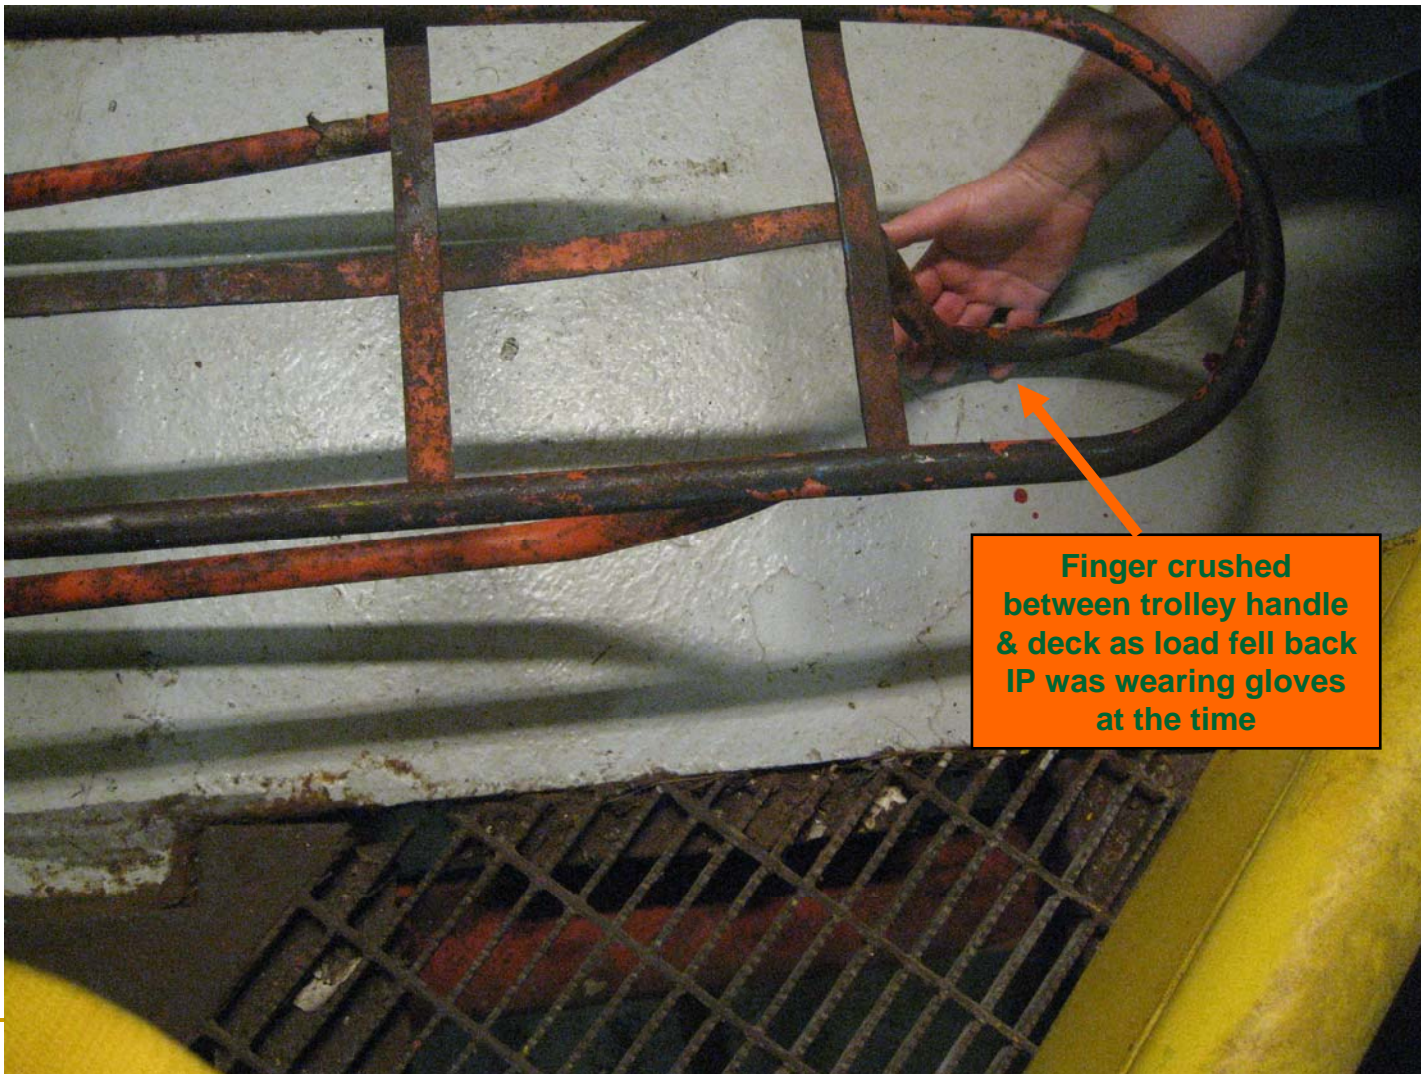
Finger crushed
between trolley handle
& deck as load fell back
IP was wearing gloves
at the time

- Install mechanical lifting / trolley securing arrangement for this task
- Conduct hazard hunt across rig to identify areas where mechanical lifting points are required
- Develop a JSA for handling power packs and other similar activities as identified from the hazard hunt
- Educate crew on the suitability of various trolleys and hand safety
