GEODYNAMICS  
LIMITED

# Dropped IBOP Actuator Arm

# Dropped IBOP Actuator Arm - Chronology

RIG 100 Work floor

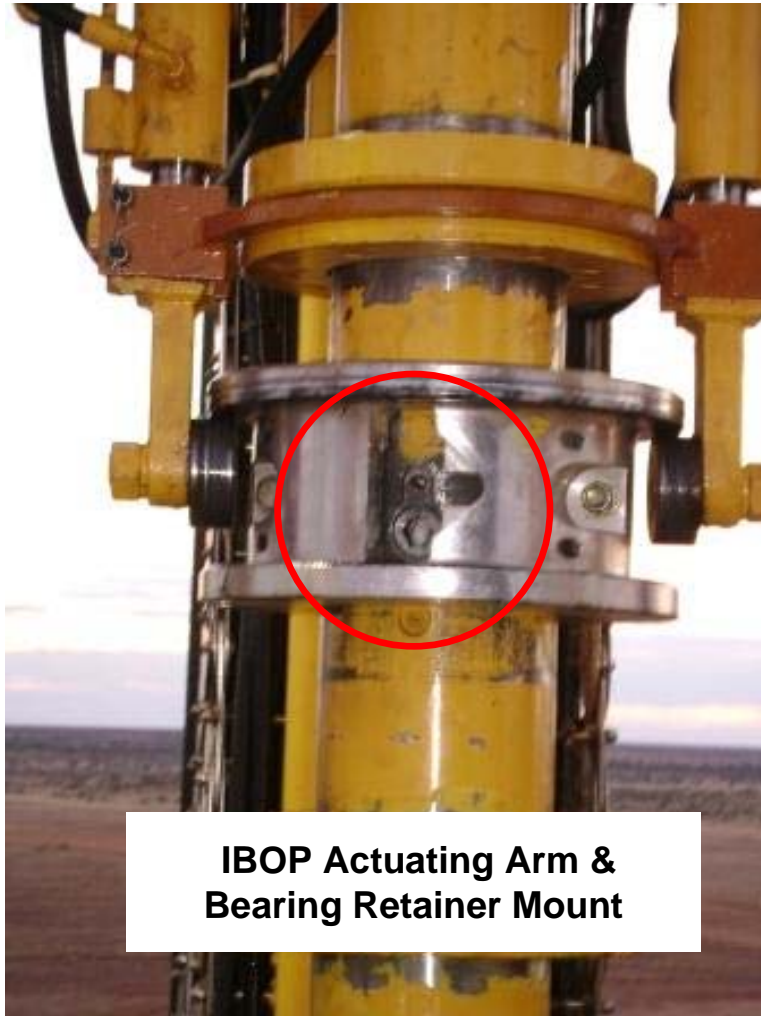
**IBOP Actuating Arm & Bearing Retainer Mount**

## 1. Loose bolts on IBOP actuator arm bearing retainers.

- The assembly is fitted through the actuator sleeve preventing a clear view of the mating surfaces and protruding circlip.
- There was no locking system in place to prevent the retainer bolts from unscrewing.

- Design, manufacture and install a retainer plate as secondary fall protection for the actuator arm.
  - Use a MOC process to review the new design ensure the new design of the product does not compromise any other function and to ensure all implications are understood and addressed.

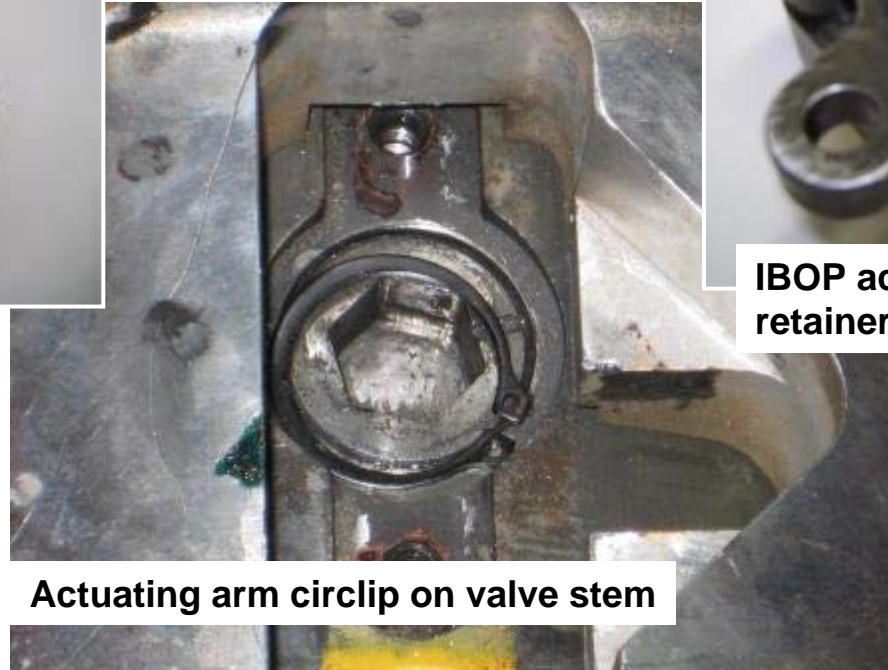
**Actuating arm circlip on valve stem**

## 3. Inadequate clearance for actuating arm circlip inside IBOP housing

- Equipment design needs improvement - a simple dimensional check on the design documents by another party should have identified the problem .

- Issue a product alert to inform end users of the valve stem manufacturing defect and recall for modifications all units in service.
  - Review and modify engineering change procedure to ensure the final product assembles and operates as designed and intended (Issue previously identified).
