GEODYNAMICS  
LIMITED

# Dropped Sheave Saddle Bracket

# Dropped Sheave Bracket - Chronology

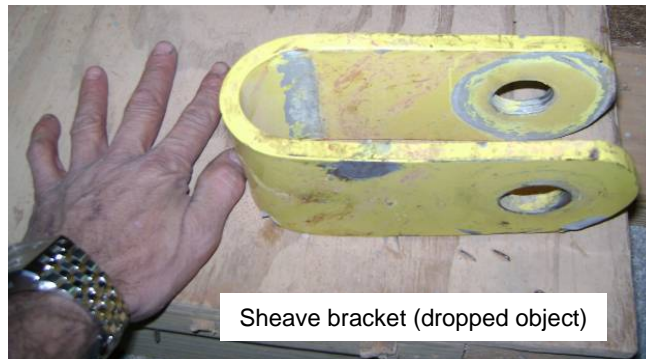
- The 2.5 kg bracket fell approx 12m striking a cross beam above the monkey board level (where the assisting Floorman was located) and then deviated through the back of the mast, falling another 46m.
- The bracket landed on the edge of a mud pump skid and bounced back towards the drawworks.
- At that time the oncoming Derrickman was walking towards the mud pumps near where the bracket landed.
- The Tourpusher was alerted immediately and all operations were suspended and crew mustered.

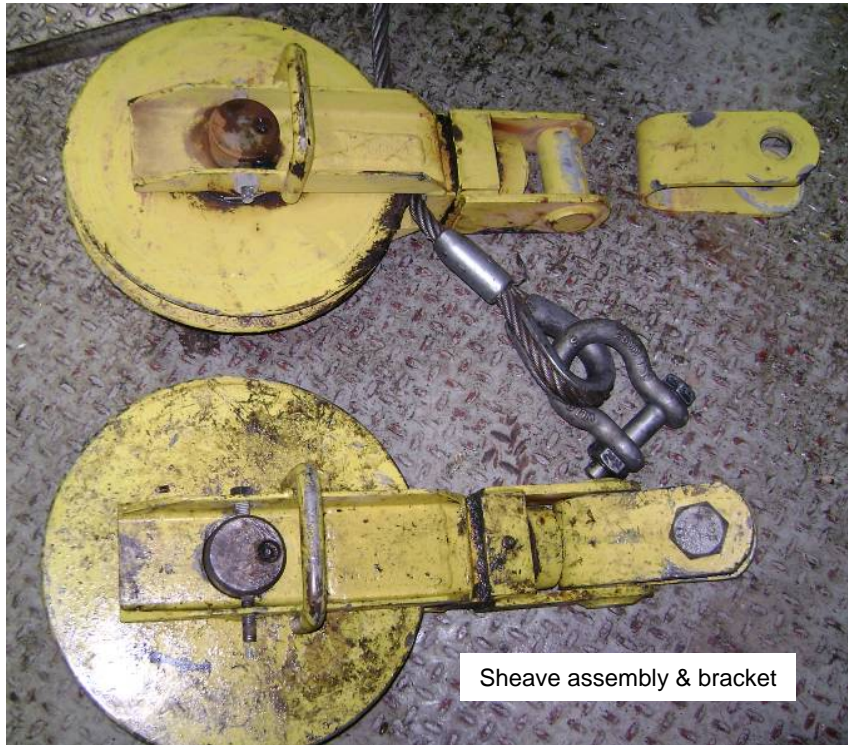
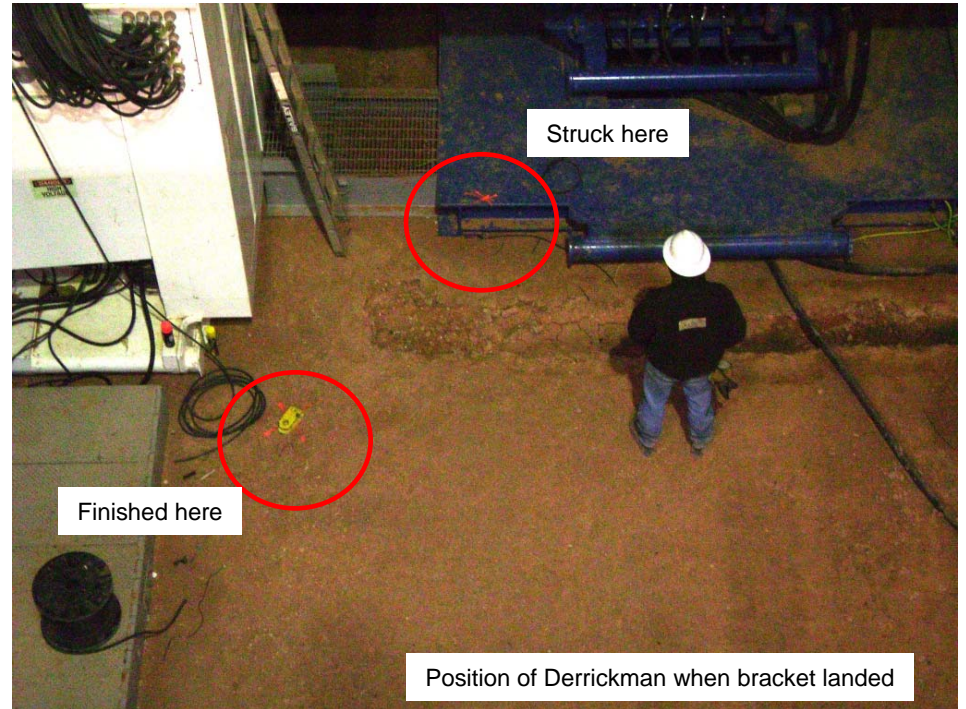
# Dropped Sheave Bracket

- Attempt to free the jammed winch line without success.
- Need to detach sheave - a harness was placed around the sheave to secure it when detached.
- A locking pin and nut was removed from the bolt that secured the sheave bracket to the pad eye. When the bolt was removed the bracket twisted around and fell free from the sheave block.

1. Lack of knowledge / experience/ training on rig specific new design equipment. No SOP for stabbing board operation available.
2. No counter weight on the end of the winch line.
3. Winch line sheave position in relation to the task resulted in an over head work position.
4. Driller was fatigued after ascending and descending the mast twice, as well as pulling through the winch line. Incident happened at end of shift at midnight.
5. Design of equipment (2 piece sheave block): Failure to identify risk of the sheave design fault during rig assembly & commissioning process.

- Obtain and install one piece sheave blocks in place of the two piece design.
- Update JHA training gaps within Rig 100 crews.
- Increase of key GDY/EWG personnel in future new plant acceptance - familiarise themselves with equipment, its installation, operation and removal; and to assist in creating SOP's for new equipment.
