Starting a new drilling project in PNG

Drill Safe Conference Brisbane

6th December 2007

Dropped Object – Rigging Screw

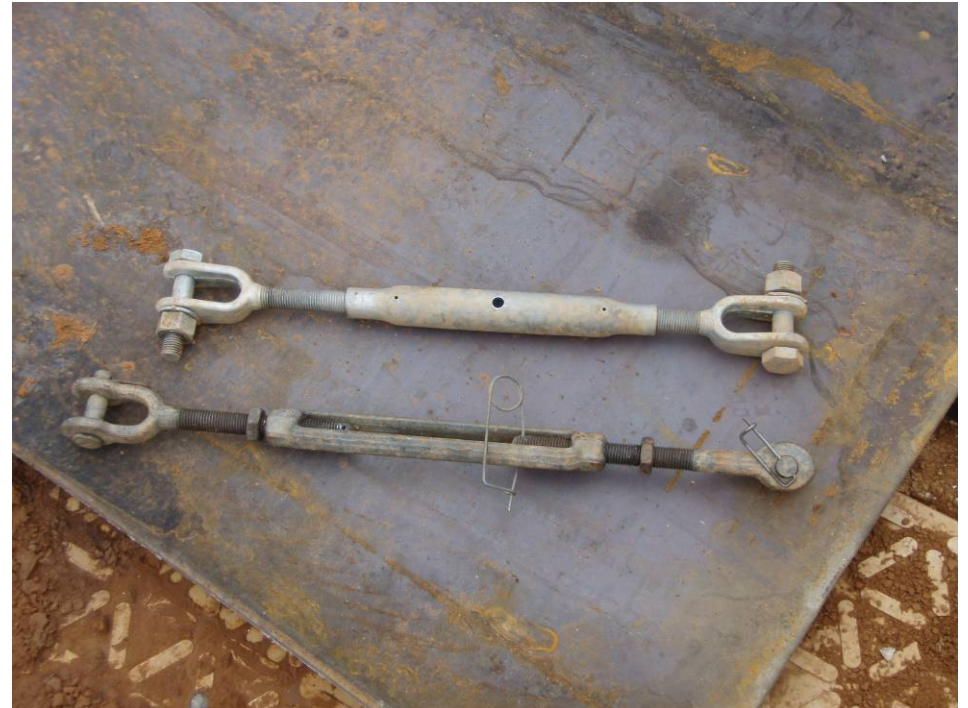
- Both Rigging Screws and Turnbuckles are normally referred to as Turnbuckles. OEM drawing call for Turnbuckles to be fitted.
- The design of the Rigging Screw is such that the thread is enclosed inside a tubular section of steel making it hard to determine how far the jaw threads are screwed in.

- Jaw ends of the Rigging Screws are not fitted with any secondary securing device i.e. locking nut to prevent them from backing out. Turnbuckles are fitted with locking nuts.

- Before sending the workers up the derrick the AD screwed in both ends of the Rigging Screw a few turns. Given that one end screws clockwise and the other anti-clockwise it is possible that he may have actually backed one end out some turns instead of in. This would not be noticeable within the tubular section.

- Rigging Screws were new and easy to screw in and out. Given the position of the Rigging Screw during climbing it is considered possible that with every ladder rung climbed the person's right thigh may have been knocking the bottom jaw causing it to turn and back out.

- Failure to **STOP THE JOB**. Employee did not intervene even though he knew they were the wrong type. Onsite Supervisor to reinforce “Stopping the Job” is a right and an expected practice.
- Rigging Screws have been taken out service and replaced with OEM recommended Turnbuckles.
- The end of the Turnbuckle jaw thread has been drilled to allow a safety pin to be fitted. This will act as an extra safety device in addition to already fitted locking nuts.
- Permit to Work and Job Safety Analysis awareness sessions were held with all onsite crews.
