Rig Move LTI
MDC Rig #151 – Raslie 9
09:45 21st November 2007

6 December 2007

Incident Summary

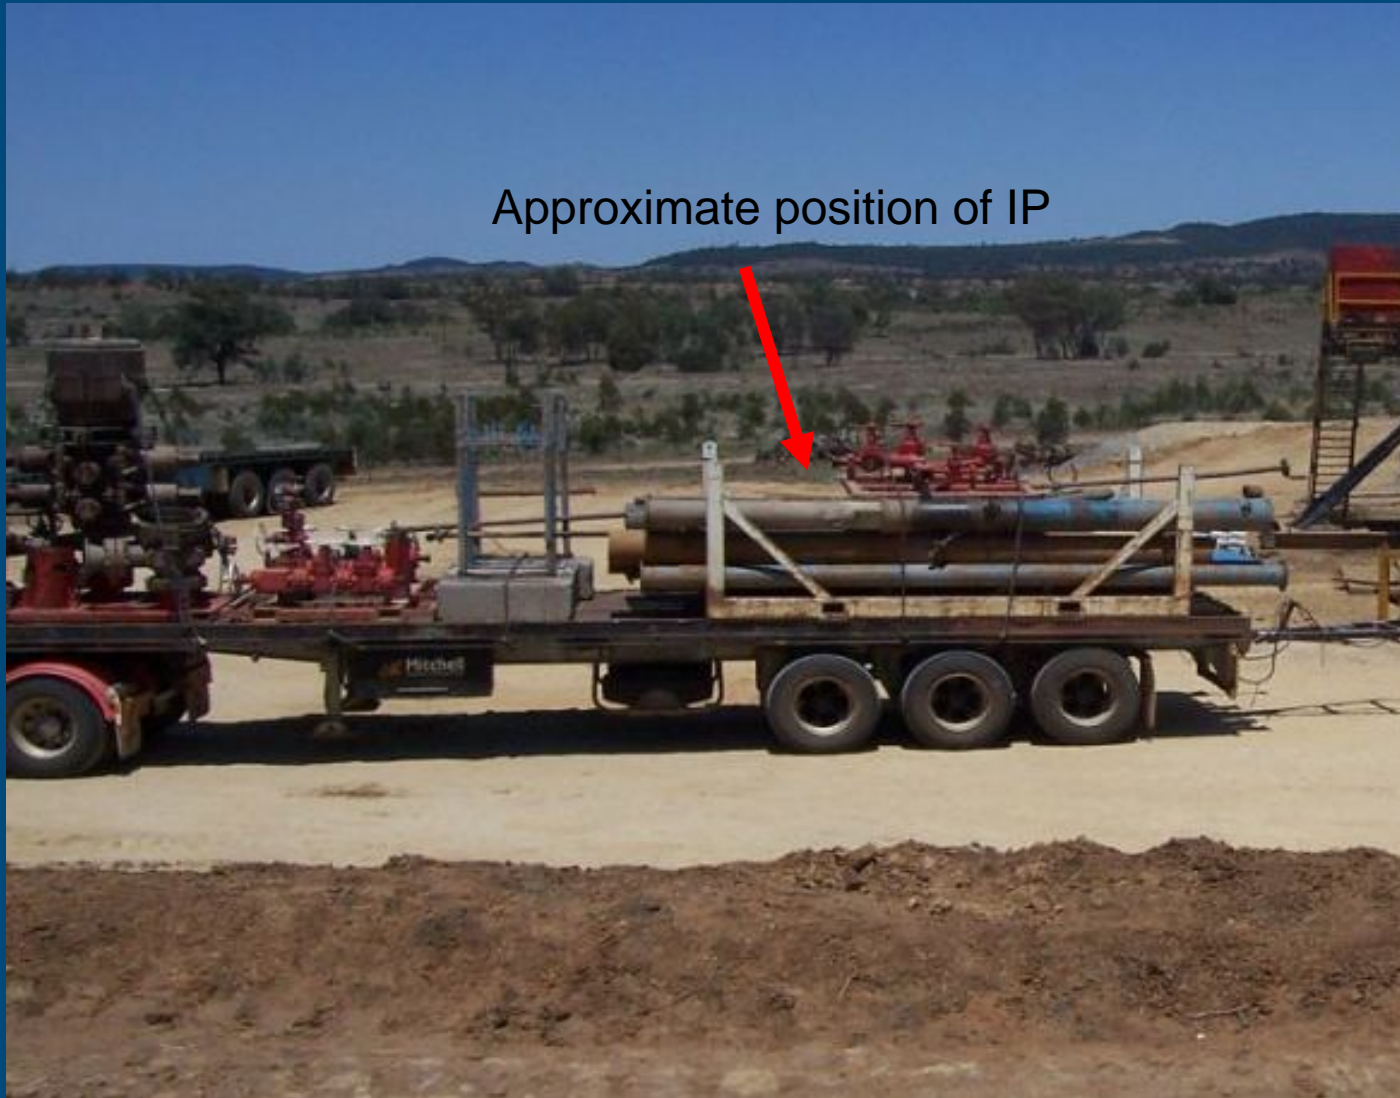
Incident Photos

- IP climbed onto the trailer and onto of the flow line located in the bolsters to better position the dunnage (approx. 2.7m above ground level).
- The Derrickman noticed this unsafe act, and asked the IP to get down

- As the IP attempted to get down, the flow line moved causing him to fall to the ground injuring his elbow
- IP was taken to Roma hospital for X-rays and later transported to Toowoomba for surgery

- Implement detailed rig move plan for all future rig moves
- Crews to be reinducted on working at heights requirements
- Mitchell Drilling to outline crew expectations and standards, and enforce these were applicable
- Expectation of Site Supervisors to be reinforced
 - Requirement to stop operations in the event of non compliance with safe work instruction
- Currently rolling out a Safety Leadership Coaching program (to augment previous Safety Leadership courses)
 - Improve pre-job meetings/communication
 - Improve intervention skills
