Maersk Ngujima-Yin FPSO
Down man of Non-Essential Personnel due
to loss of Emergency Power
6th July 2008

Ian Davison
Maintenance Superintendent
(Acting Operations Manager on day of Incident)
Maersk Ngujima-Yin FPSO

MAERSK NGUJIMA-YIN FPSO

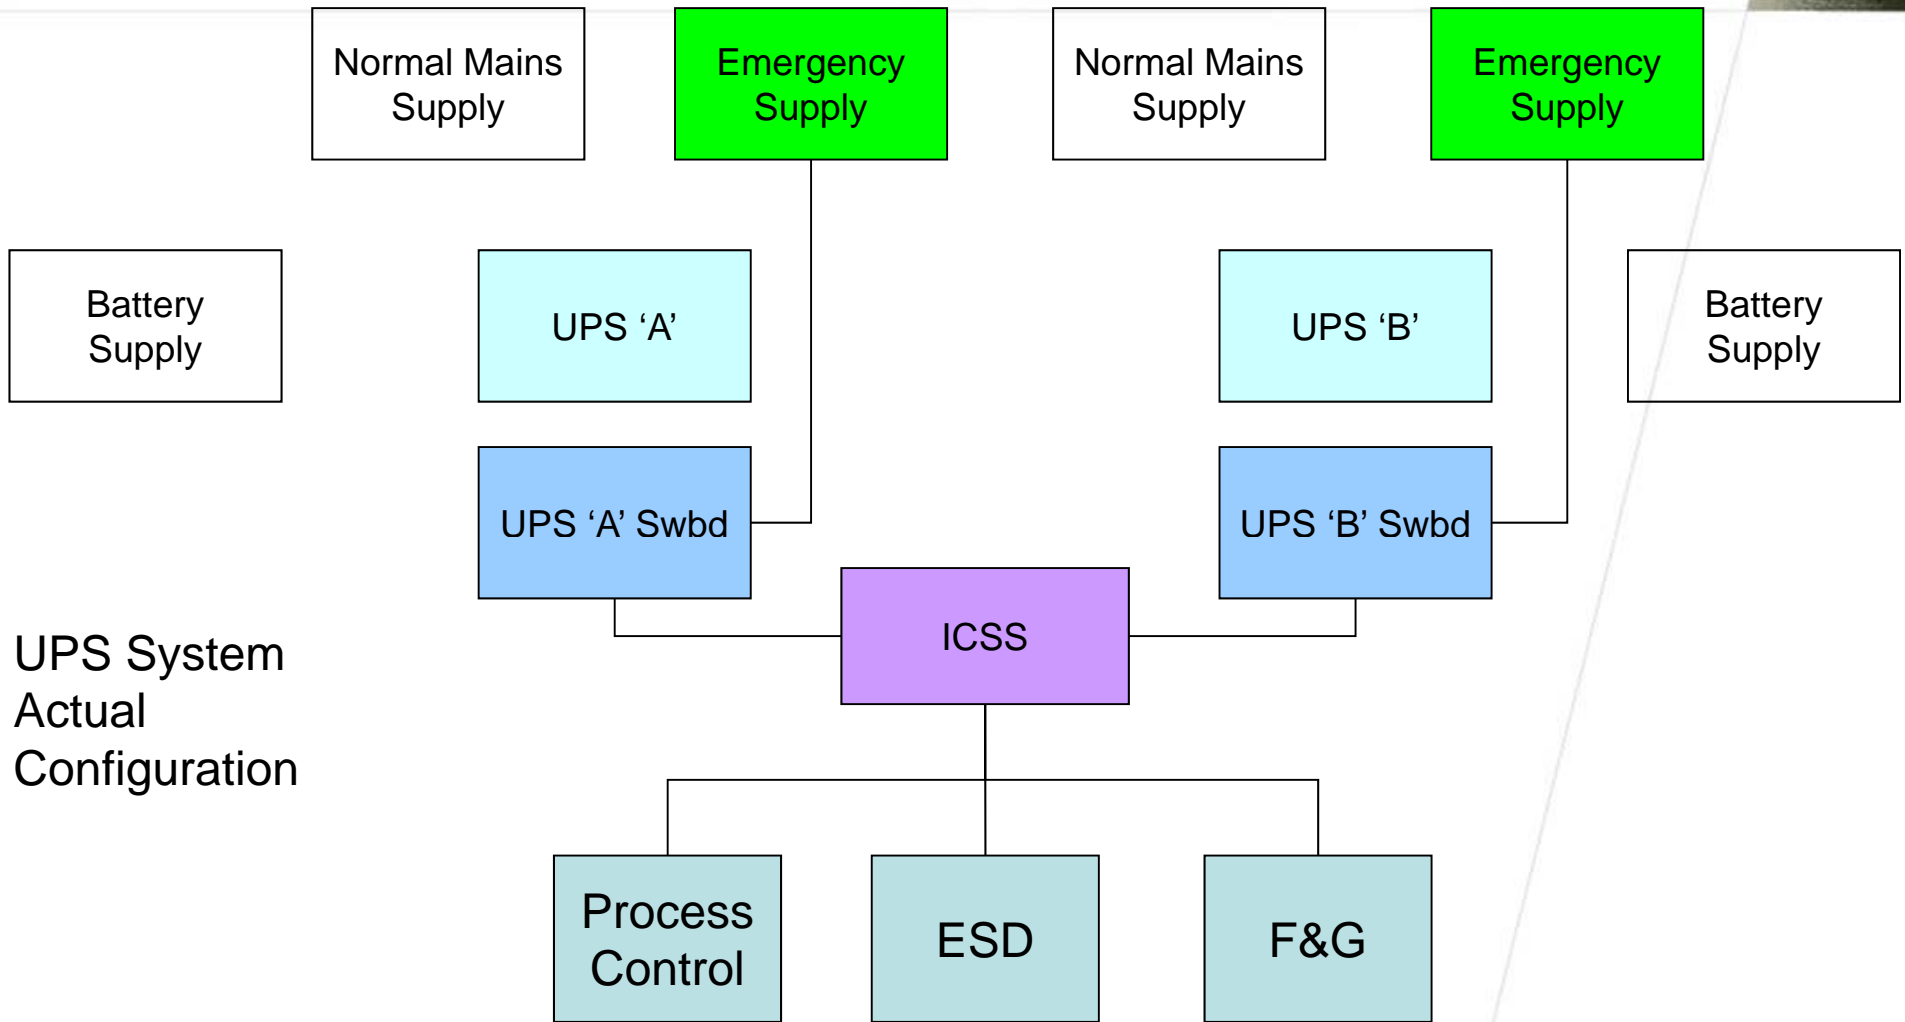
UPS System Actual Configuration

- UPS 'A' was in Maintenance By-Pass.
Several components had failed on 1st July 2008
- UPS 'B' was in Maintenance Bypass.
Unit bypassed when smell of arcing noticed 3rd July
- UPS Vendor due to mobilise with spares 7th July
