**Maersk Ngujima-Yin FPSO**  
**Down man of Non-Essential Personnel due**  
**to loss of Emergency Power**  
**6<sup>th</sup> July 2008**

**Ian Davison**  
**Maintenance Superintendent**  
**(Acting Operations Manager on day of Incident)**  
**Maersk Ngujima-Yin FPSO**

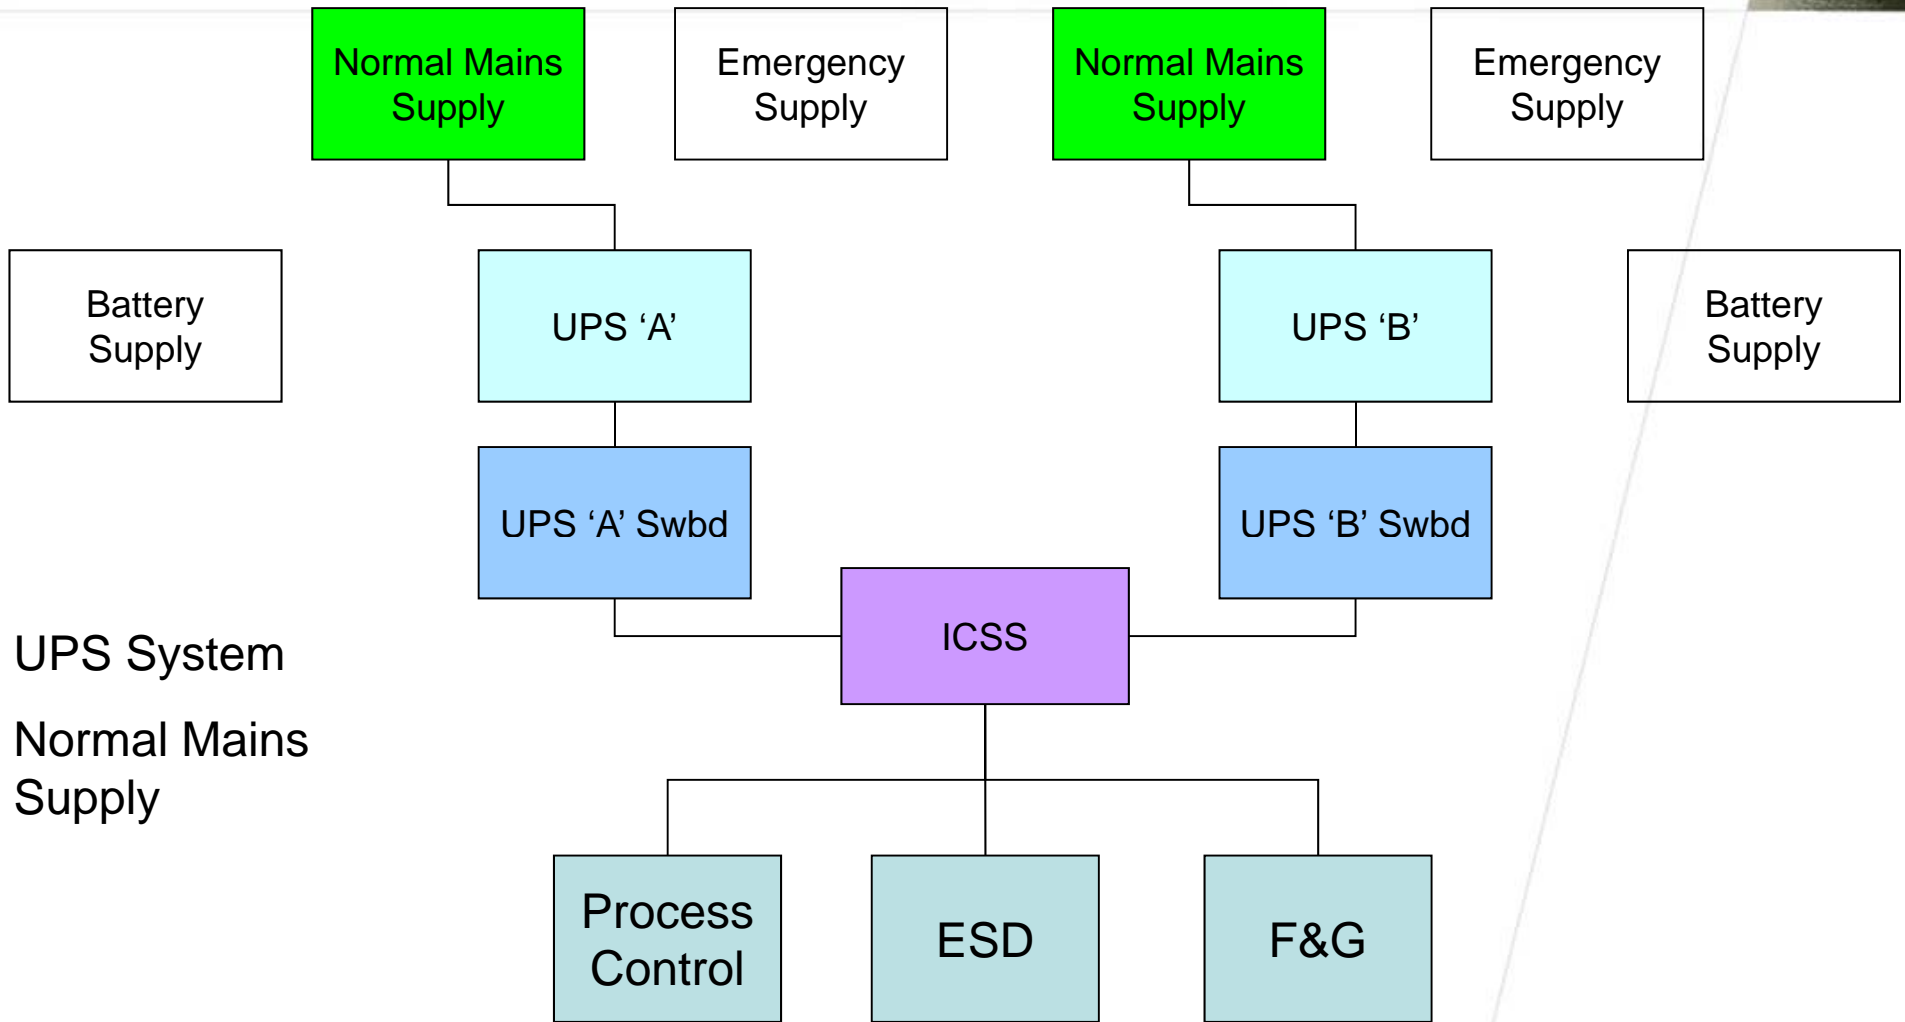
UPS System  
Normal Mains  
Supply

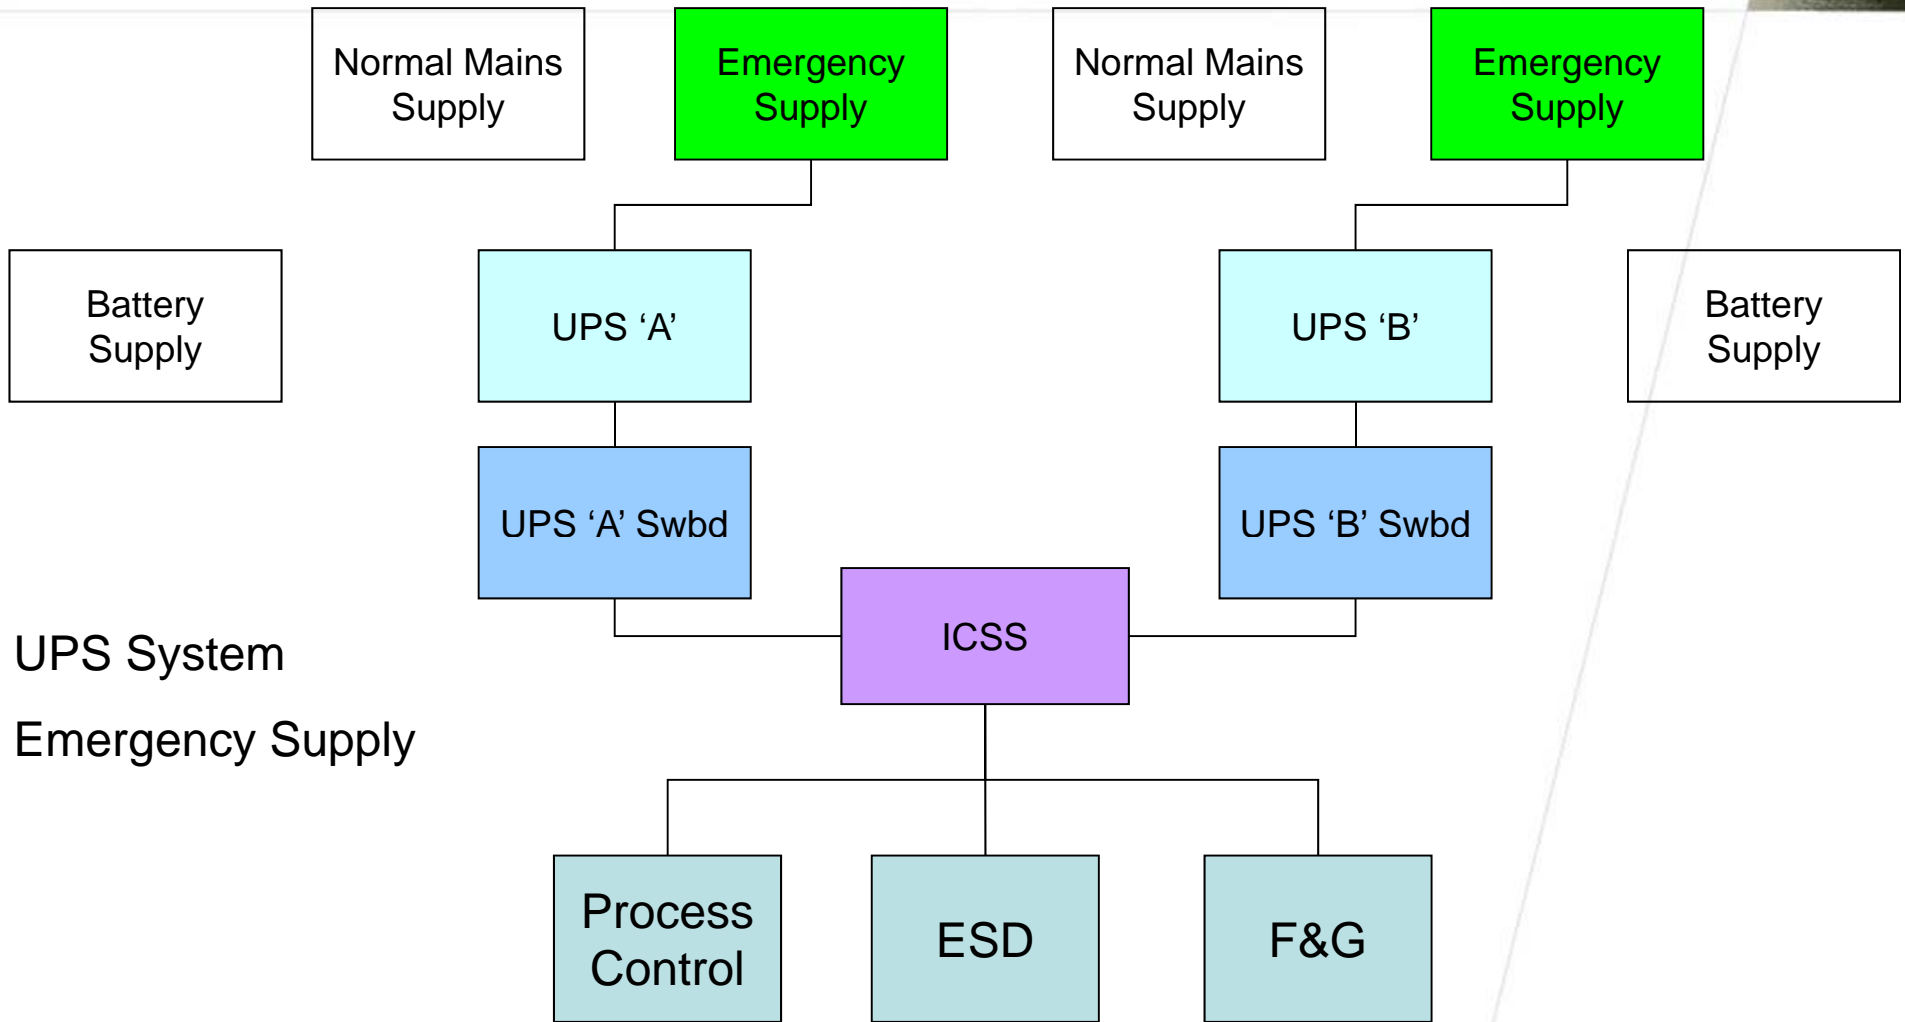
UPS System  
Emergency Supply

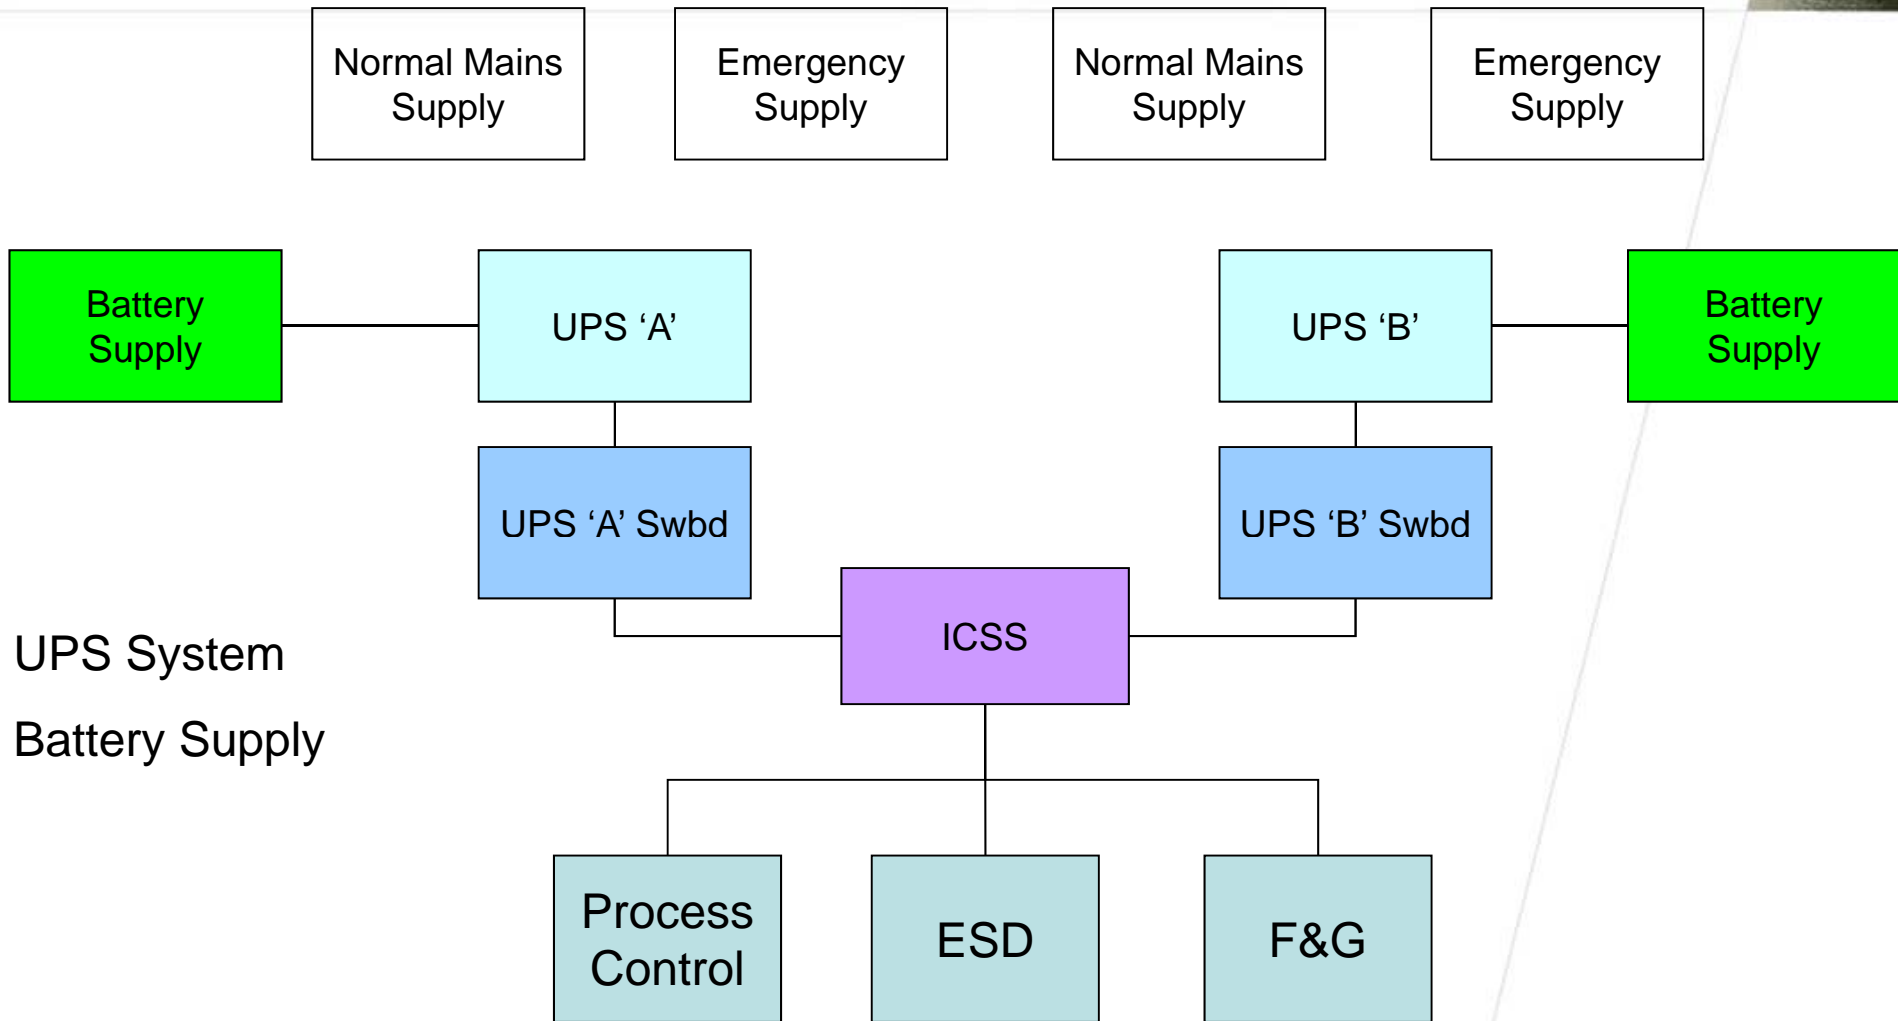
UPS System  
Battery Supply
