# Support Vessel Incident

Vent Line Cap Strikes Man in the Face

P Dodd, December 4, 2008

# Support Vessel Incident – 4 July 08

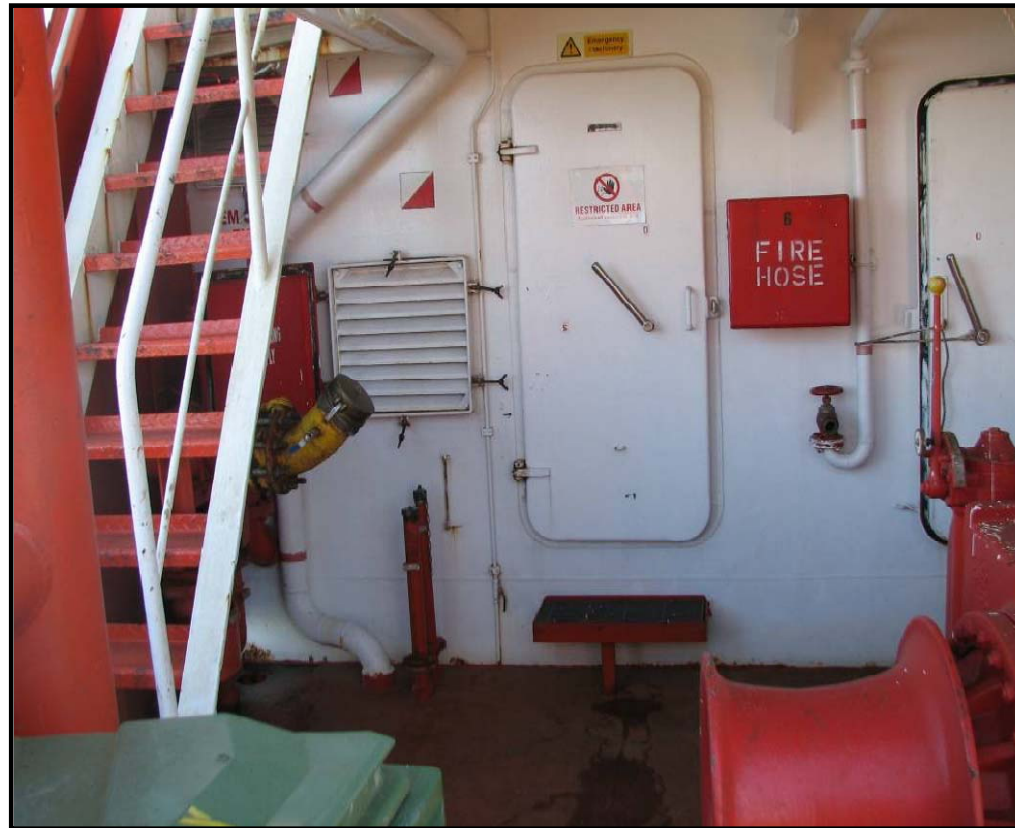
# Vent Line Location

- Chief Engineer went down from the bridge to the deck and went over to Pod 1 vent line with Chief Mate to investigate

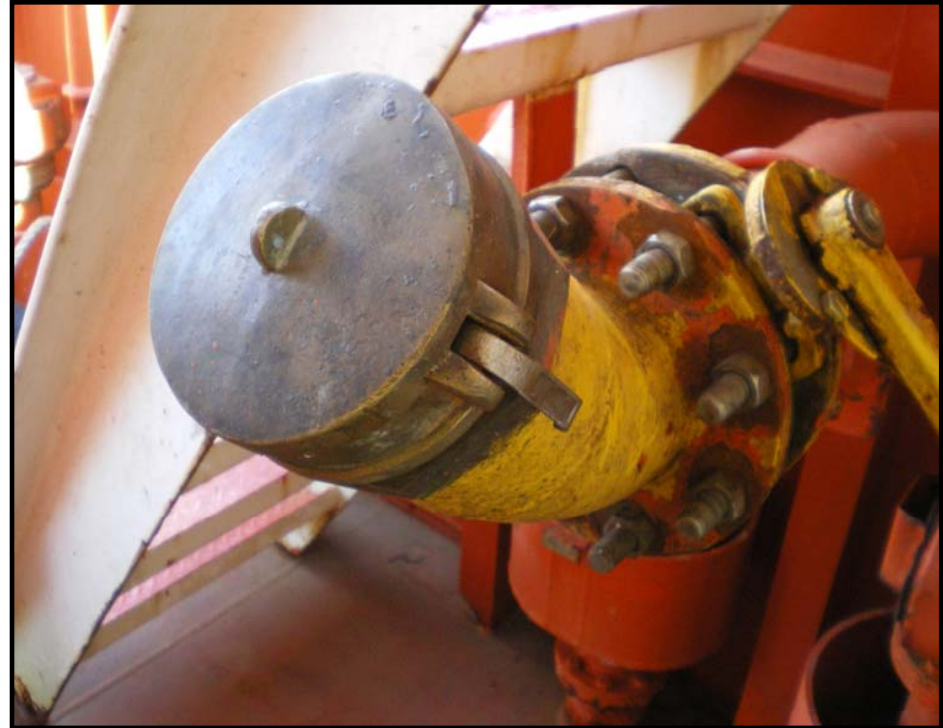
# Pod 1 Vent Line

- C. Engineer identified that vent line rubber hose was not on the correct vent line (hose had been fitted to a different fill/discharge line as part of earlier maintenance work)
- Confusion between C. Engineer and C. Mate over pod tank being pressured
- C. Engineer & C. Mate went to check if there was pressure in the vent line

Vent line normally has a rubber hose from here to direct dust from tanks overboard

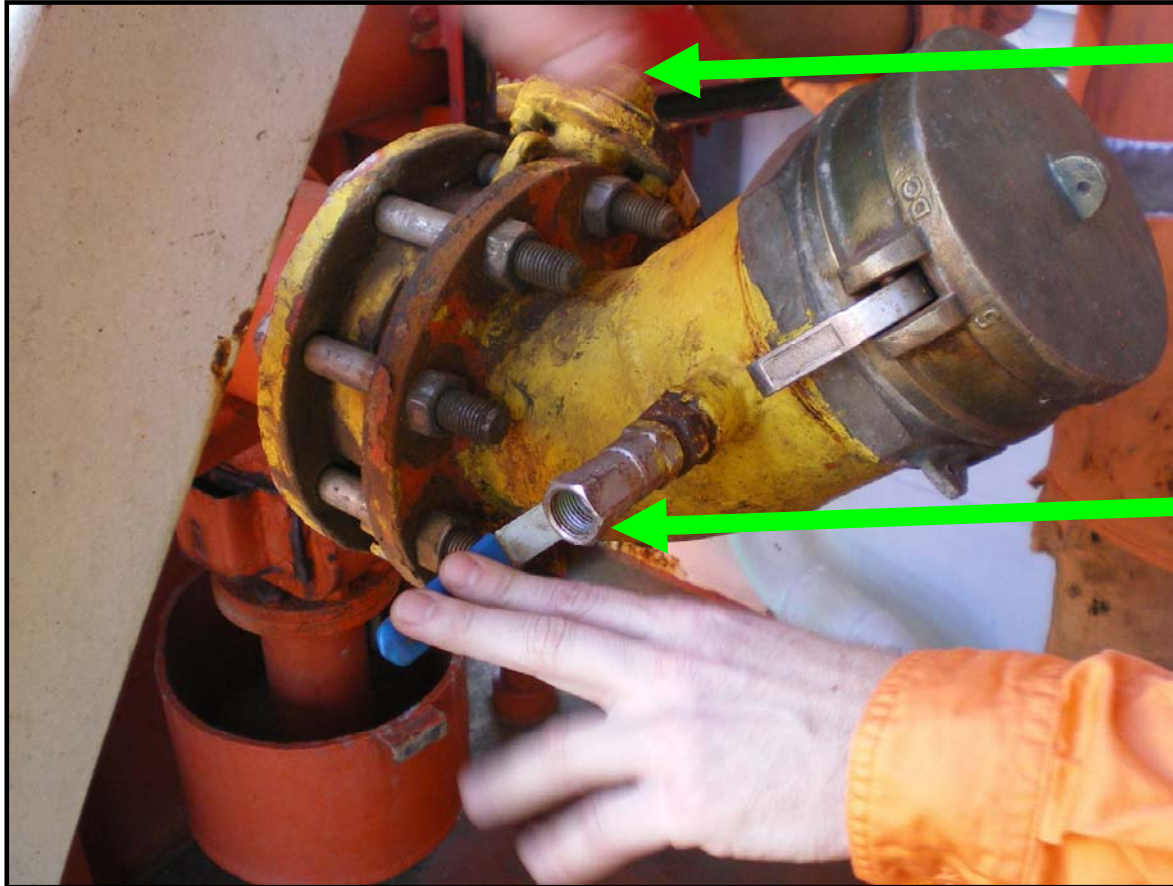
# Position of Men

2. C. Mate cracked open butterfly valve to check for air

1. C. Engineer (IP) opened bleed off valve and stood to the side to avoid potential air flow from valve

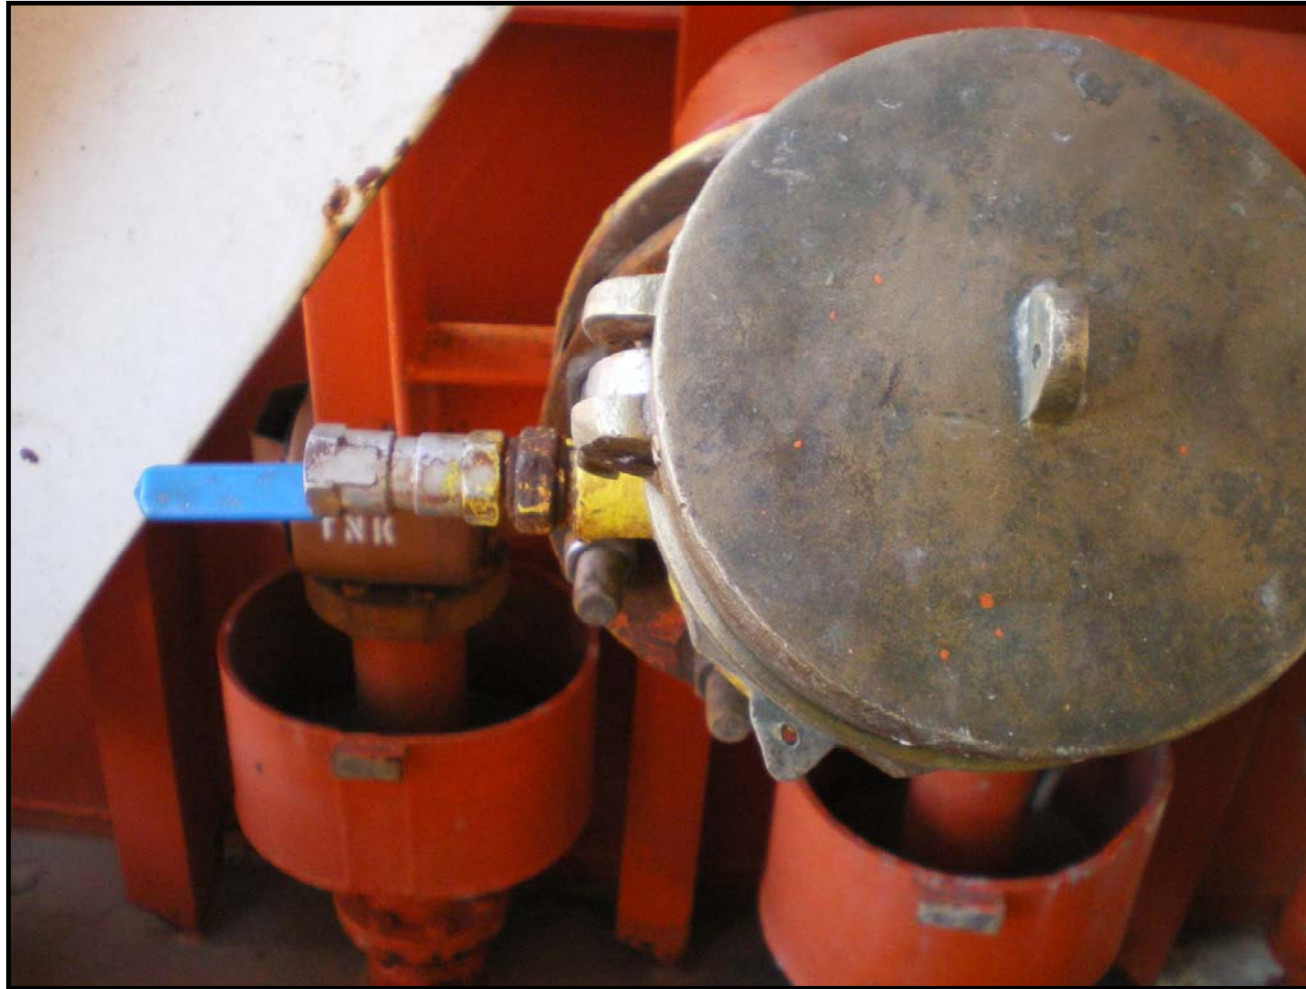
# Vent Cover Projectile

3. Camlock vent cap blew off and struck the man on the side of the face

Pressure unknown but max system pressure up to 5 bar (75 psi)

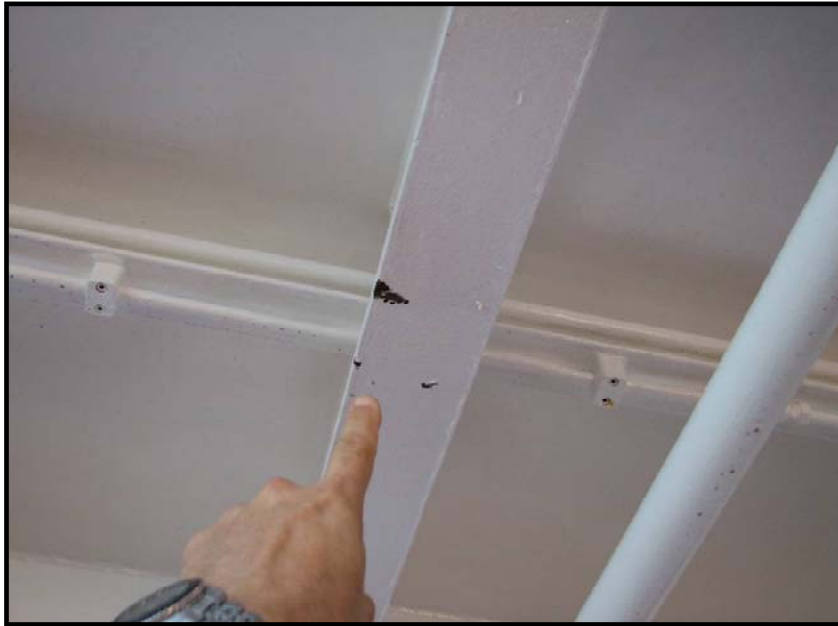
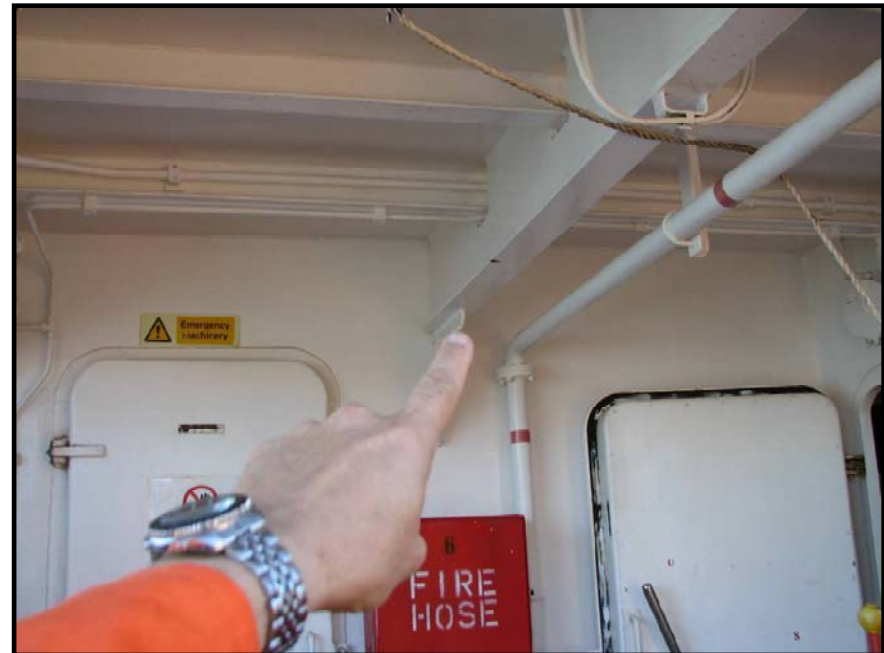
4. Vent cap continued on upwards and struck beam above and ended in the winch house
