HALLIBURTON

Steady Flow System Loss of Containment

Taproot Investigation

The Incident

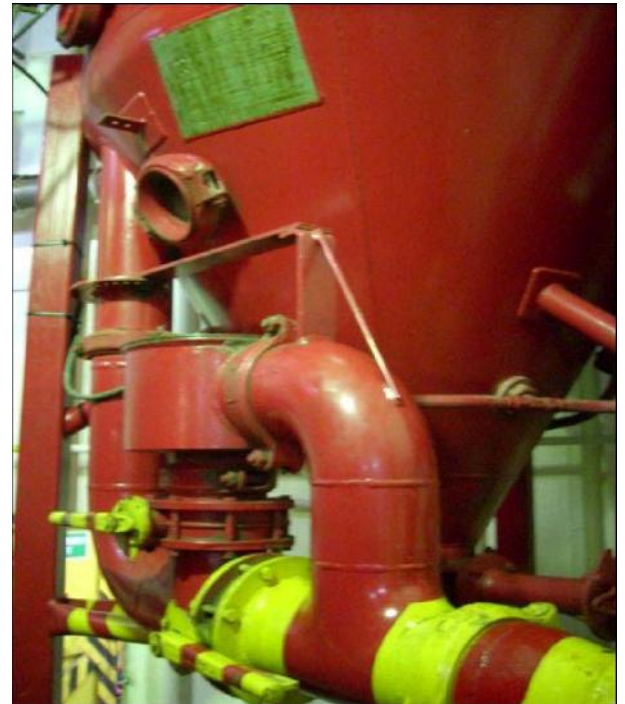
SFB Pressure Gauges & Bello Fram Valve

On the morning of July 4, 2009, a near miss event occurred during maintenance operations on pneumatic cementing equipment specifically the Steady-Flow Bin (SFB) that was installed on an offshore drilling rig,

Cement product was released under pressure from the vent line attached to the SFB covering the two operators working on the system and the corresponding work space and equipment with dry cement

Halliburton to investigate the current practise of utilizing silicon sealant to maintain a pressure seal on the lid of the Bellophram Valve and ensure its safety & effectiveness.

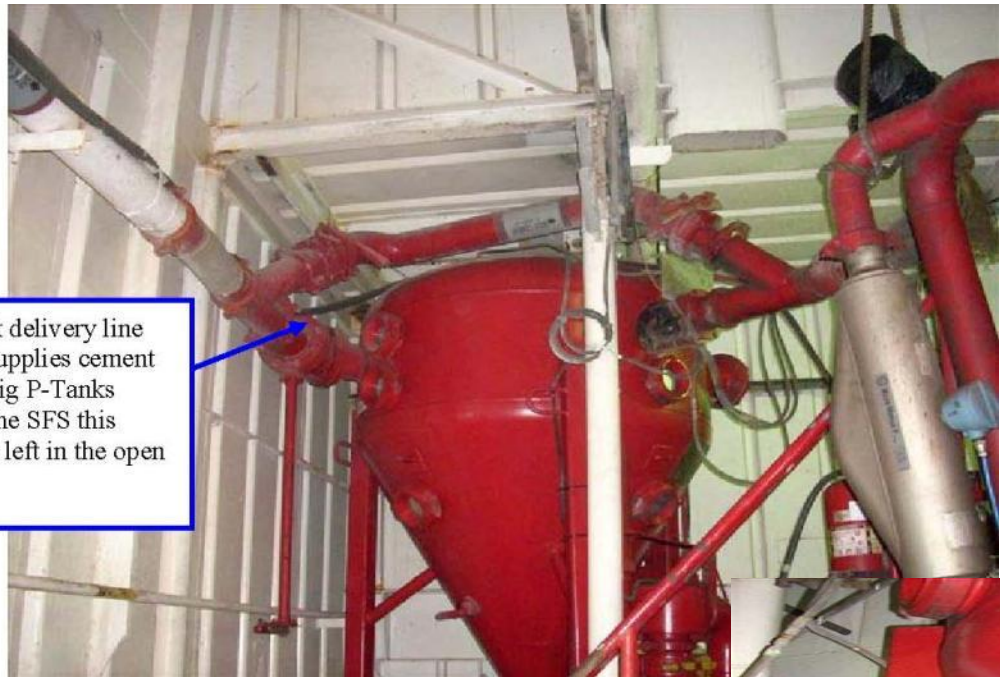
Main bulk delivery line
this line supplies cement
from the rig P-Tanks
direct to the SFS this
valve was left in the open
position

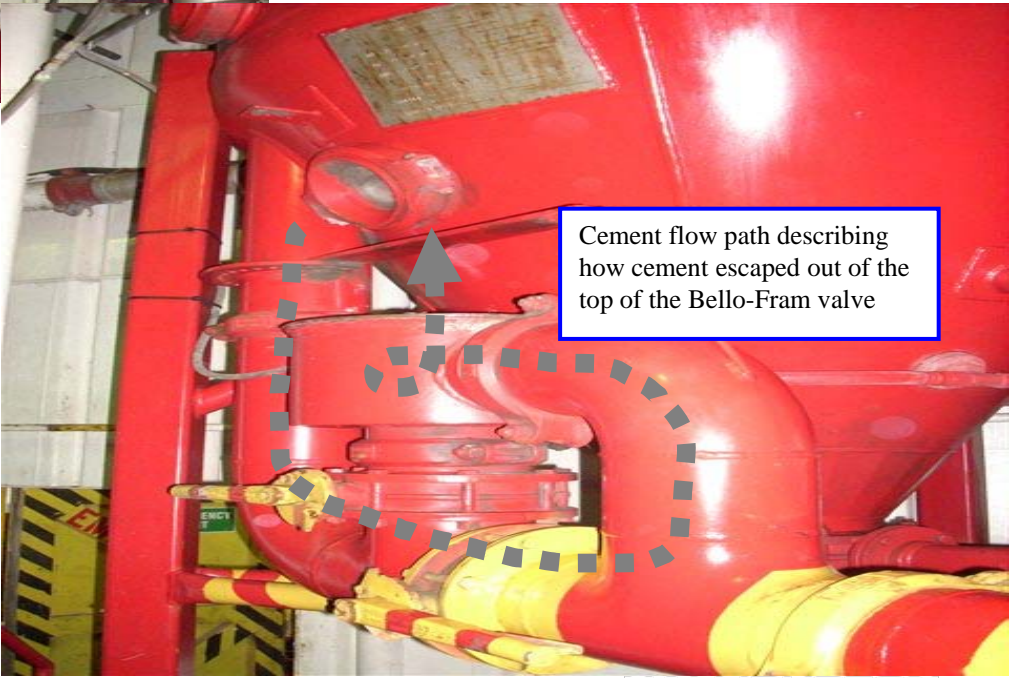
Cement Flow Path

Cement flow path describing
how cement escaped out of the
top of the Bello-Fram valve

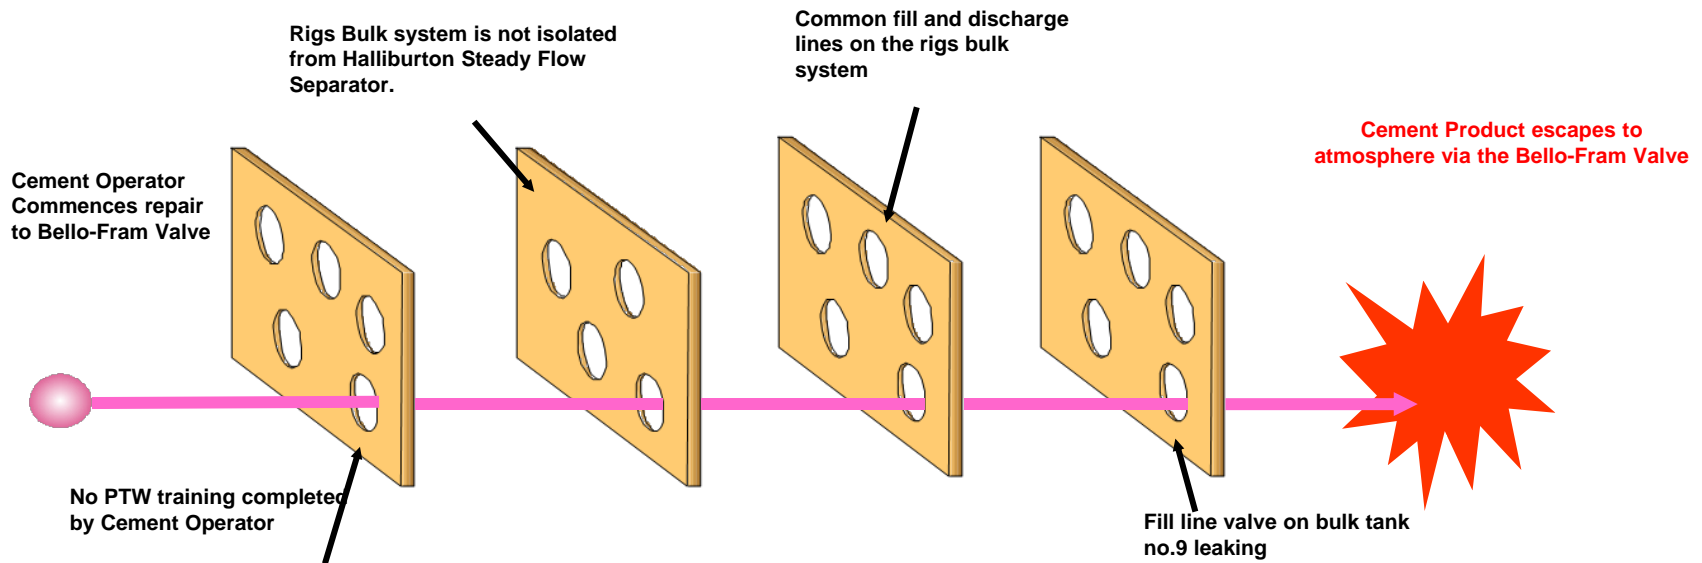
Causal Factors

CF-1 Cement Operator had not completed PTW training when joining the rig

CF-2 Cement Operator starts maintenance without a PTW in place

CF-3 Fill line valve on rig's P-Tank No.9 leaking

CF-4 Fill and discharge lines on rig's P-Tanks are a common line
