HALLIBURTON

Mismatched Iron Connections

Mismatched Hammer Unions – Ongoing Issue

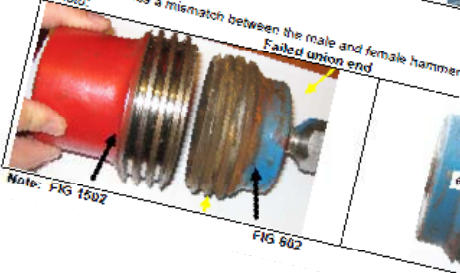
A worker while operating a sand filter valve in a temporary well test setup, sustained severe multiple injuries caused by the impact from a female hammer union, inadvertently dislodged from a side outlet, as well testing was in progress. He was thrown 19 ft from the sand filter equipment. He was evacuated to a regional clinic where he underwent emergency surgery. He later died in the clinic.

Connection was a mismatch between the male and female hammer union end

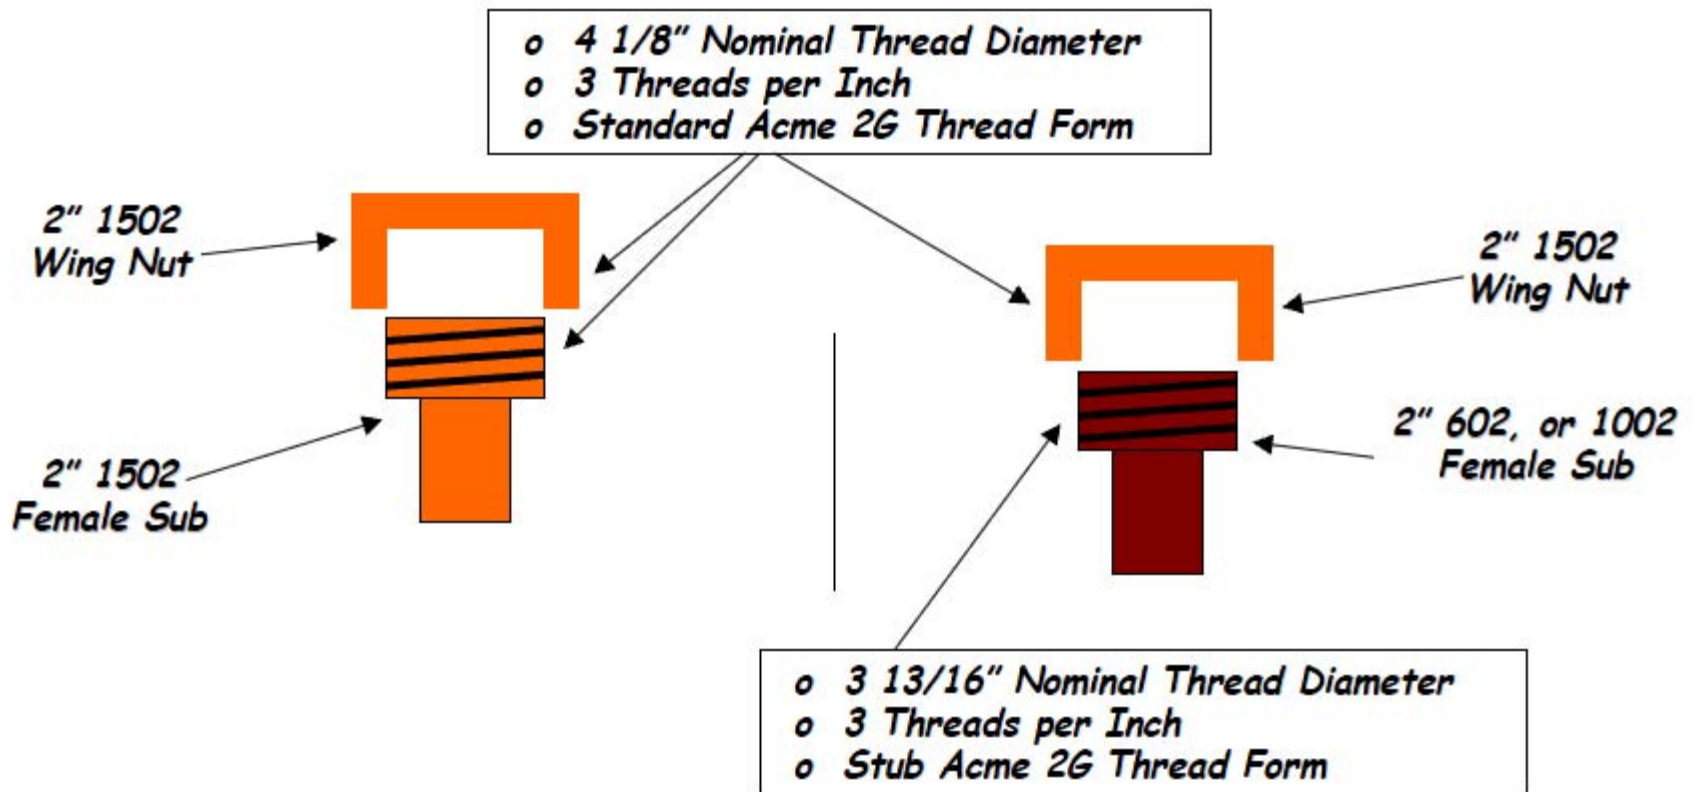
A 2" 1502 Wing Nut will make up to a 2" 602 or 1002 thread half and will hold some pressure ! However ...
... it will fail **explosively**.

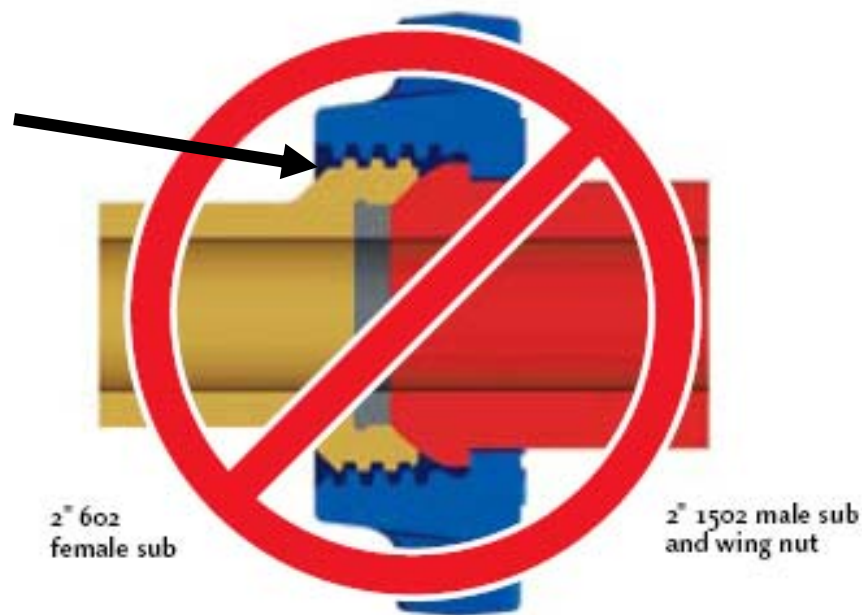
Dangerous Union Connection

- Same iron size *BUT* different Figure number and different pressure rating. Examples:
 - 2" 602 thread half & 2" 1502 wing half
 - 2" 1002 thread half & 2" 1502 wing half

Note the minimal thread engagement of wing nut thread and female sub thread.

This combination will make up, but will fail under pressure.

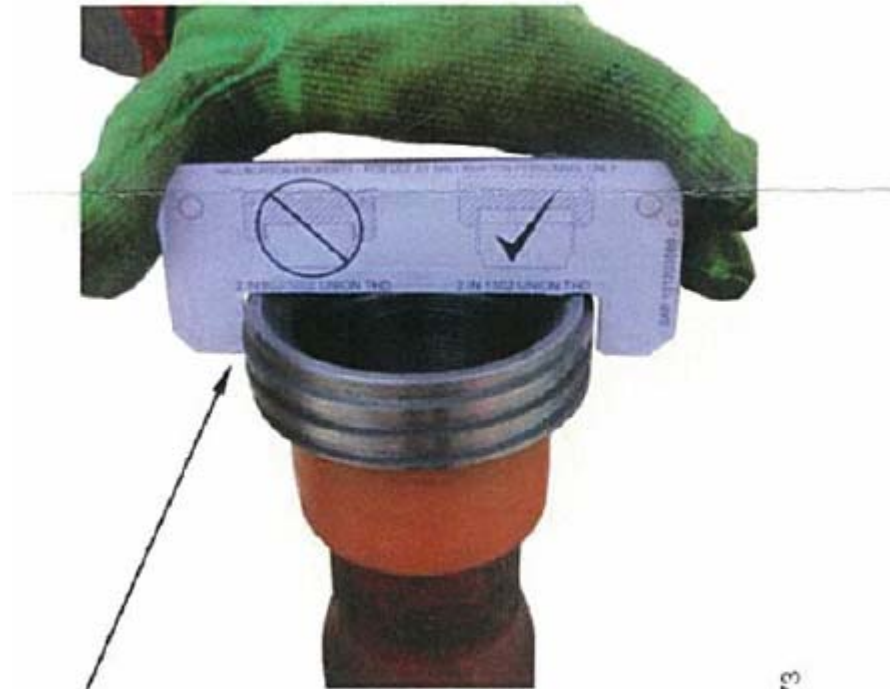
If gauge slides over threads, union is unsafe – DO NOT USE

- If the gauge fits over the threads as shown below, the connection is unsafe; **do not use**
