# Habanero-3 Well Control Review

# Habanero-3

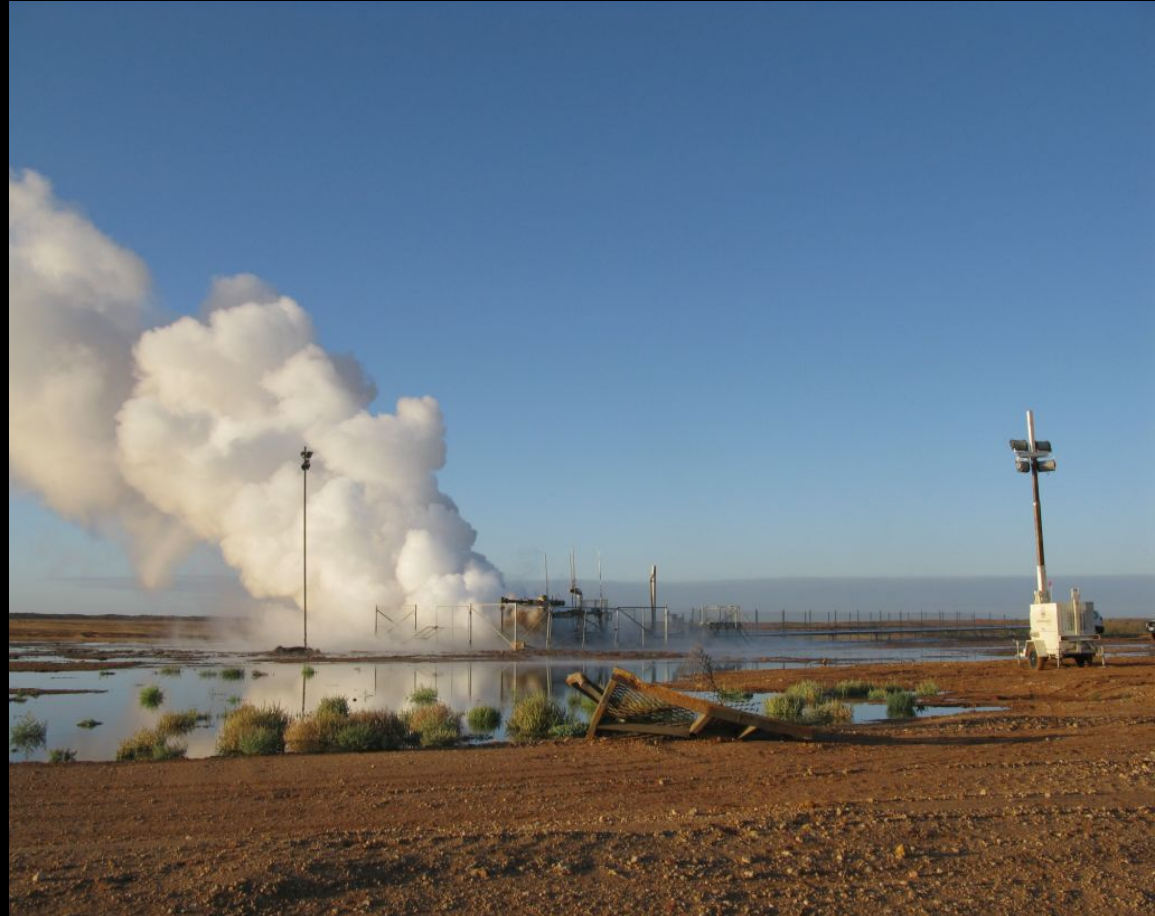
- At 8:19 pm on the 24<sup>th</sup> of April 2009 a rapid release of fluid occurred at Habanero-3

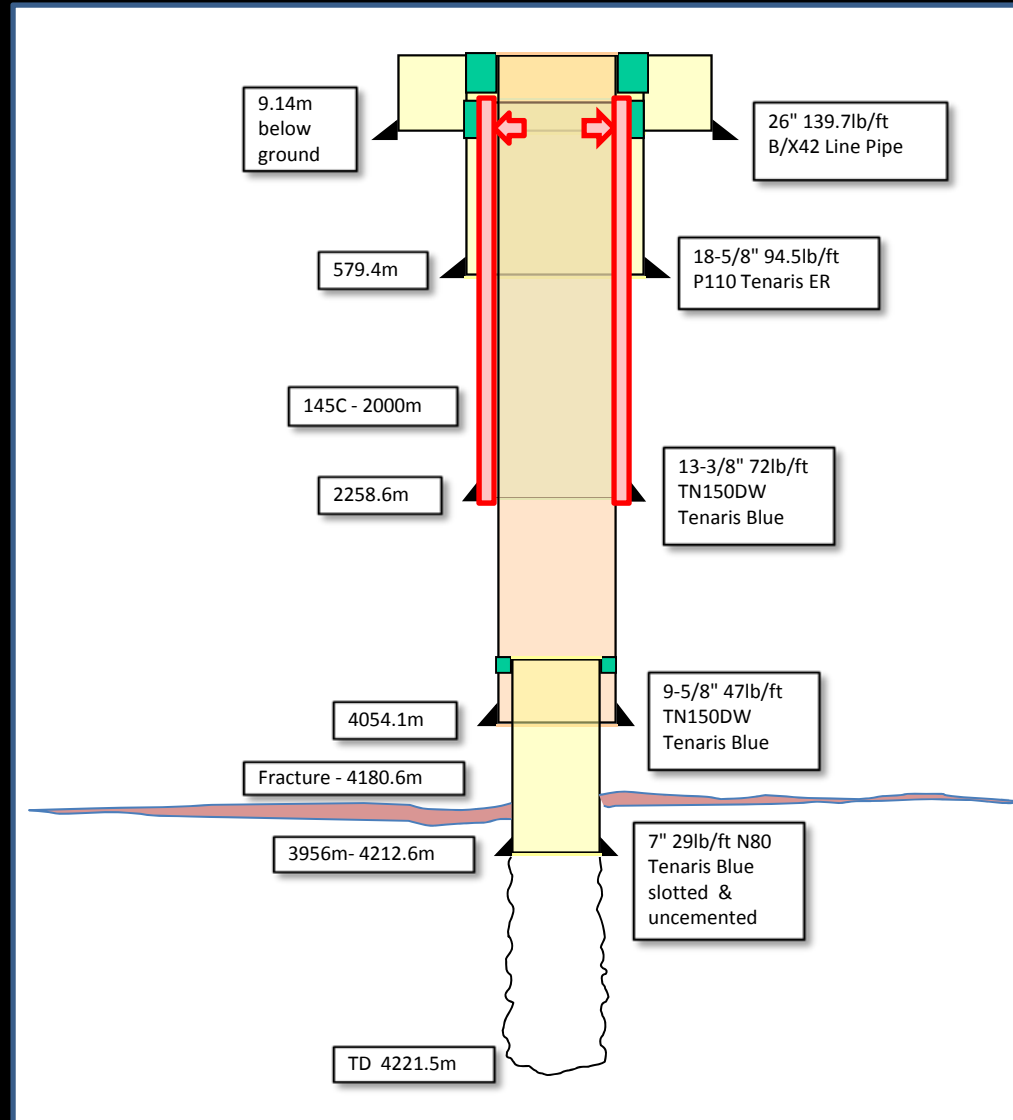
- The 9-5/8" casing failed from stress cracking due to hydrogen embrittlement in several locations
- Vertical stress cracks were found from 2.96 m – 8.4 m (below ground level)
- Some cracks were initiated from tong or slip marks
- When these stress corrosion cracks penetrated the 9-5/8" casing it allowed high pressure brine to pass into the 9-5/8" x 13-3/8" annular area

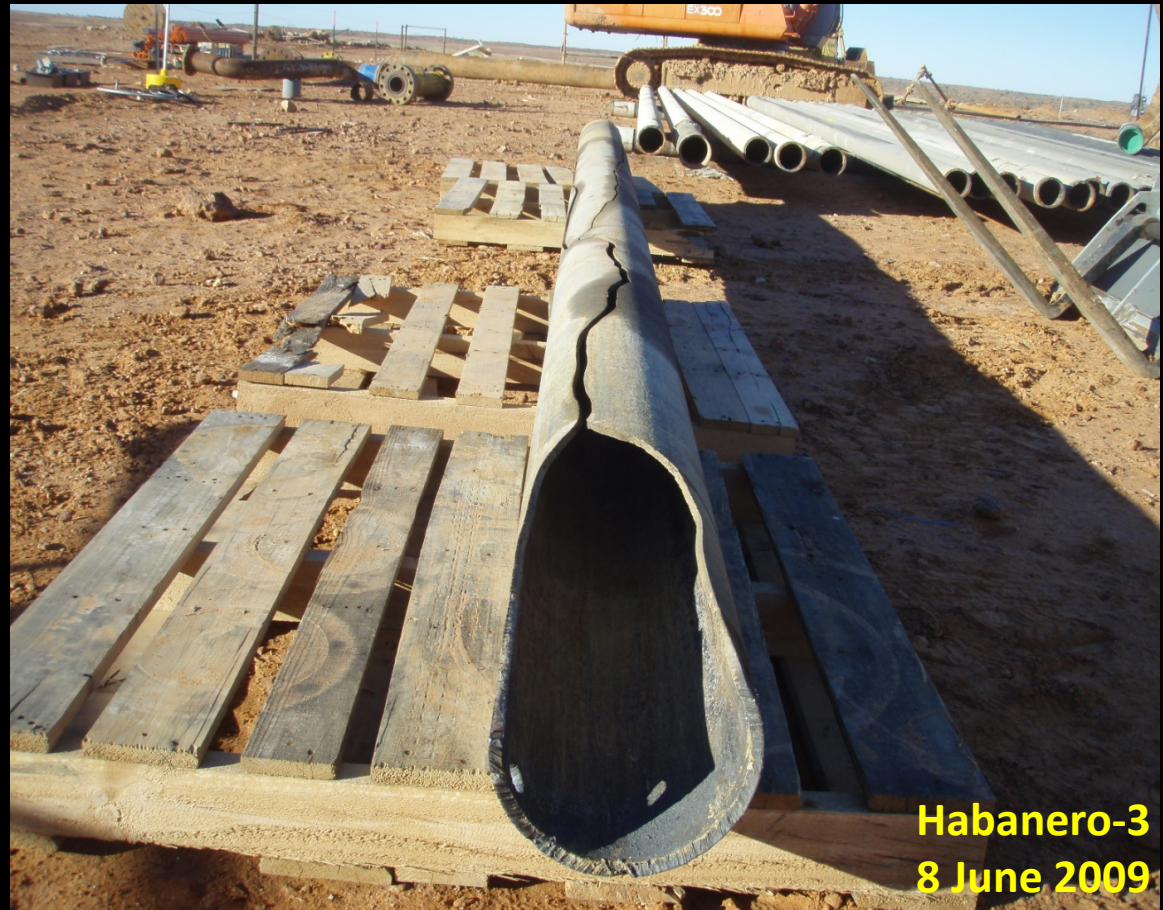
- Longitudinal cracks formed on the outside of the 9-5/8" casing indicating stress corrosion cracking resulting from hydrogen migrating to areas of high residual stress on the outer surface of the 9-5/8" casing.

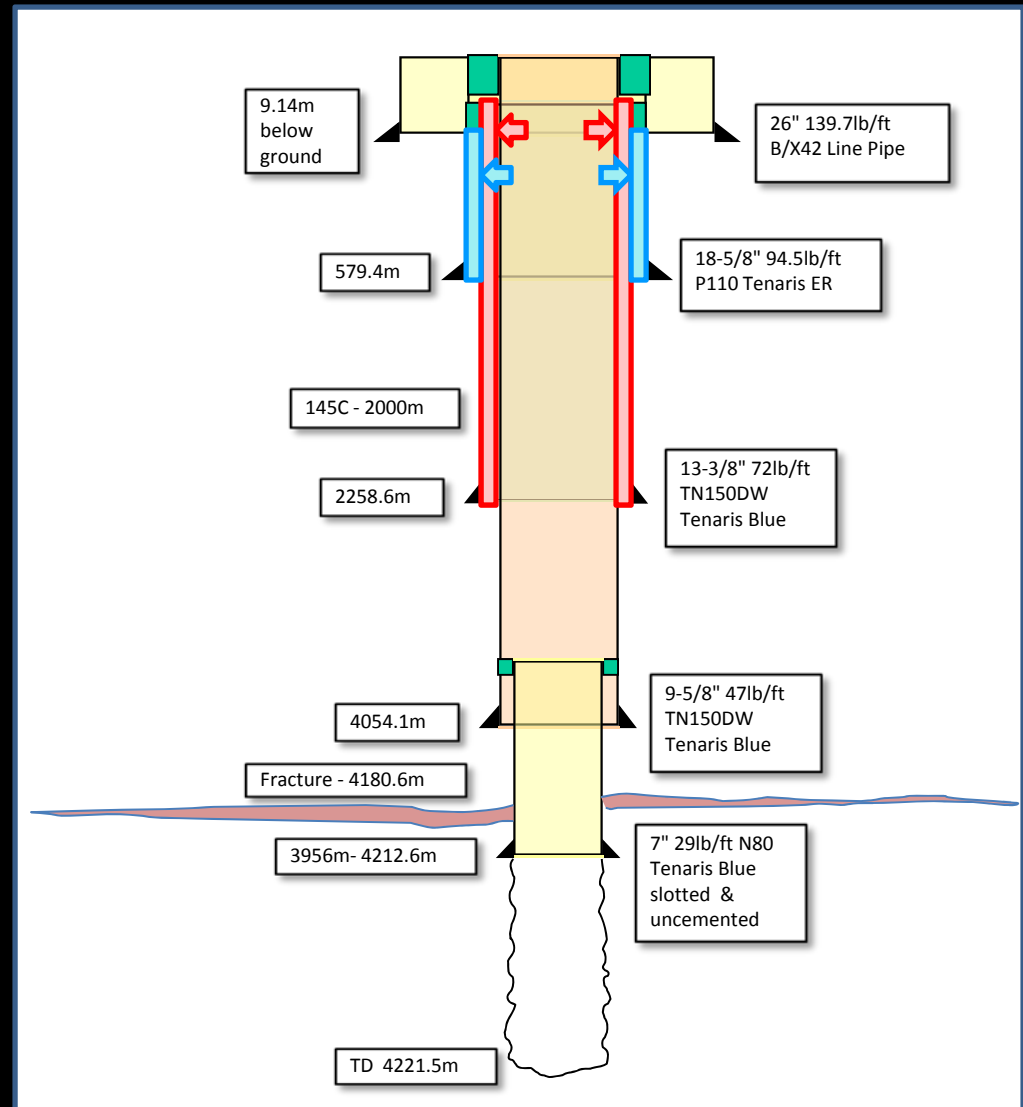
- After being exposed to hydrogen and high pressure fluids a crack formed in the 13-3/8" casing
- This allowed the brine to charge the annular area between 18-5/8" casing and the 13-3/8" casing

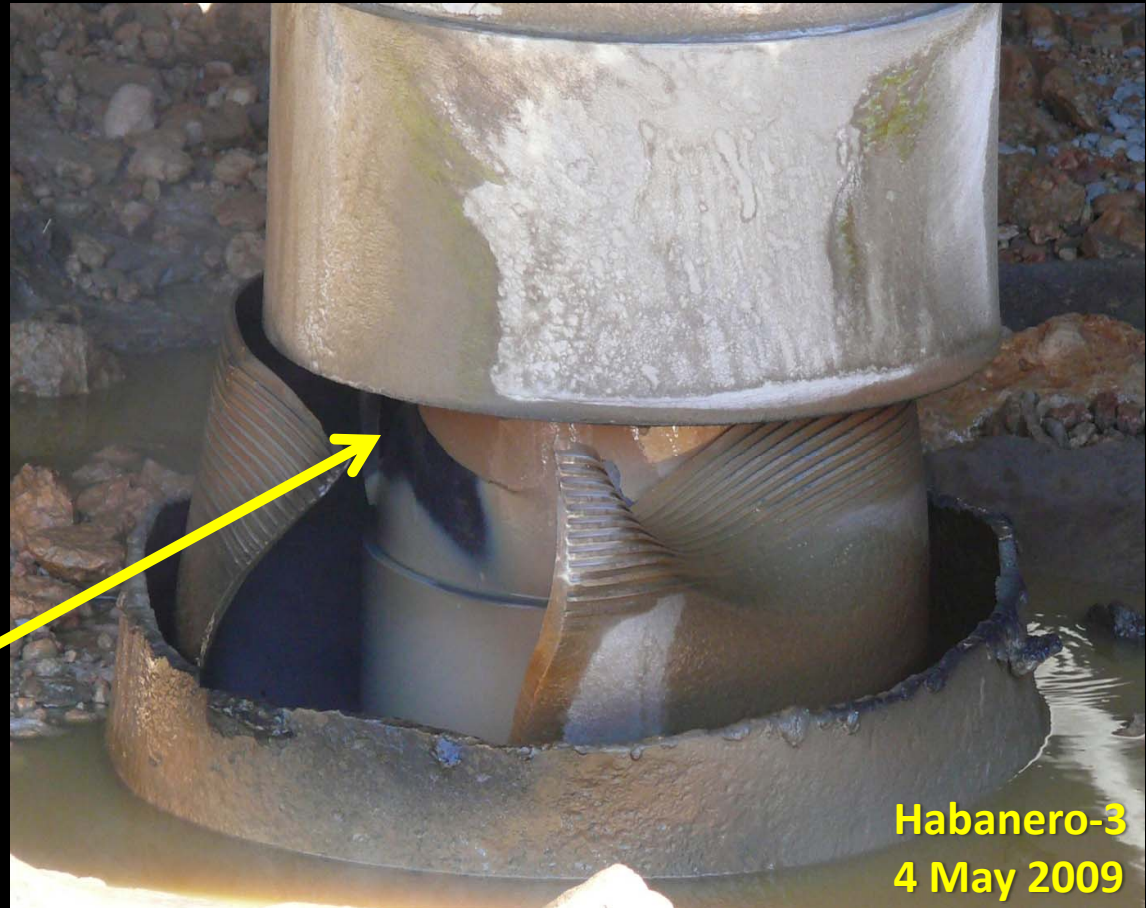
- The crack in the 13-3/8" casing was initiated from a tong mark in the hanger pup joint
- Repeat efforts to make up this connection may have caused deep tong marks
- Evidence of fluid scour

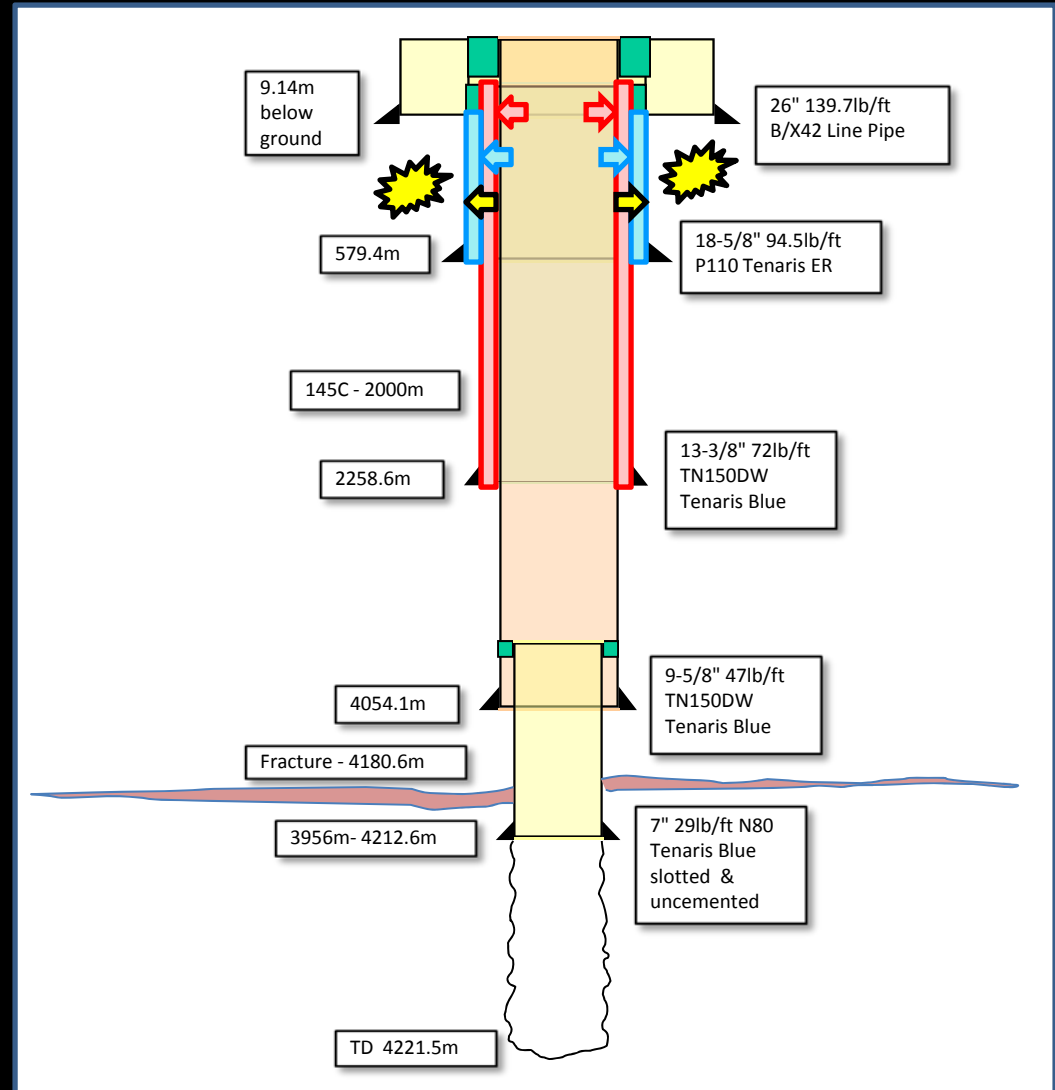
- No evidence of brittle failure or cracking in the 18-5/8" casing
- A release of pressure from 18-5/8" x 13-3/8" annulus resulted in the rapid fracture of the 13-3/8" casing and complete fracture of the 9-5/8" casing 1.7 m (below ground level)

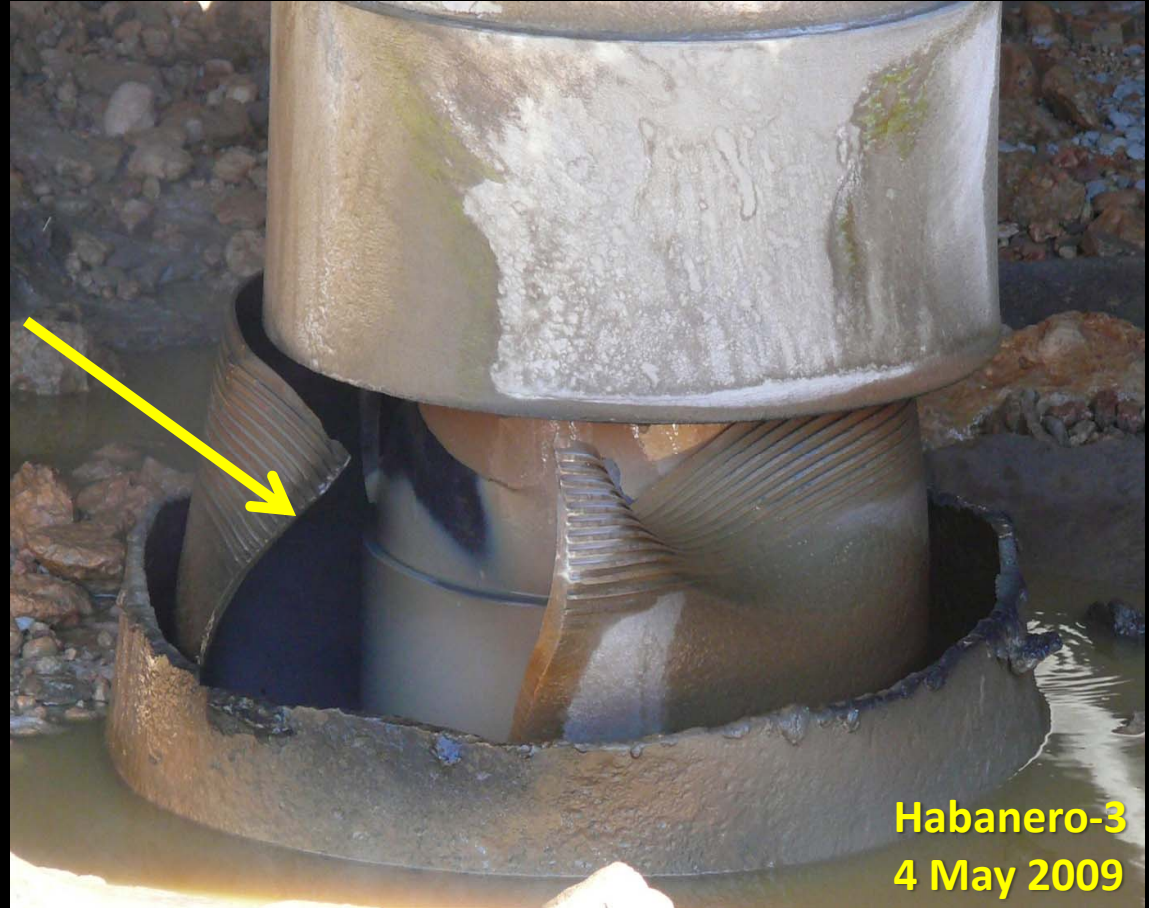
- 18-5/8" not designed to contain reservoir pressure
- 18-5/8" casing rated to 4840 psi (internal yield pressure – Tenaris web site)

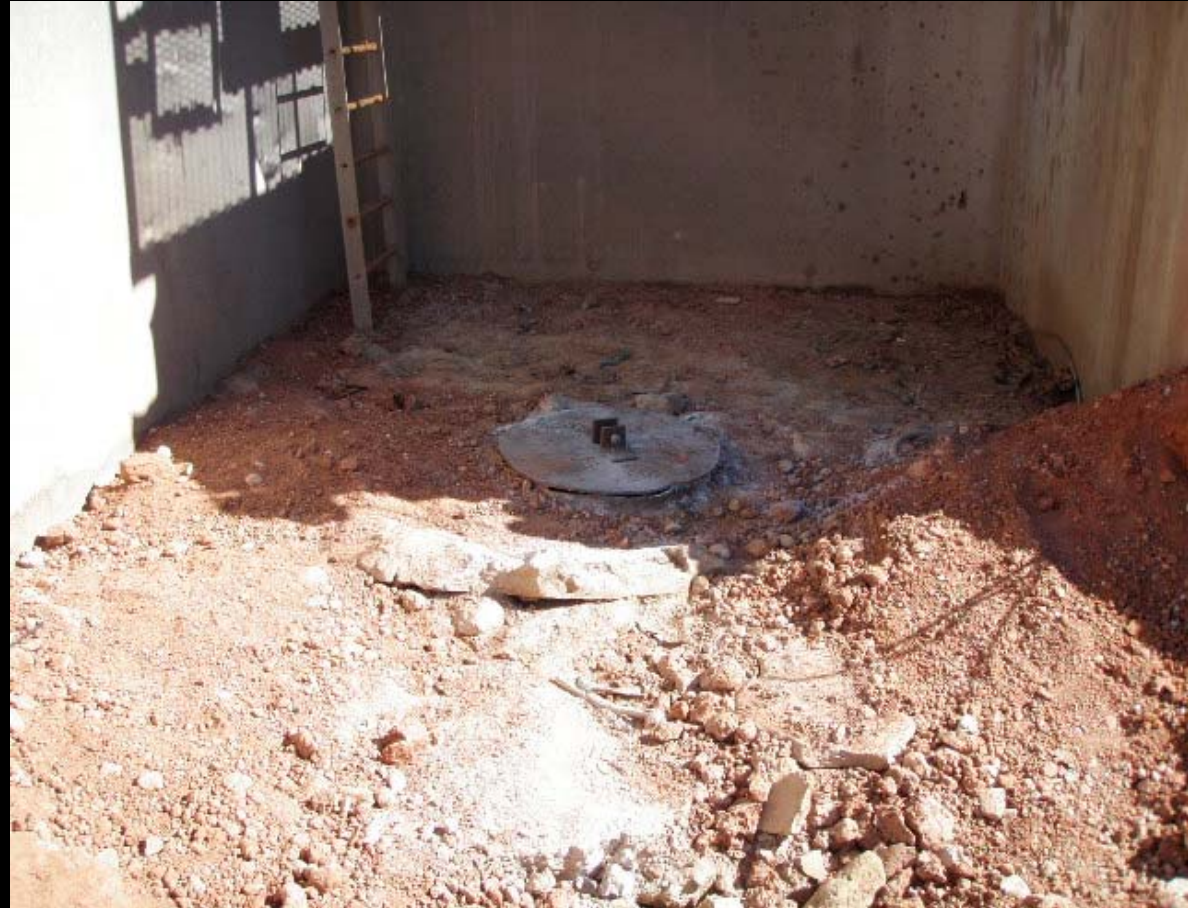
- The well was suspended on May 23<sup>rd</sup> with two downhole cement plugs and a steel cap welded on the 13 3/8" casing and 26" conductor.
- Quest Engineering has been contracted to further investigate the chemical reaction that caused the casing failure.
