Jack Bates

Investigation

Serious Injury Case Roustabout struck by Diverter Running Tool (26th November 2004)

conducted by
Transocean

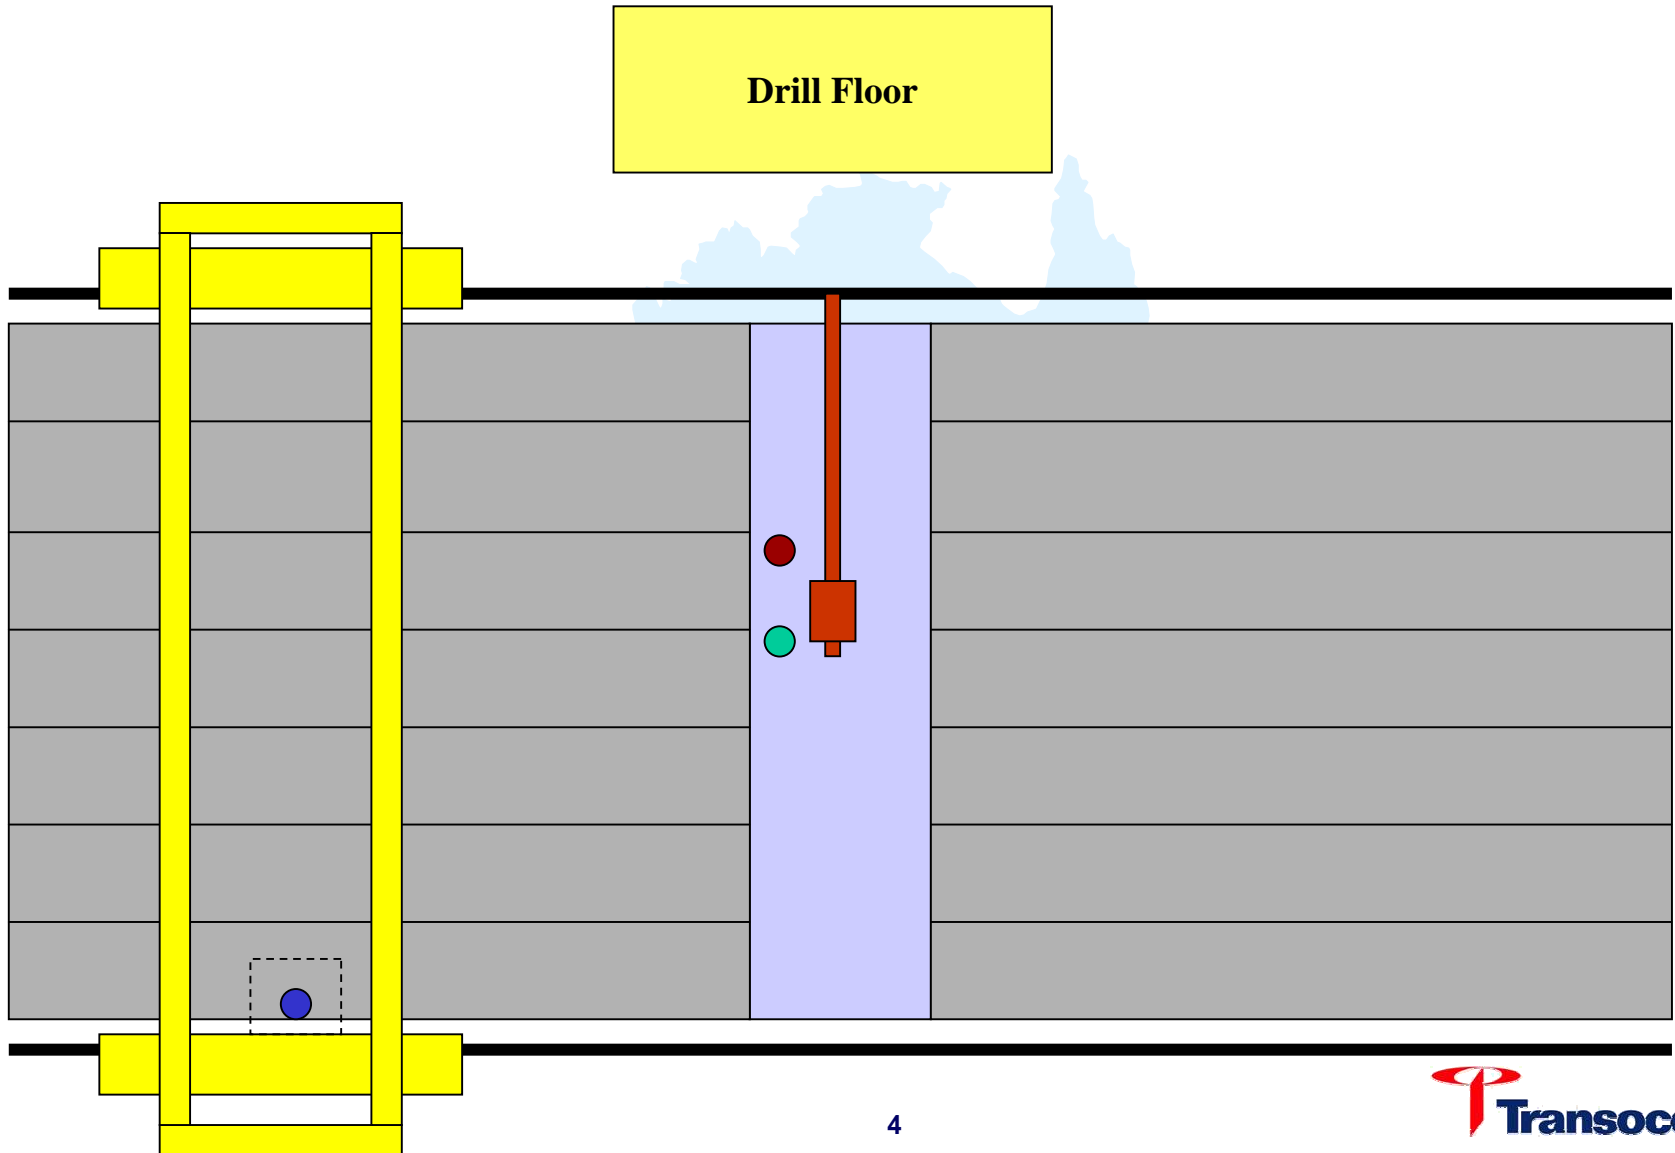
Prior to Incident

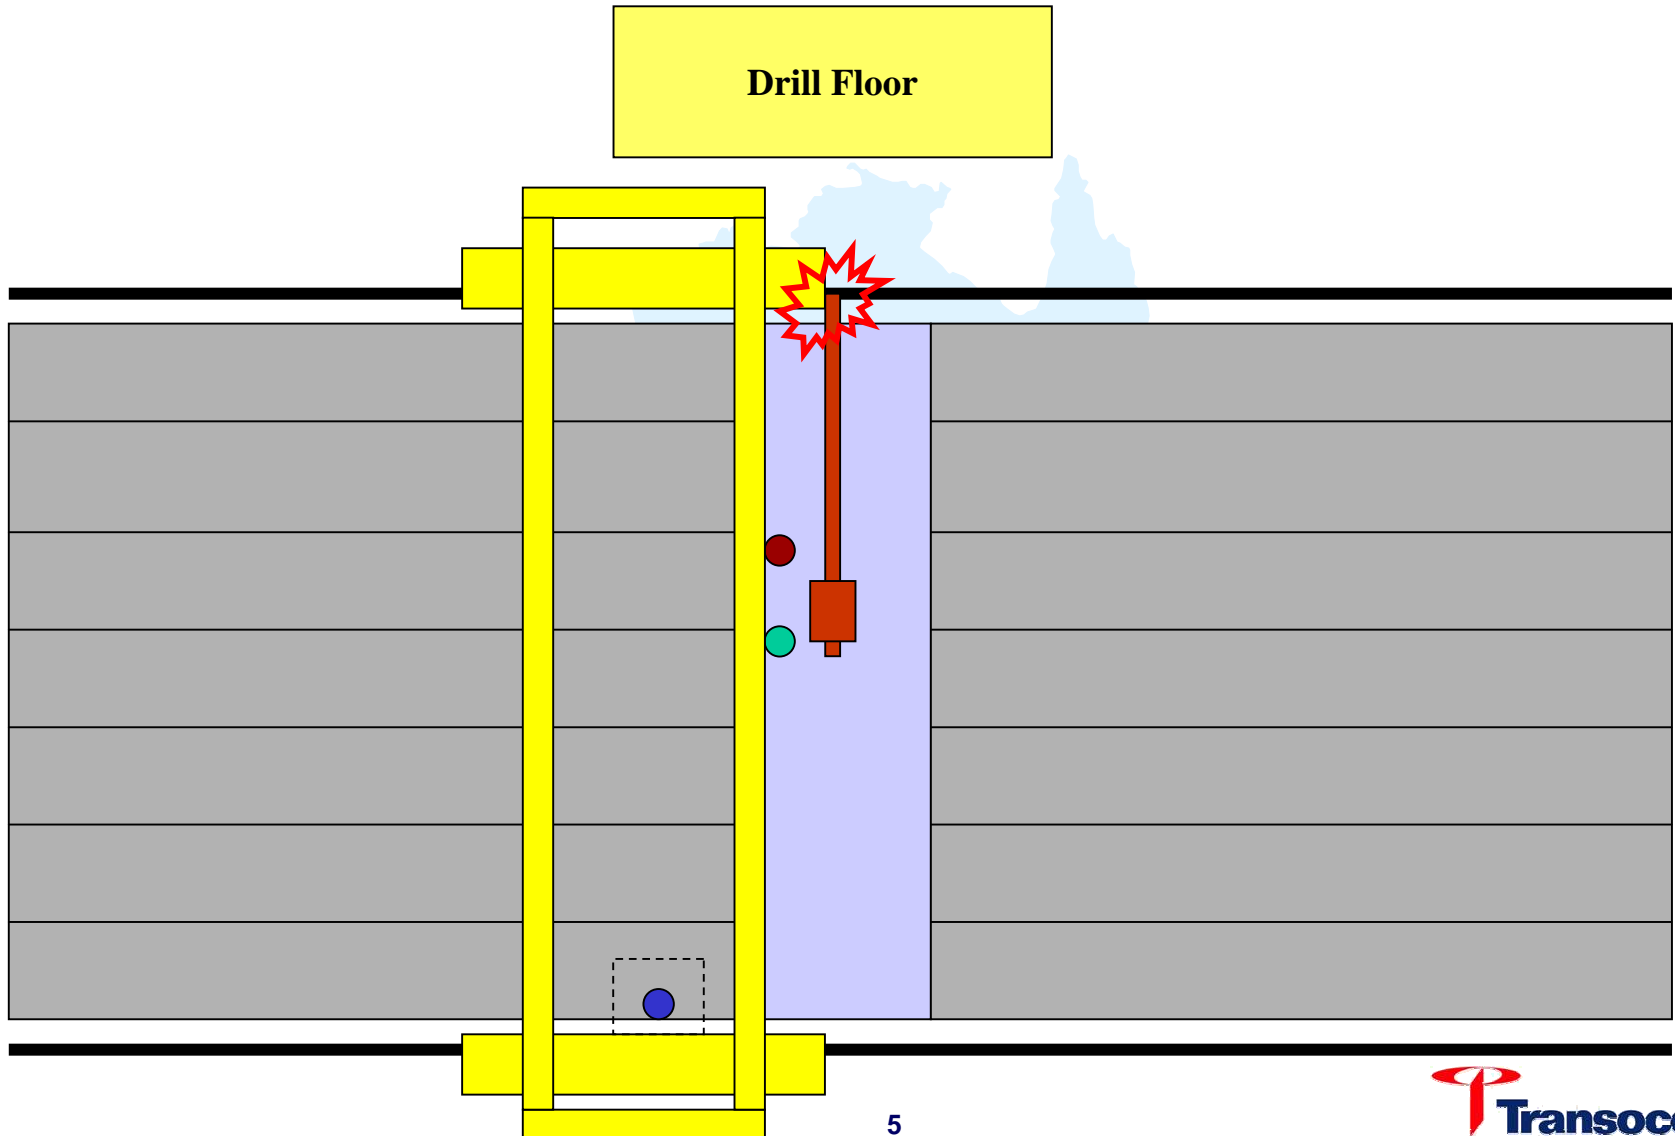
Collision Point

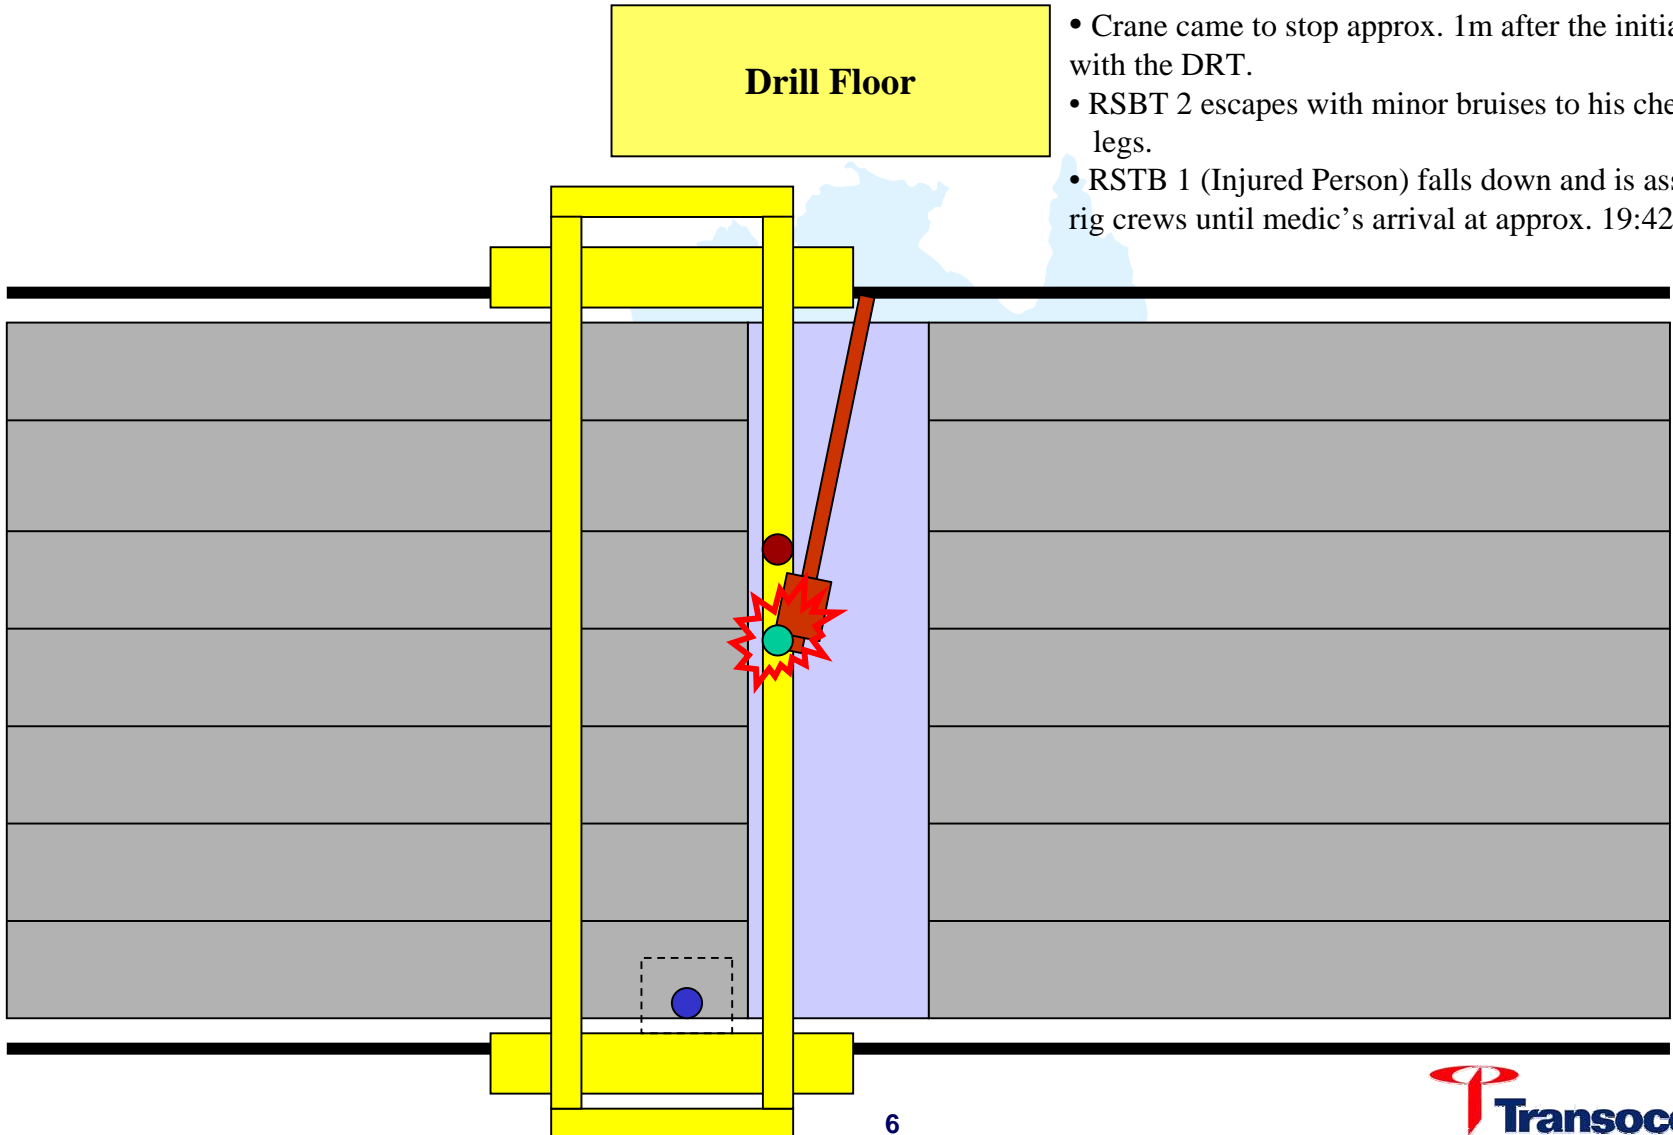
Roustabout was Struck by Diverter Running Tool

- Crane came to stop approx. 1m after the initial collision with the DRT.
- RSBT 2 escapes with minor bruises to his chest and legs.
- RSTB 1 (Injured Person) falls down and is assisted by rig crews until medic's arrival at approx. 19:42 hrs

Install a "trip wire" system to shut the crane down, should there be anything protruding over the maximum allowable overhang while the Landel crane passes over the Dodge Truck.

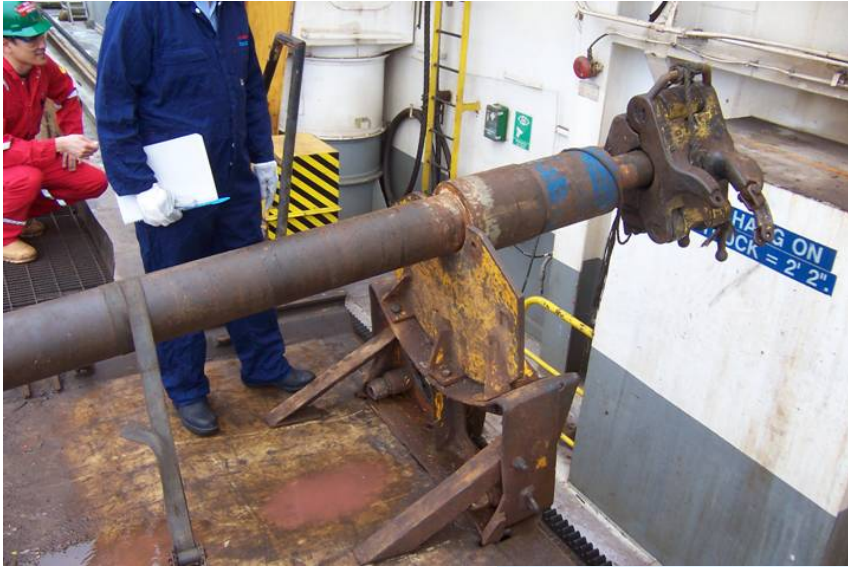
Tool position prior to impact
(securing straps not in place at the time of impact)

Note: The tool shown in these two photos was placed in this position during investigation

- Reinforce and communicate with ALL crews about the critical maximum allowable overhang of 2' 2".
- THINK plan will be conducted with at least one Supervisor present. Relevant RSP and TRA to be referenced in the THINK Plan as necessary.
- Relevant RSP's will be handed out to the crews at Pre-Tour Meetings for review and discussion.
- Rig Supervisor's to continue carrying out competency assessment of **new** personnel related to RSP's and TRA's. OIM to participate in competency assessments for critical tasks. Same for **long term** personnel.

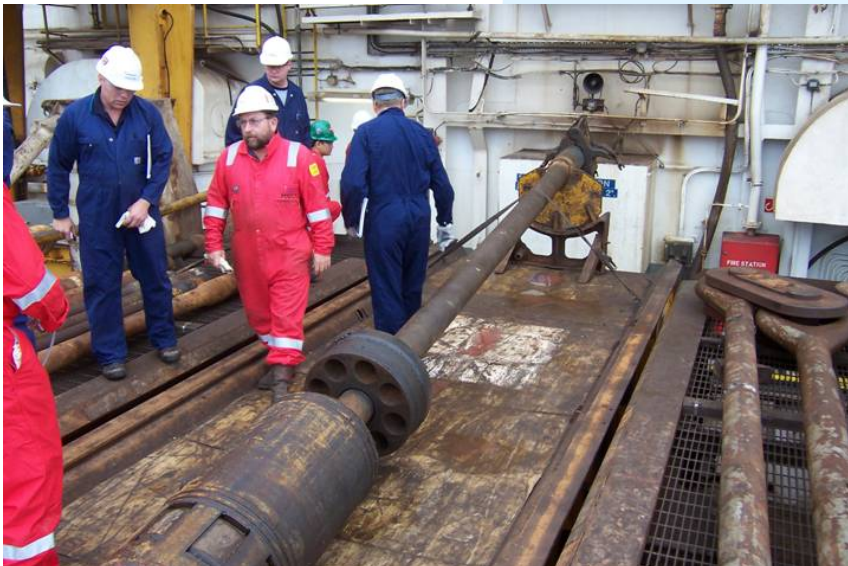
Tool position prior to impact

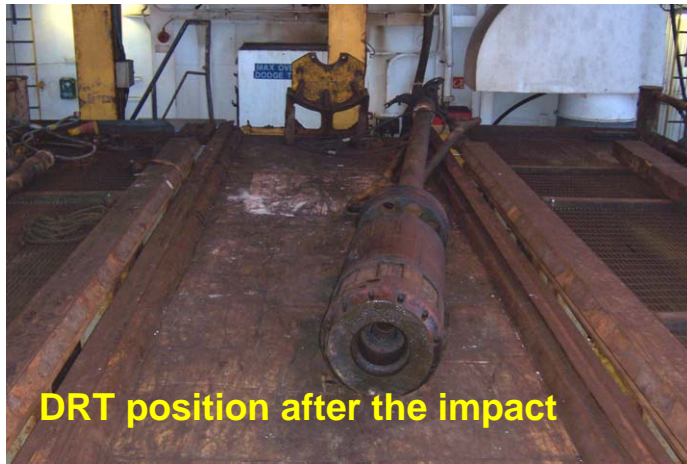
DRT position after the impact

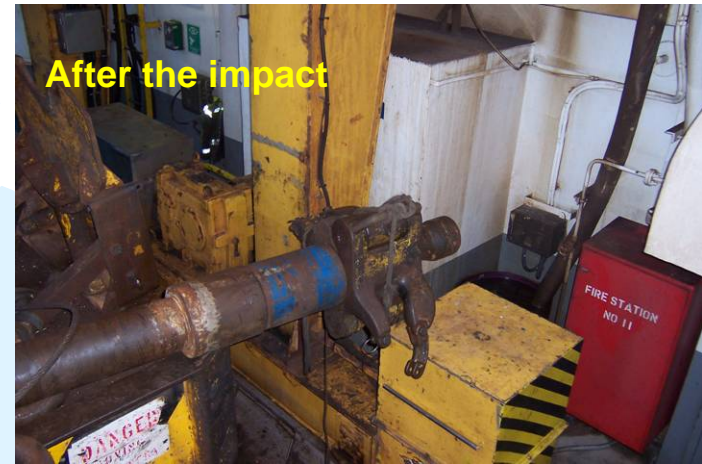
After the impact

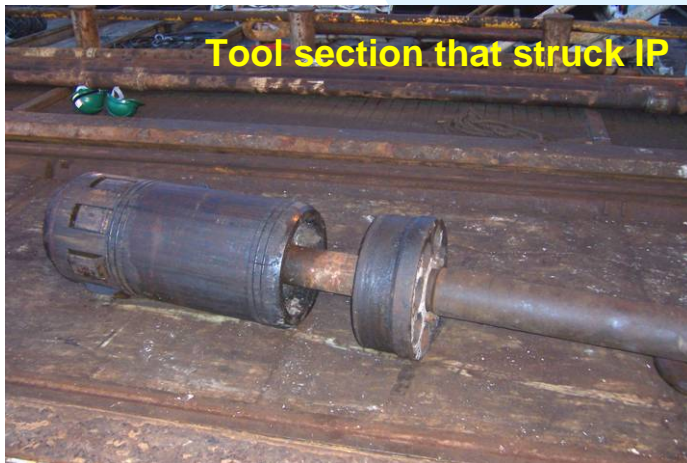
Tool section that struck IP

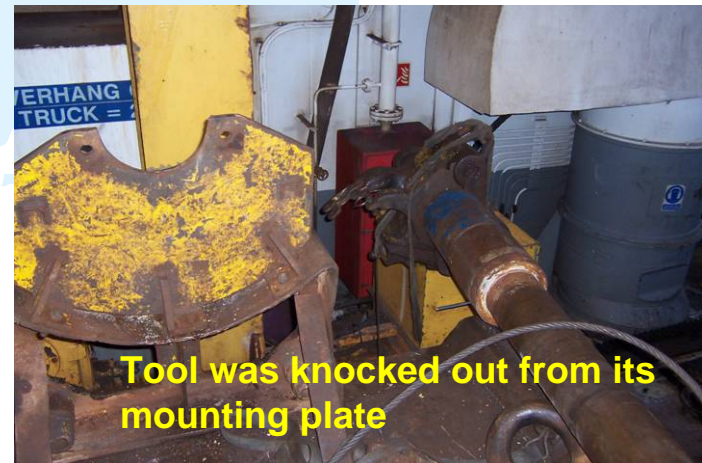
Tool was knocked out from its mounting plate

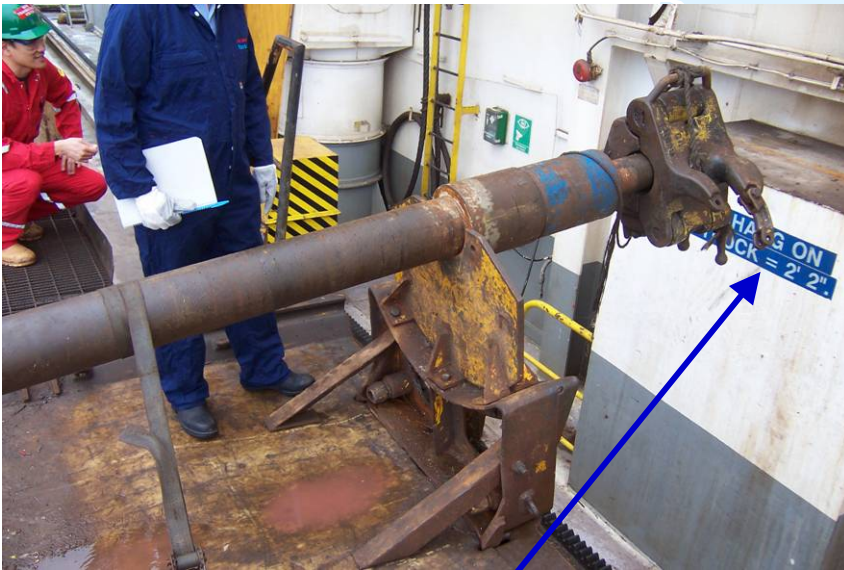
Sign next to the Dodge Truck

- Two chains (25.5in each length) were also welded at the end of Dodge truck to confirm the maximum allowable overhang. Signs were also posted (next to the Dodge Truck and on the Drill Floor next to the Dodge Truck operating Station).

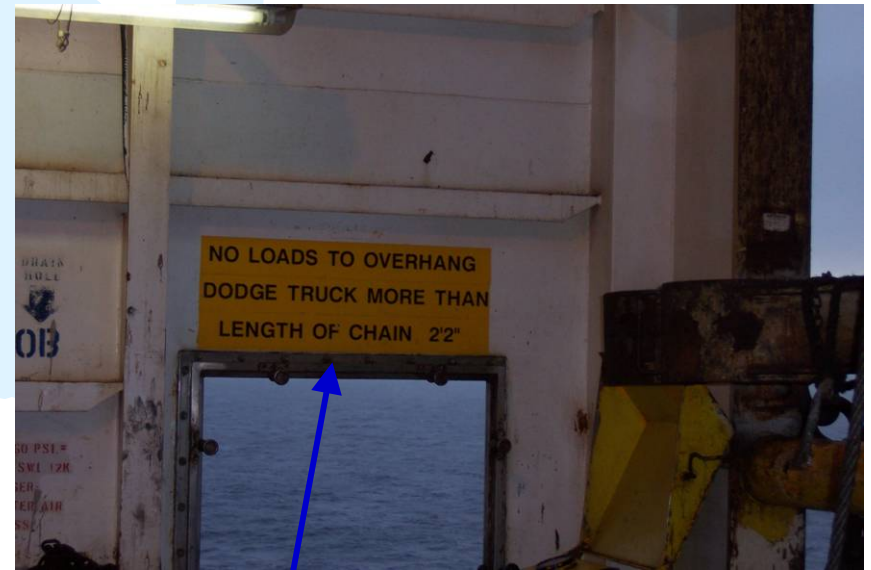
Sign on Drill Floor
