## Inspection of Clamp Type Drill Line Retainer

### 1.0 Purpose

To provide an inspection procedure for clamp type drill line retainers that focuses on the suitability of the U bolts, the threads of the retainer nuts and the condition of the clamp body.

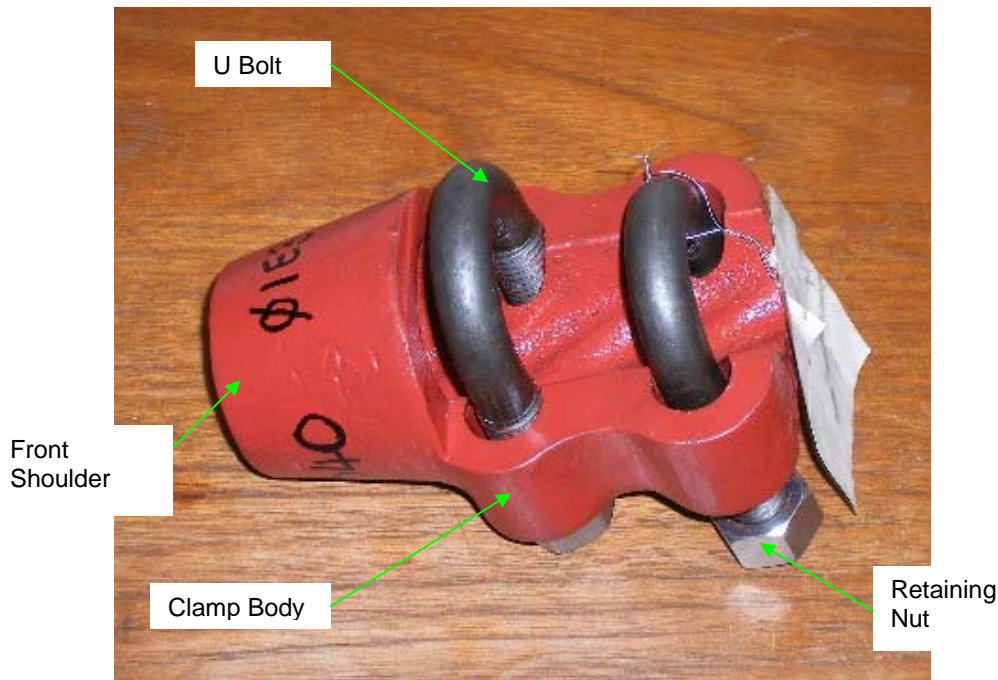
Figure 1 – Clamp Type Drill Line Retainer

Clamp Type Drill Line Retainer: A mechanical component that consists of a body, two U bolts and four retaining nuts that is used keep the fastline retained to the draw works drum.

1. The retainer nut recess is flat and free of spalling
2. The line lay ridges are not worn – refer to figure 2
3. No fretting in the U bolt holes
4. No cracks or abnormal wear on the body. Pay particular attention to front shoulder of the body – refer to figure 1

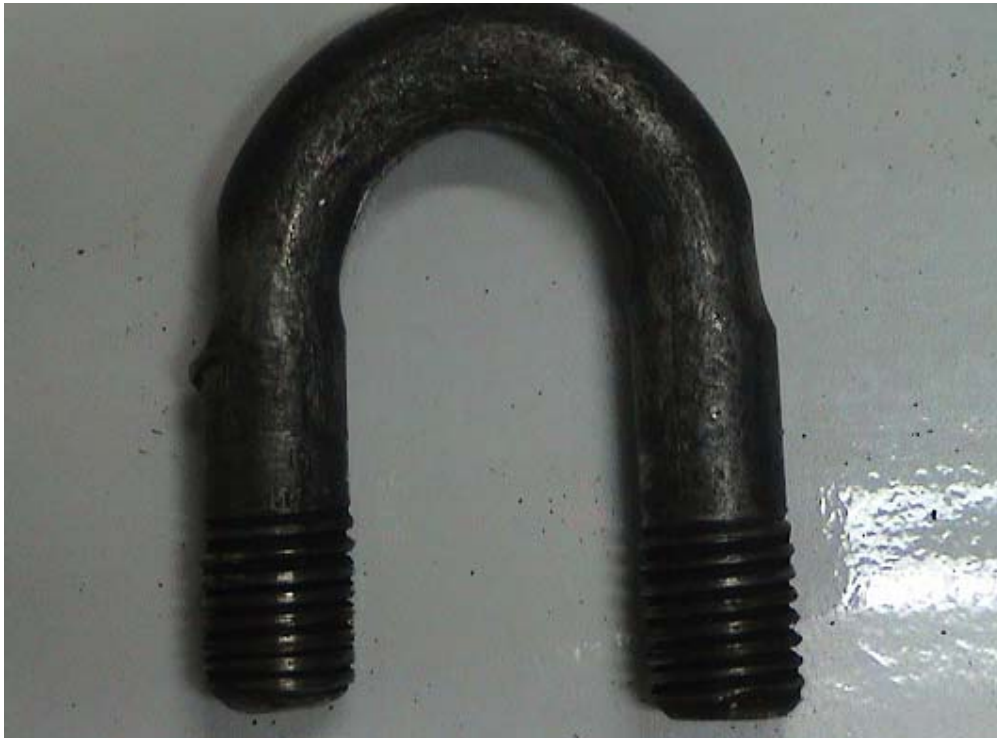
Figure 3 – Threads are damaged due to either incorrect retaining nuts or “picking up” while the nuts were fitted. **DO NOT USE.**

1. Threads are in good condition

**If any of these conditions are not met, a new retainer must be fitted. The replaced unit must be fitted with a non-compliance tag and returned to Wacol – No Exceptions**

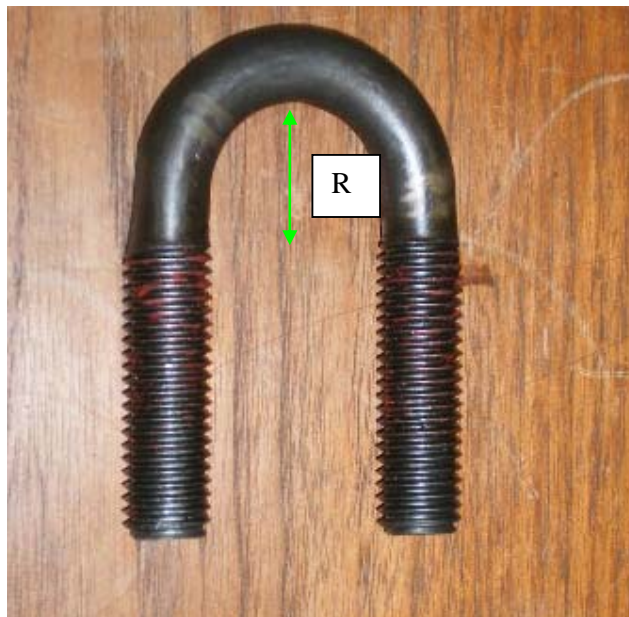
Figure 4 – U bolt in serviceable condition. Notice the thread length in comparison to the unit in figure 3

2. There is no wear or signs of movement on the clamping surface
3. The dimension shown as R on figure 4 is at least 1/5 smaller than the diameter of the drill line to be clamped.

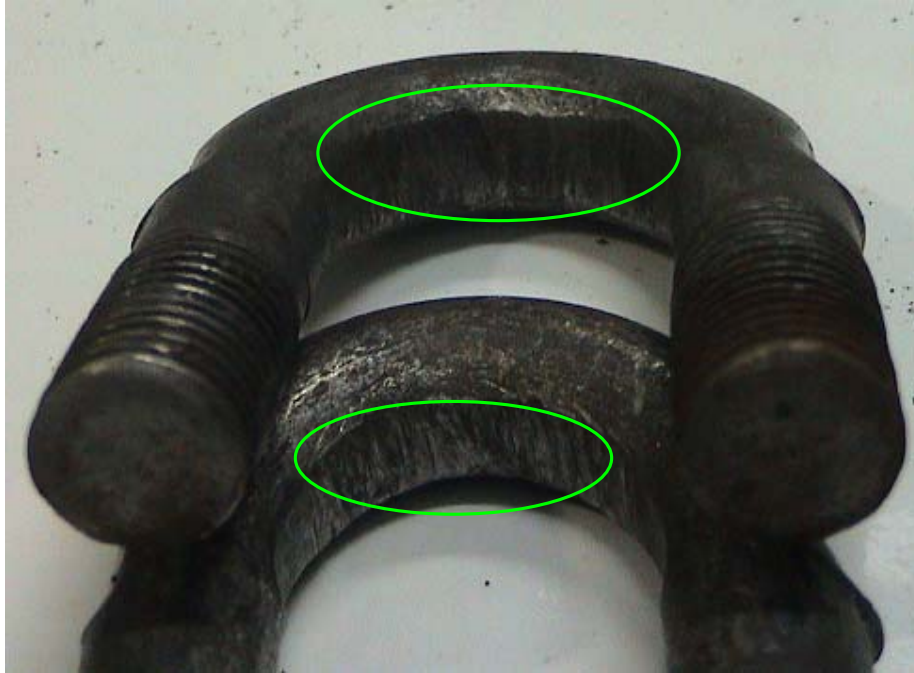
Figure 5 – U bolts showing signs of relative movement between the line and retainer. The lines are caused by gouging from the drill line. This is indicative of a problem with the clamp assembly or the installation of the clamp assembly

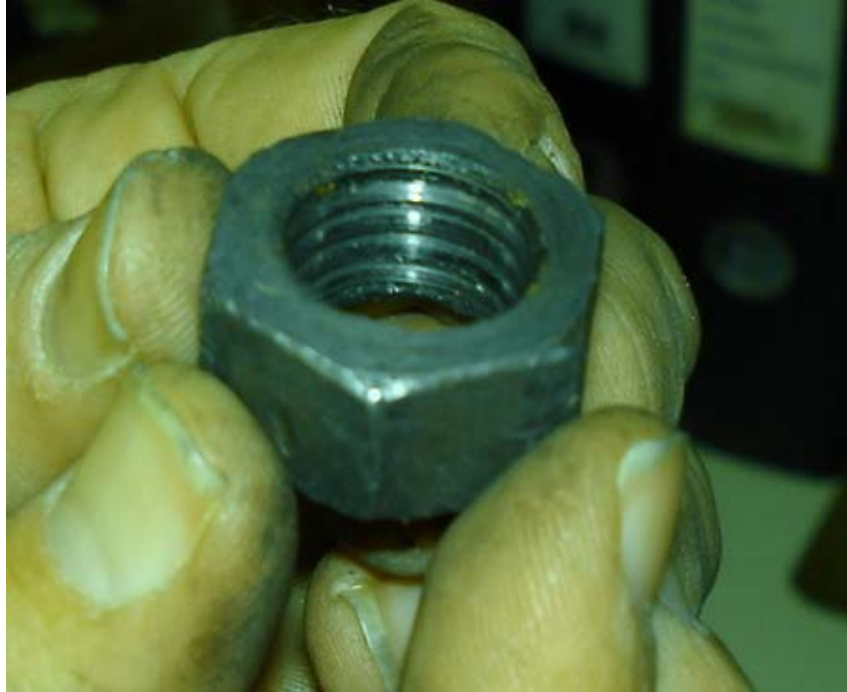
Figure 6 – Threads show signs of spalling. **DO NOT USE**

1. The threads are in good condition
