## **Ocean Bounty – LTA Foot Incident: Issues from a Client’s Perspective**

**Christian George – D&C Operations Manager**

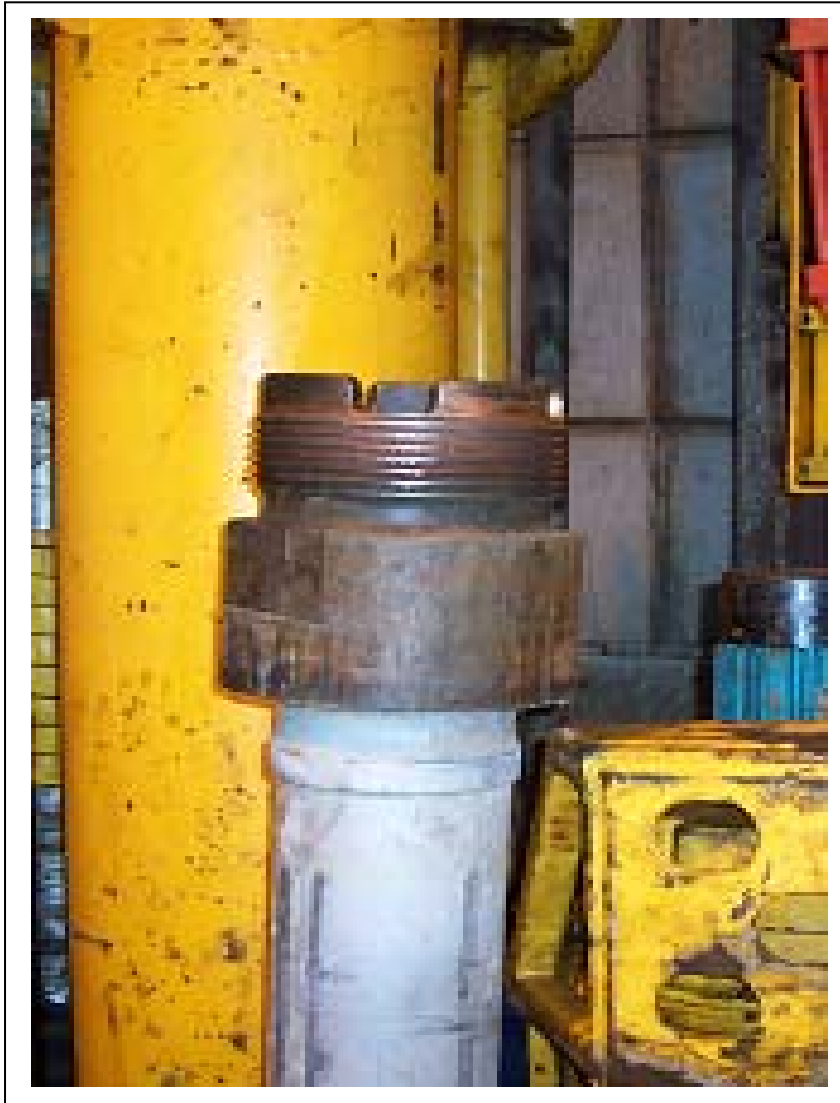
- Manufacturer of riser not aware of any additional hazard associated with equipment
- Risk assessment – could be improved: -Treated as a stand of collars by rig crew

Questions when sending new equipment offshore:

- What hazards are associated with this equipment?:
  - Has the manufacturer communicated any specific hazards (or special handling requirements)?
  - Is it an unusual size / shape / geometry?
  - Has this piece of equipment been used offshore before?
- Have these hazards been adequately communicated to the offshore team?
