ENSCO 67

**Uncontrolled Release of Single Joint Elevators
During Casing Lift**

High Potential Incident, 21 January 2007

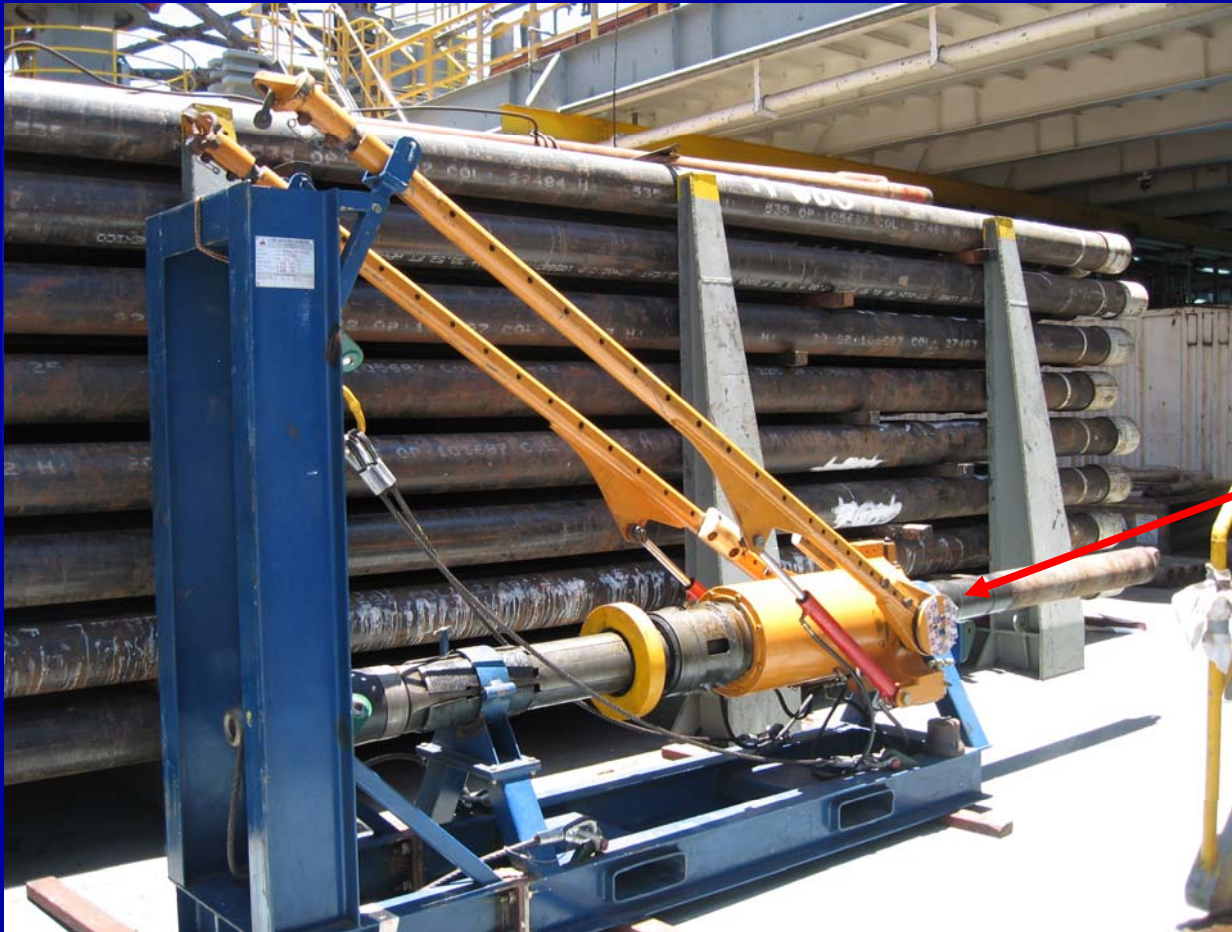
CASING RUNNING SYSTEM

This system is design to improve safety and efficiency by:

- eliminating the need for working above the drill floor

- allowing for faster make up times

- allowing casing rotation while circulating

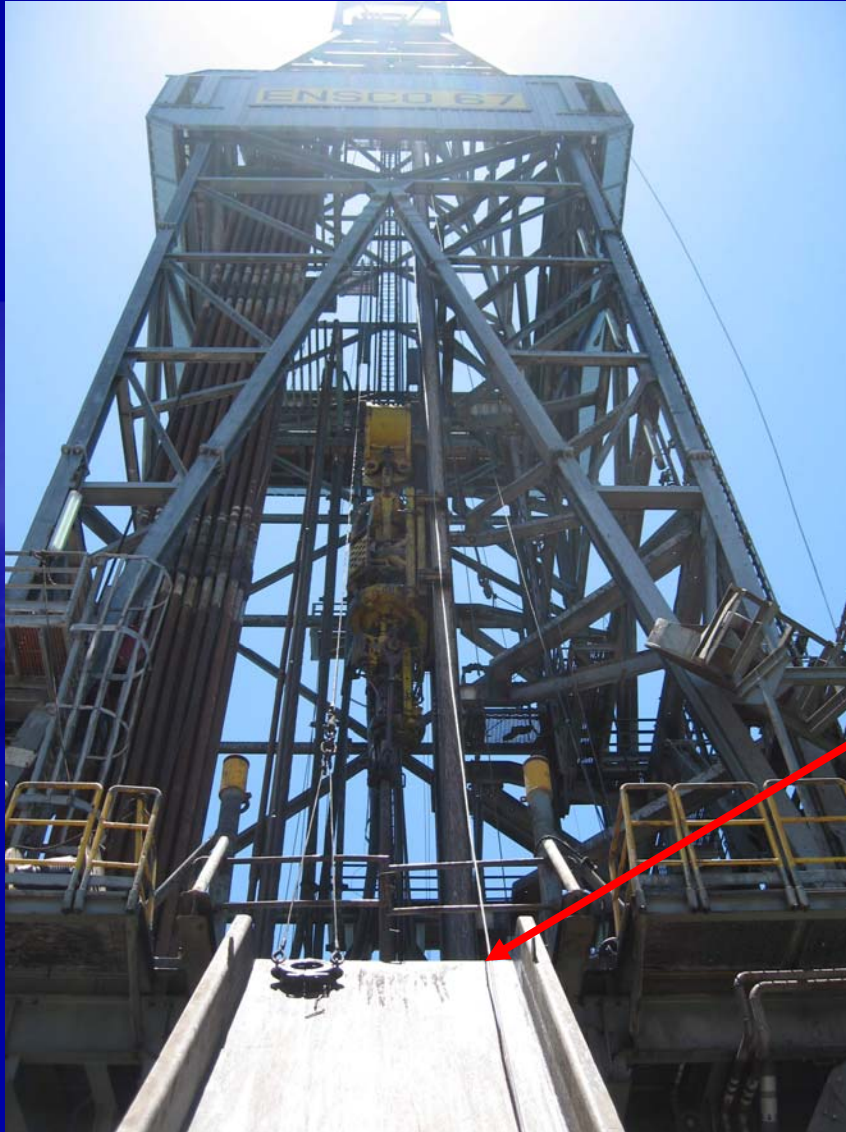
Re-enactment
looking up the V door.

Casing test run using the port
winch to obtain
measurements prior to the
setup of the Casing Running
System

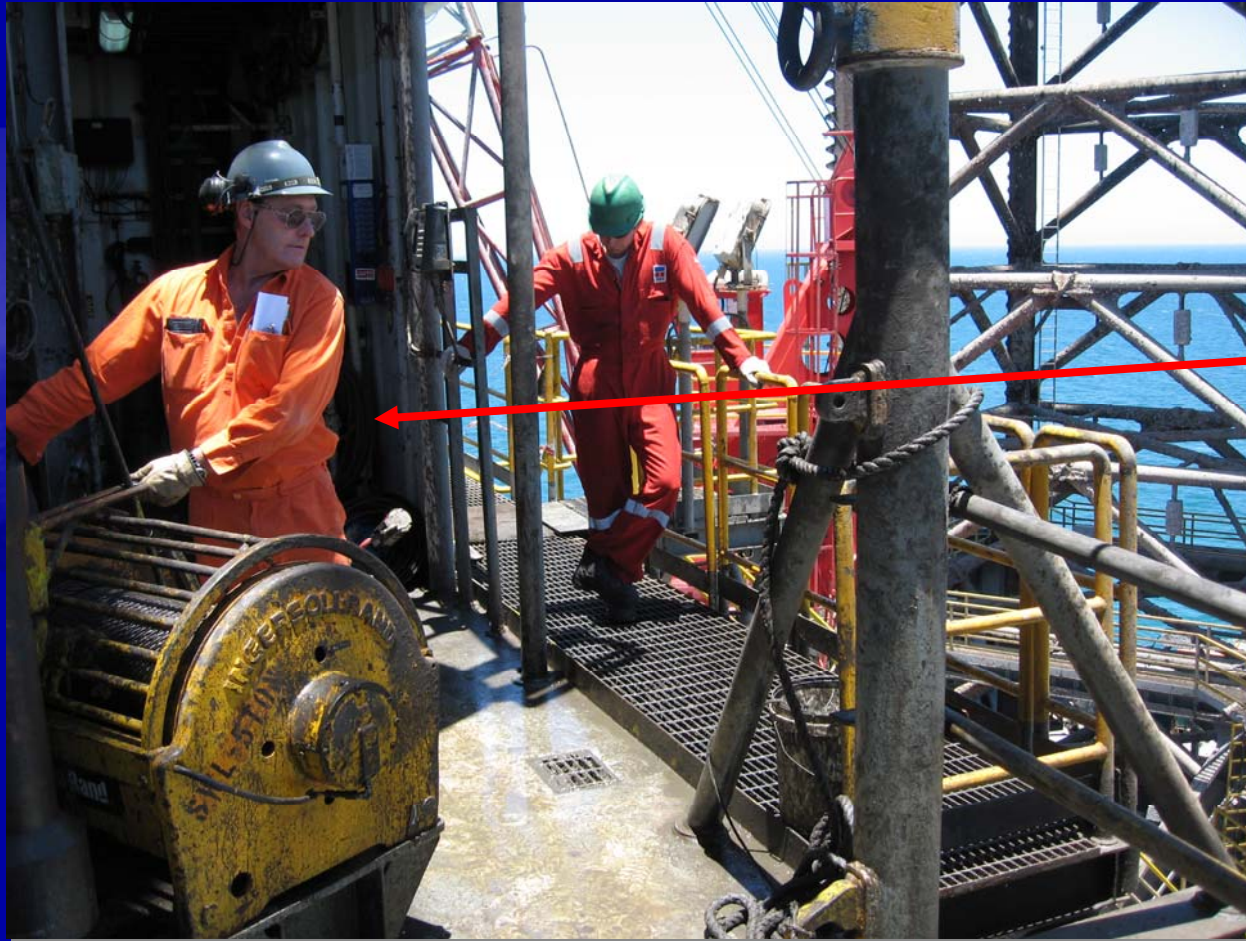
Toolpusher's
operating
position

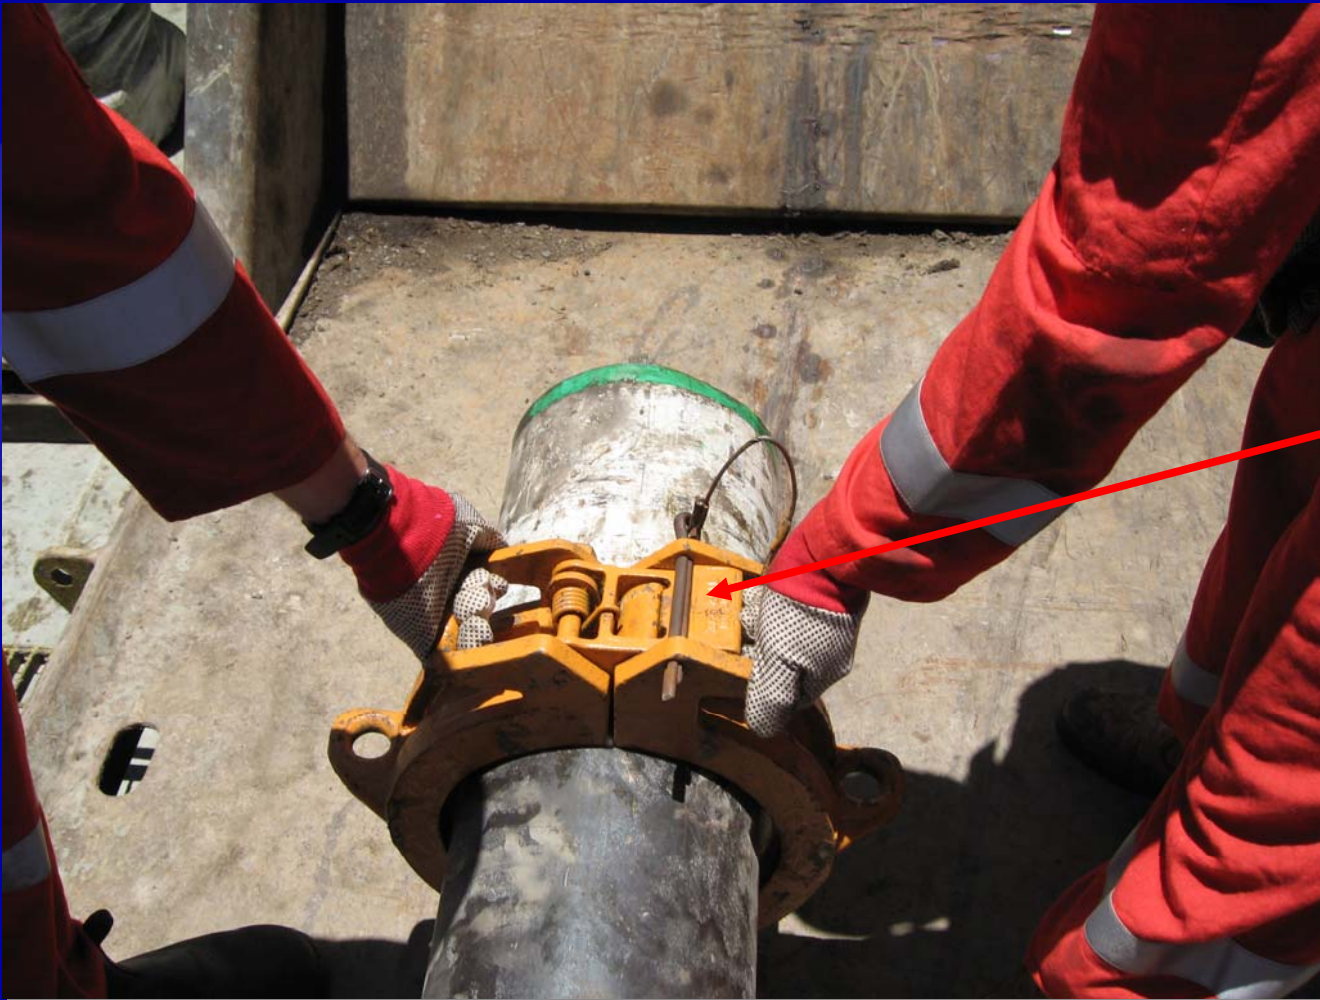
Re-enactment
Casing hands
unable to see
clearance on
underside of
elevators

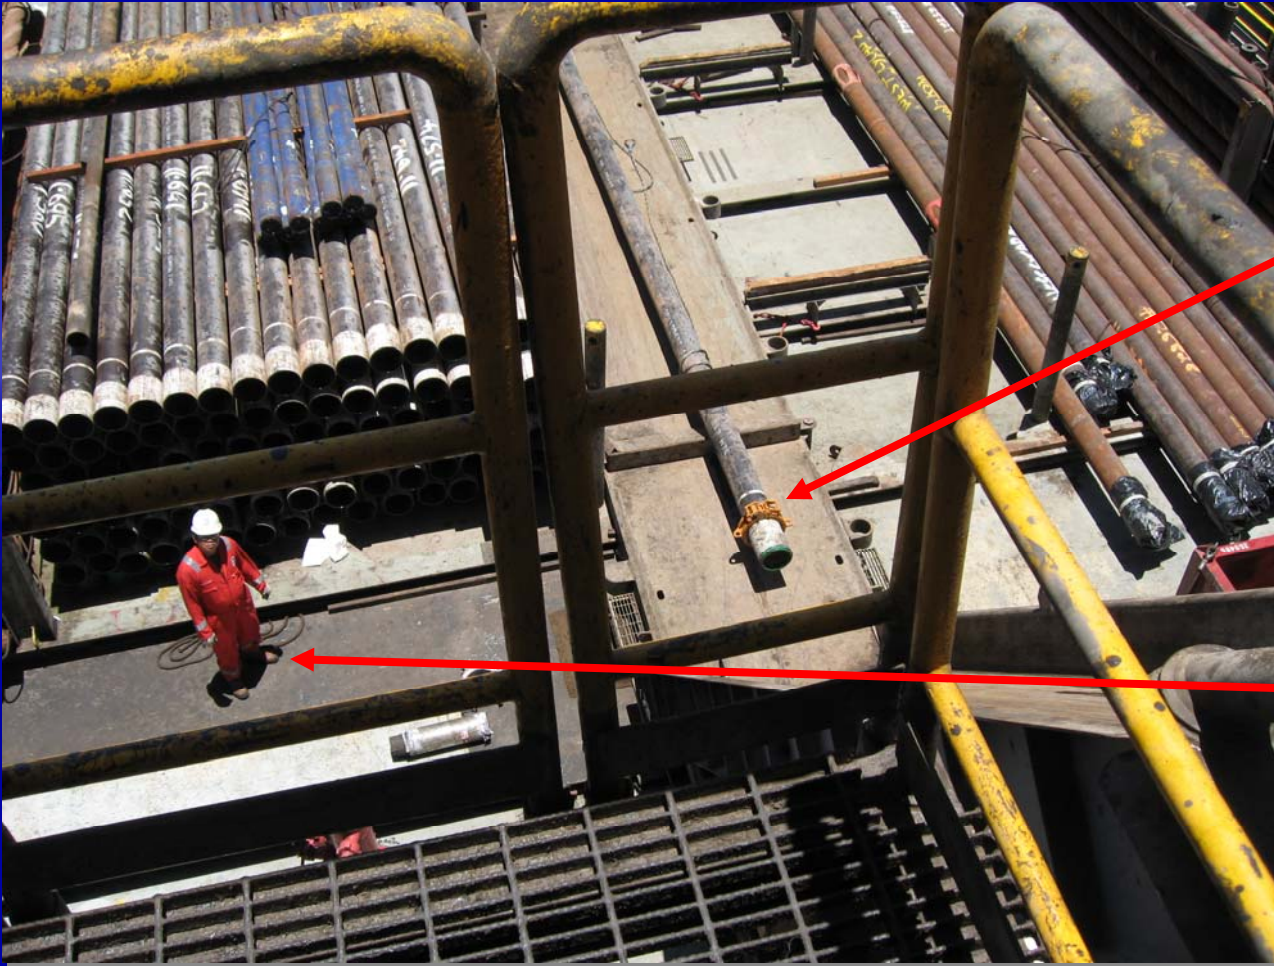
Visibility from
Toolpushers position.
Too far away to observe
incorrect size elevators

Casing Hand advised
to move away from
cat walk and stands
in this position

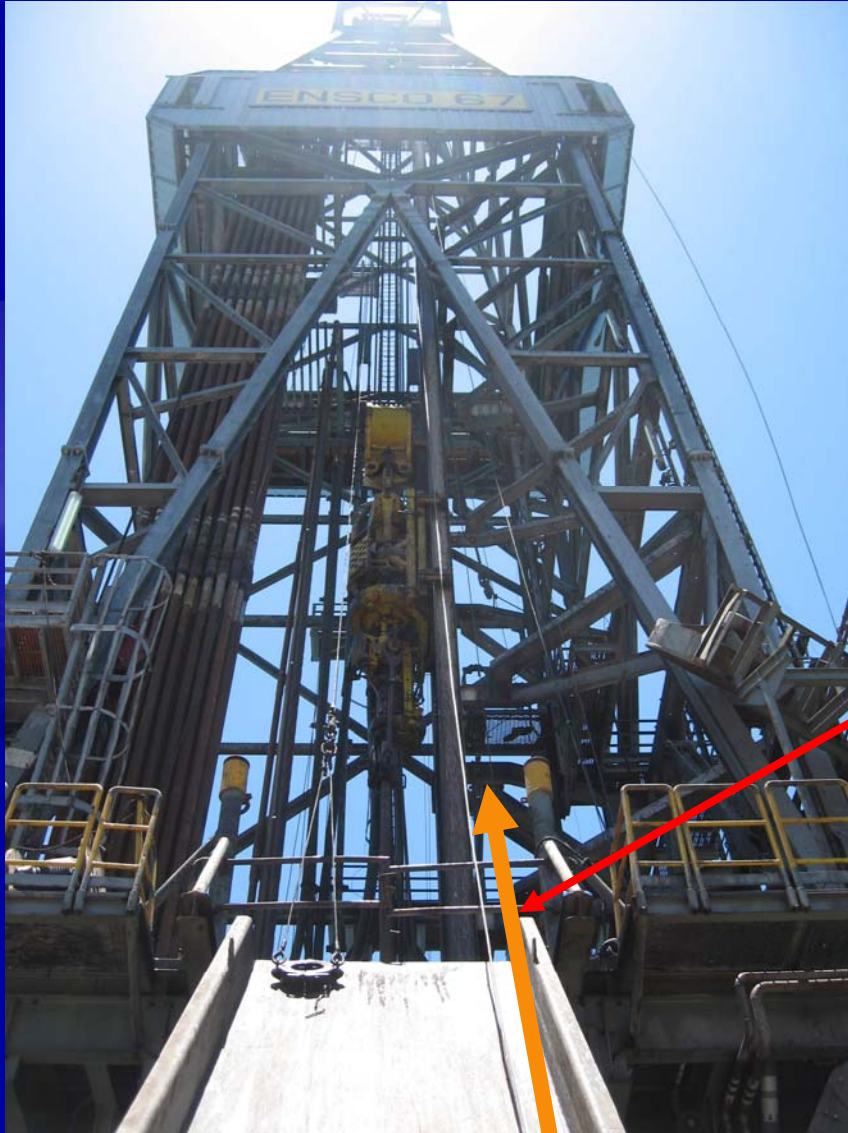
Trajectory of elevators
2.5 metres above drill
floor while two
floorhands working in
the area

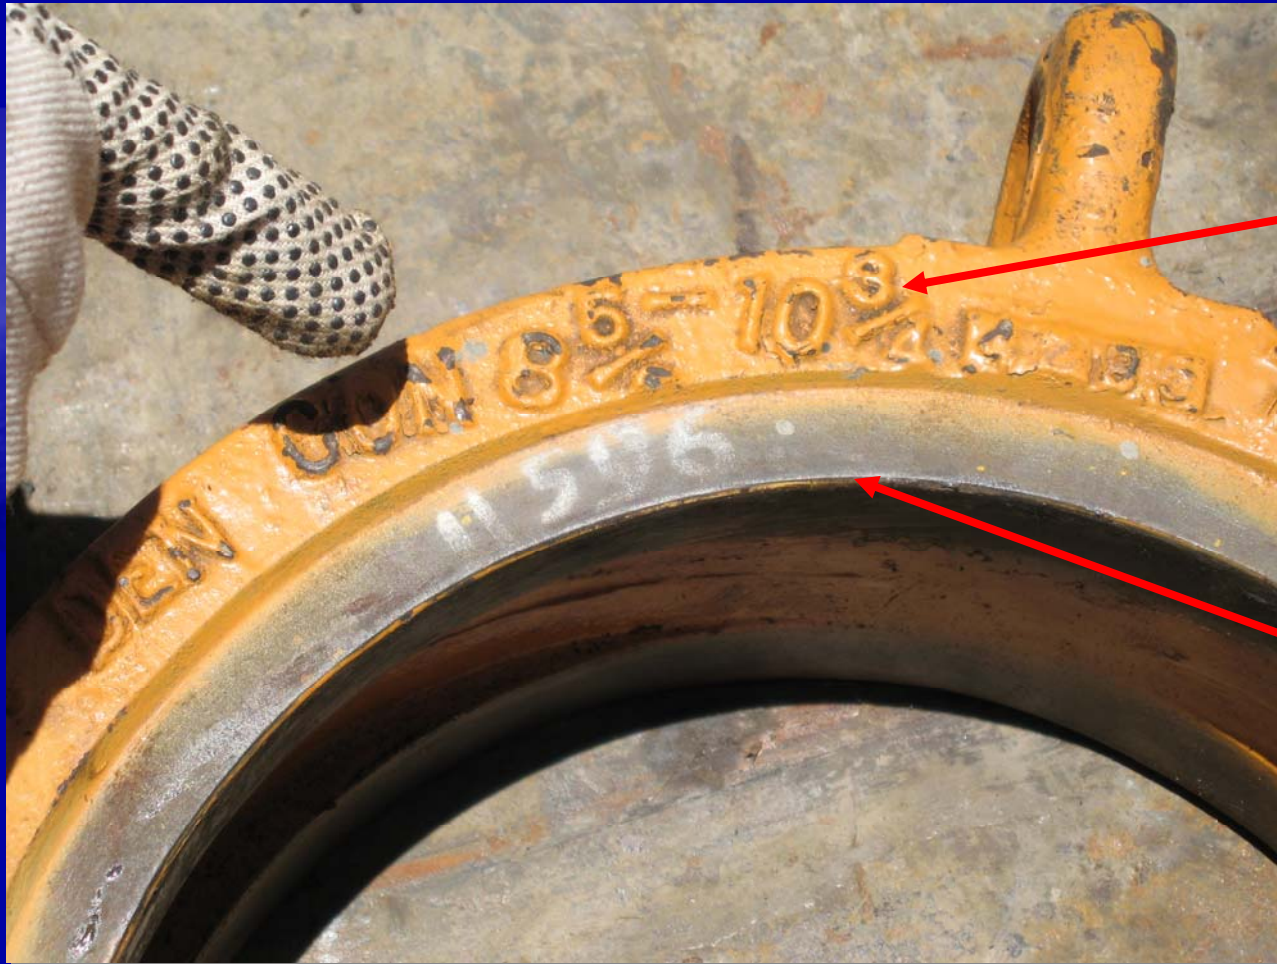
INEXPERIENCE!
Lead the casing hand supervisor to think that this was the operational range for these elevators

Vendor mistakenly supplied elevators machined for 10 3/4" casing

Vendor Manager to review internal systems and present report and assurances to client on system improvement.

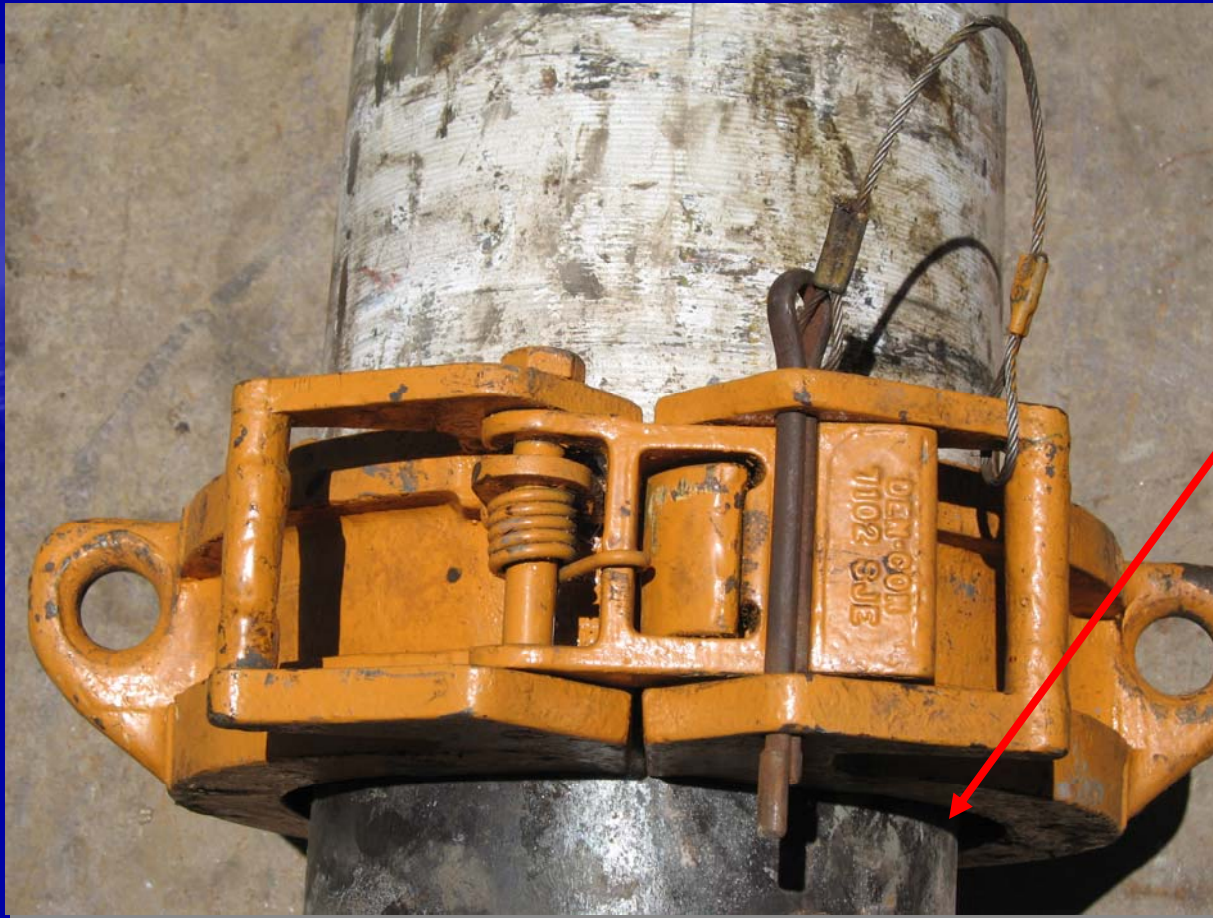
Casing Hand's view
of elevators.

Under side clearance not
visible from above
