# Ocean Bounty Manual Handling Incident March 2005

# Manual Handling Incident

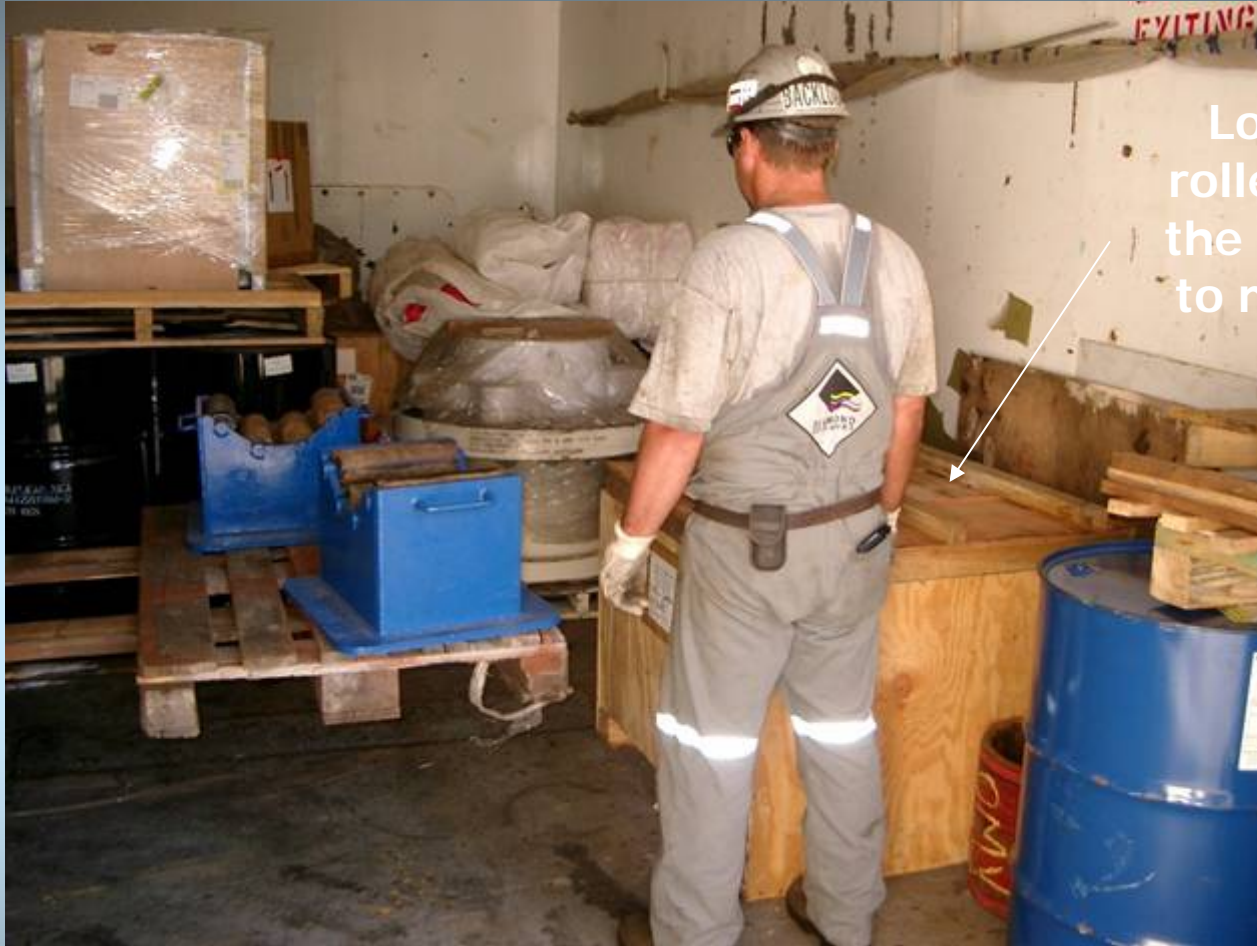
- ▶ After checking radios were off for radio silence the IP (roustabout) took time to conduct some housekeeping
- ▶ In preparation for the next well – he decided to move two rollers that had been stored in the sack room after being painted.
- ▶ The two pipe rollers were sitting on a crate at approx. waist height. (He had estimated their weight at approx 50kgs.)

Location of rollers prior to the IP attempt to move them

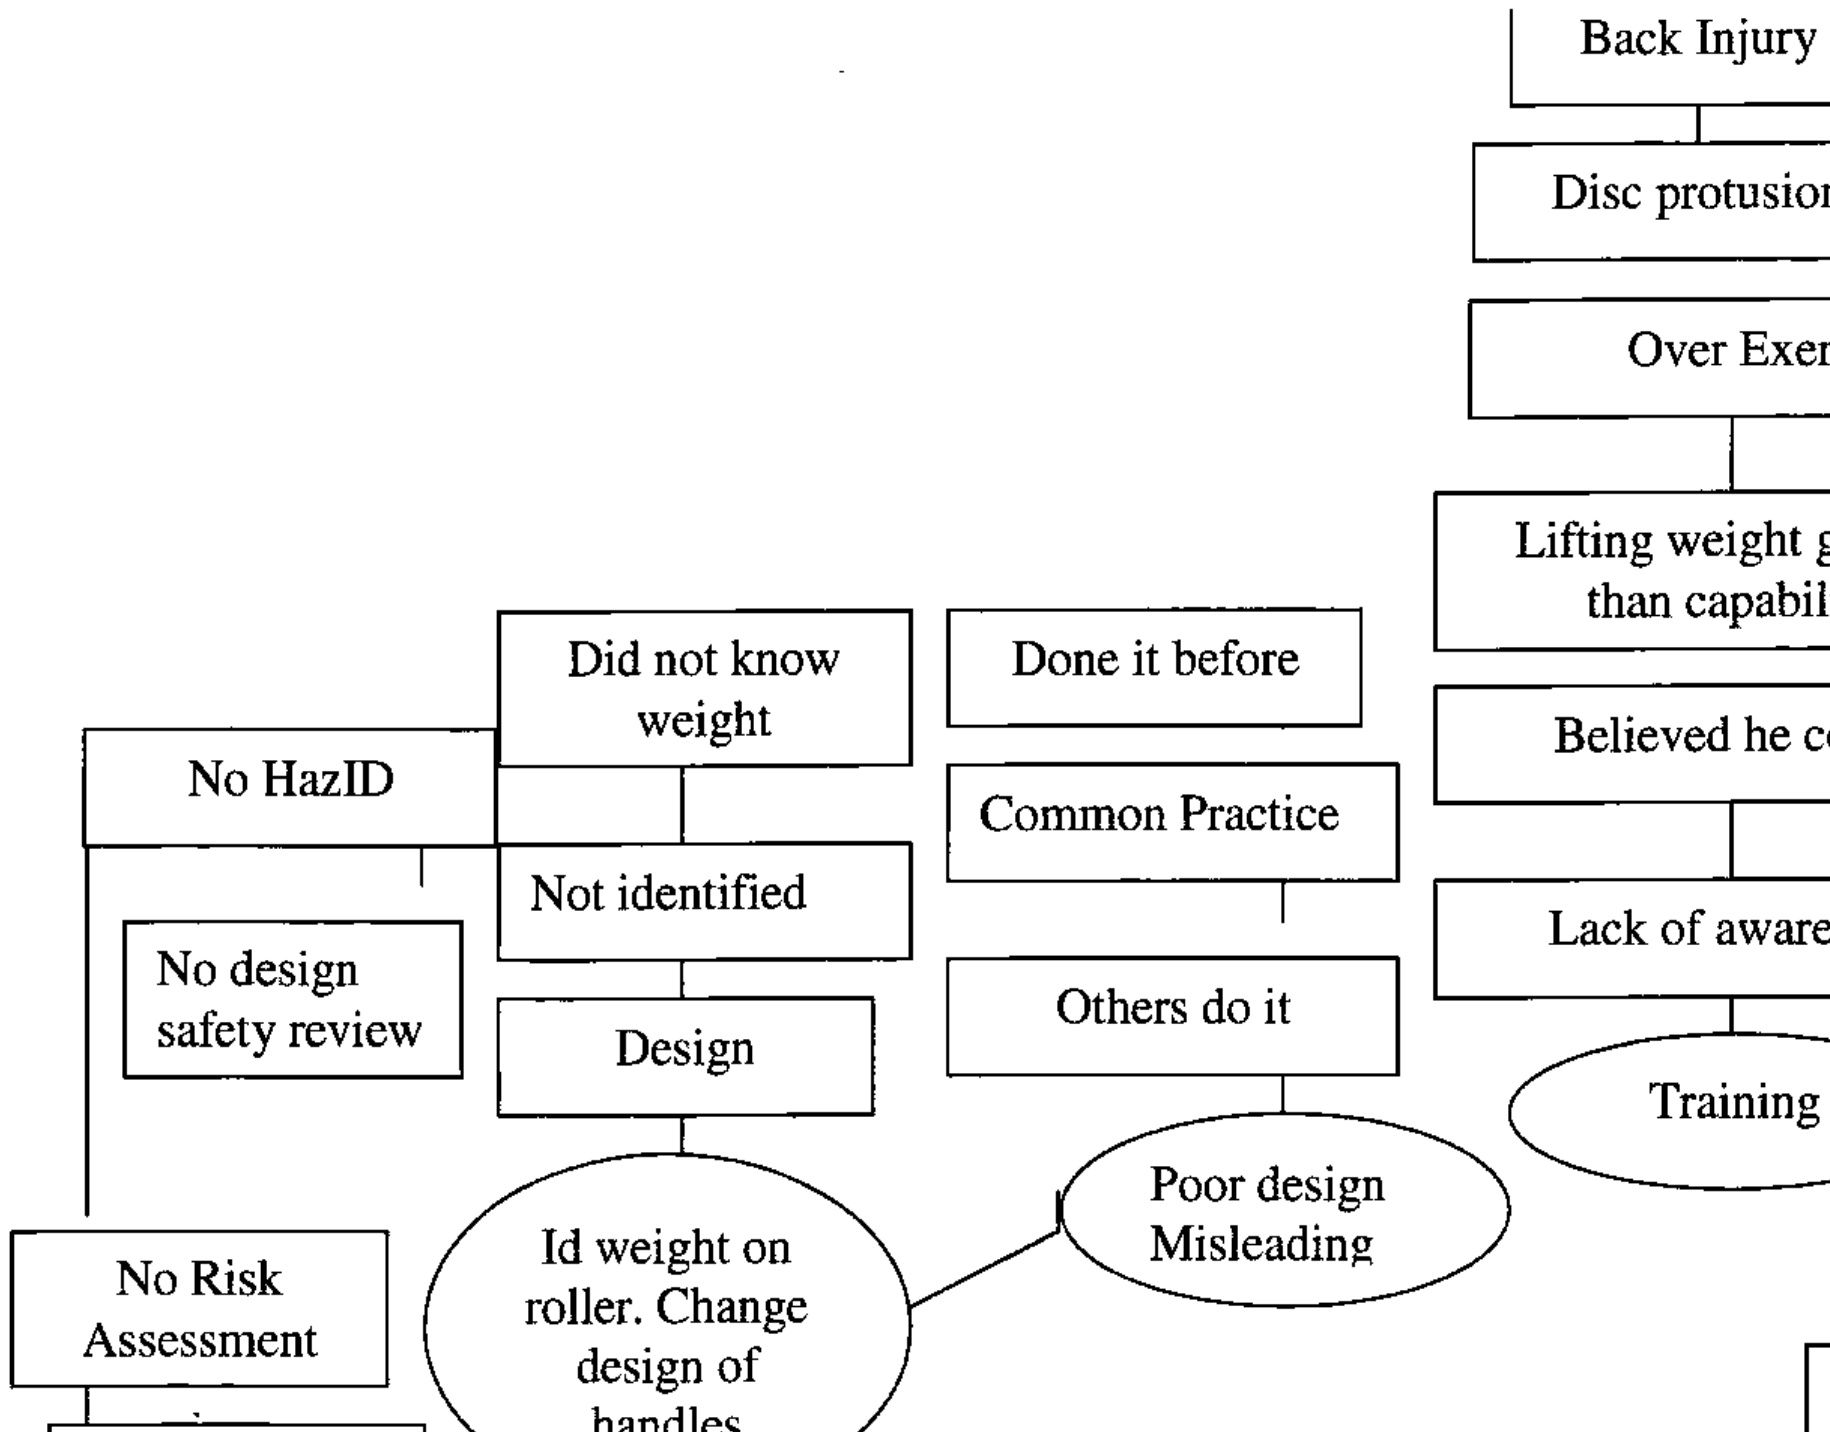
# Why Tree

- ▶ Root cause: no HazID review on rollers when accepted into rig inventory.
- ▶ Contributory causes:
  - ▶ Manual handling training ineffective
  - ▶ Policy and procedure violation
  - ▶ Inconsistent commitment to safety culture
  - ▶ Pre employment medicals – relies on disclosure.

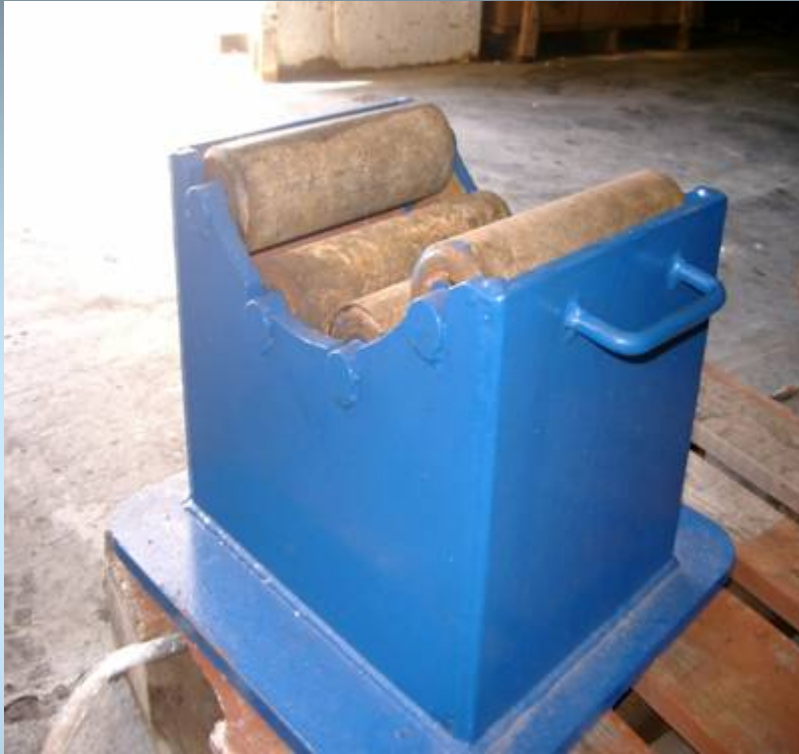
Pre incident

- ▶ **Equipment design:**
- ▶ Remove handles from rollers and replace with padeyes for lifting
- ▶ Stencil weights on heavy equipment to provide visual cue for personnel.
- ▶ **Training:**
- ▶ Manual handling training – develop risk awareness tool for rig personnel

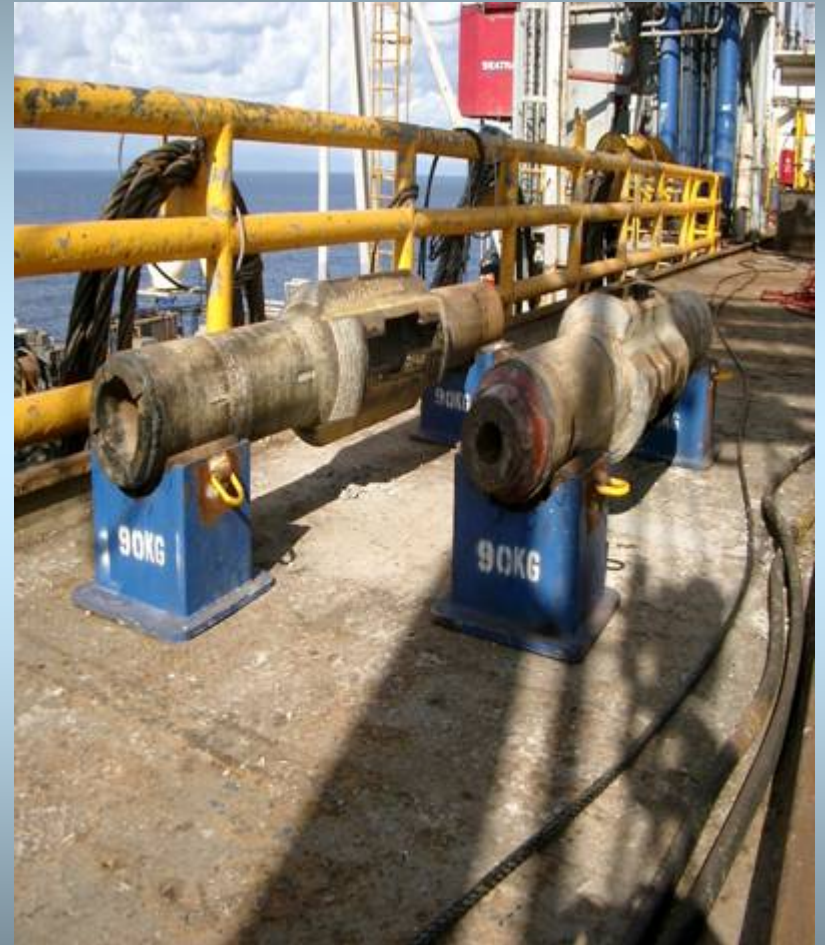
Post Incident
