Vehicle Accident - Moomba, Sep 2006

Schlumberger

Summary of Events

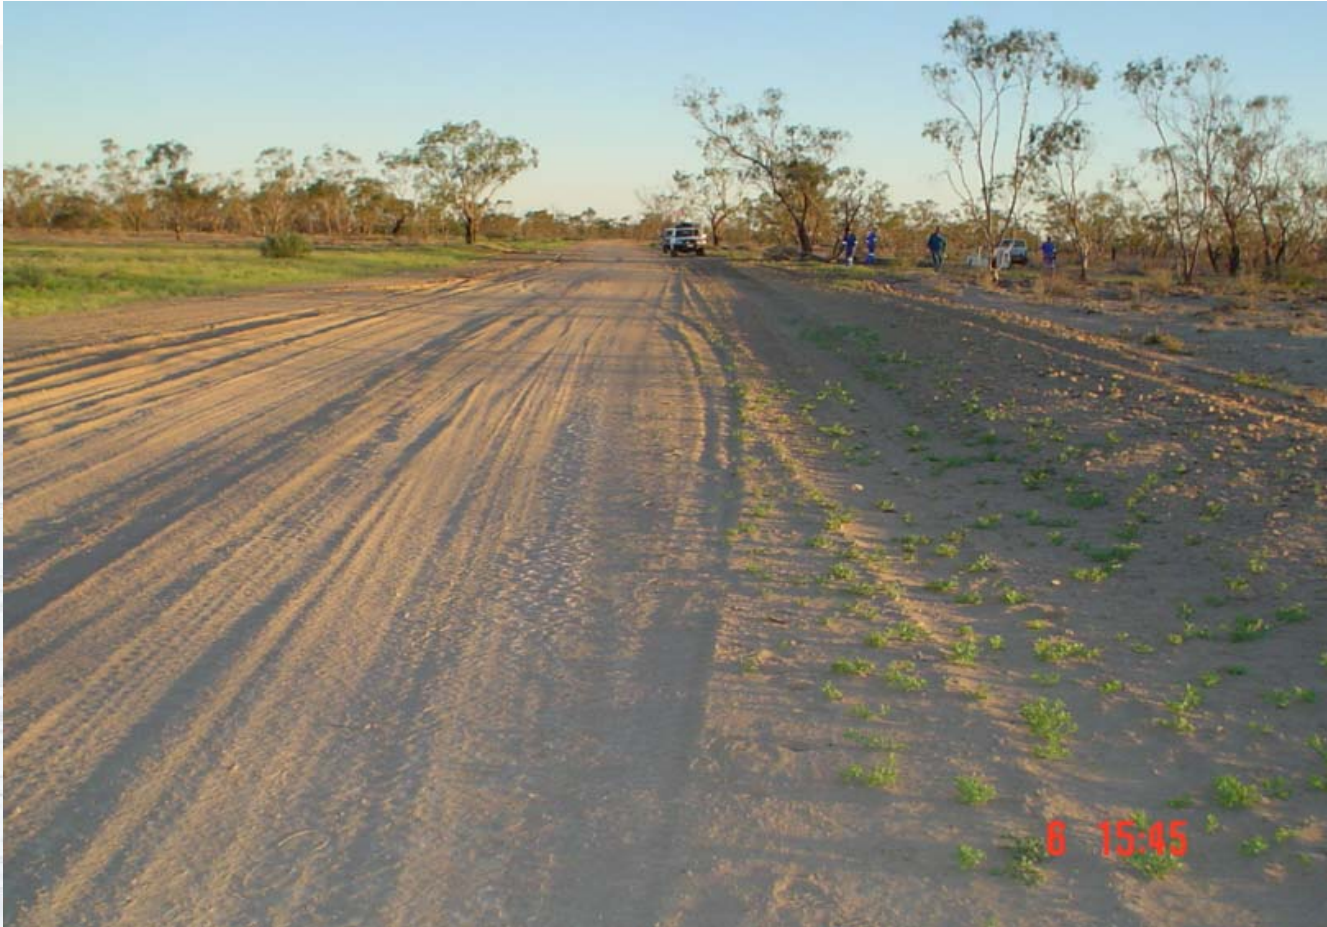
Track leading up to location of incident

Long sweeping bend

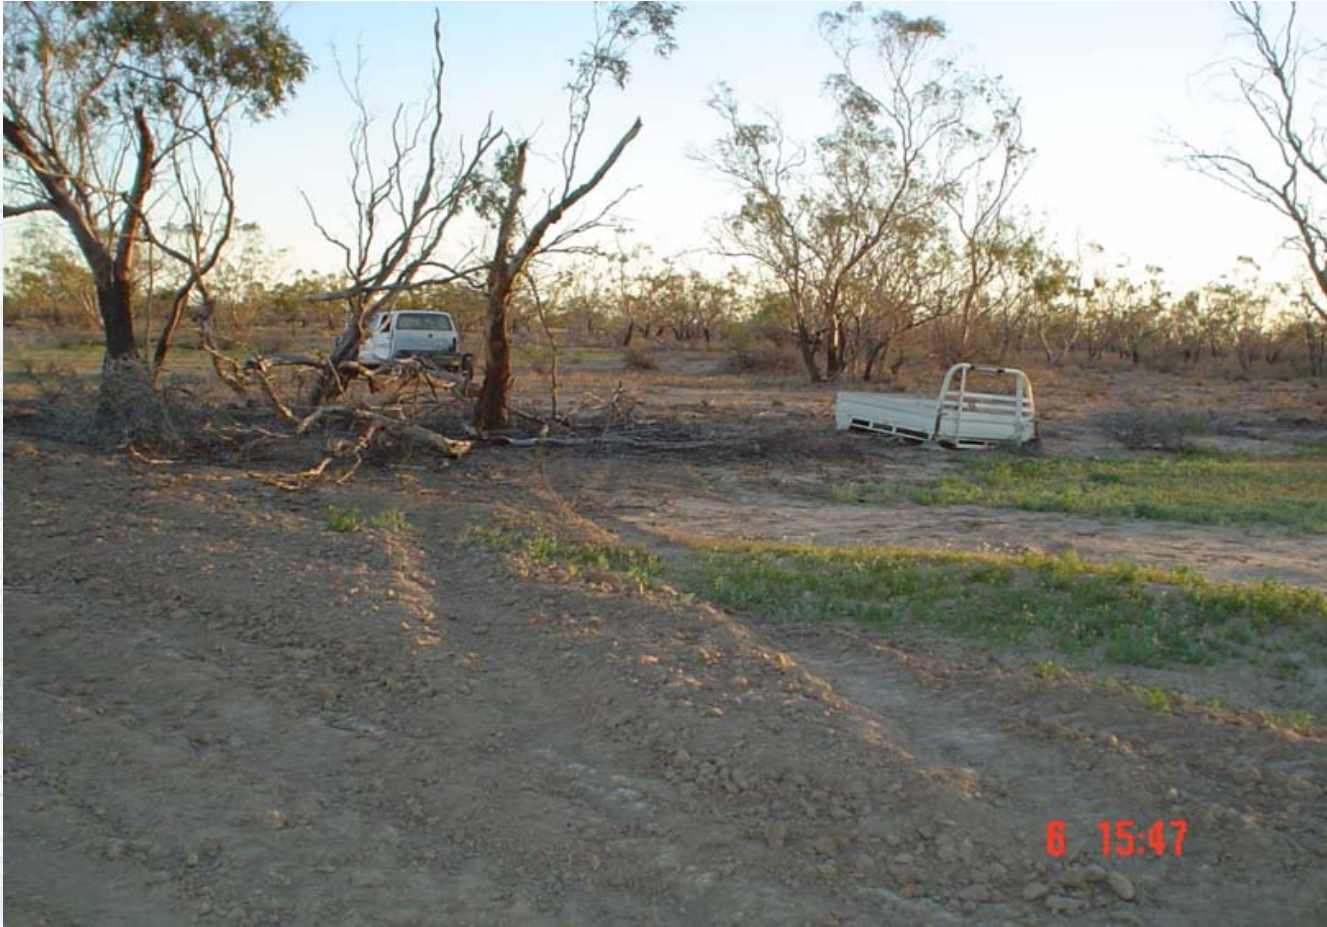
Tyre tracks leaving road

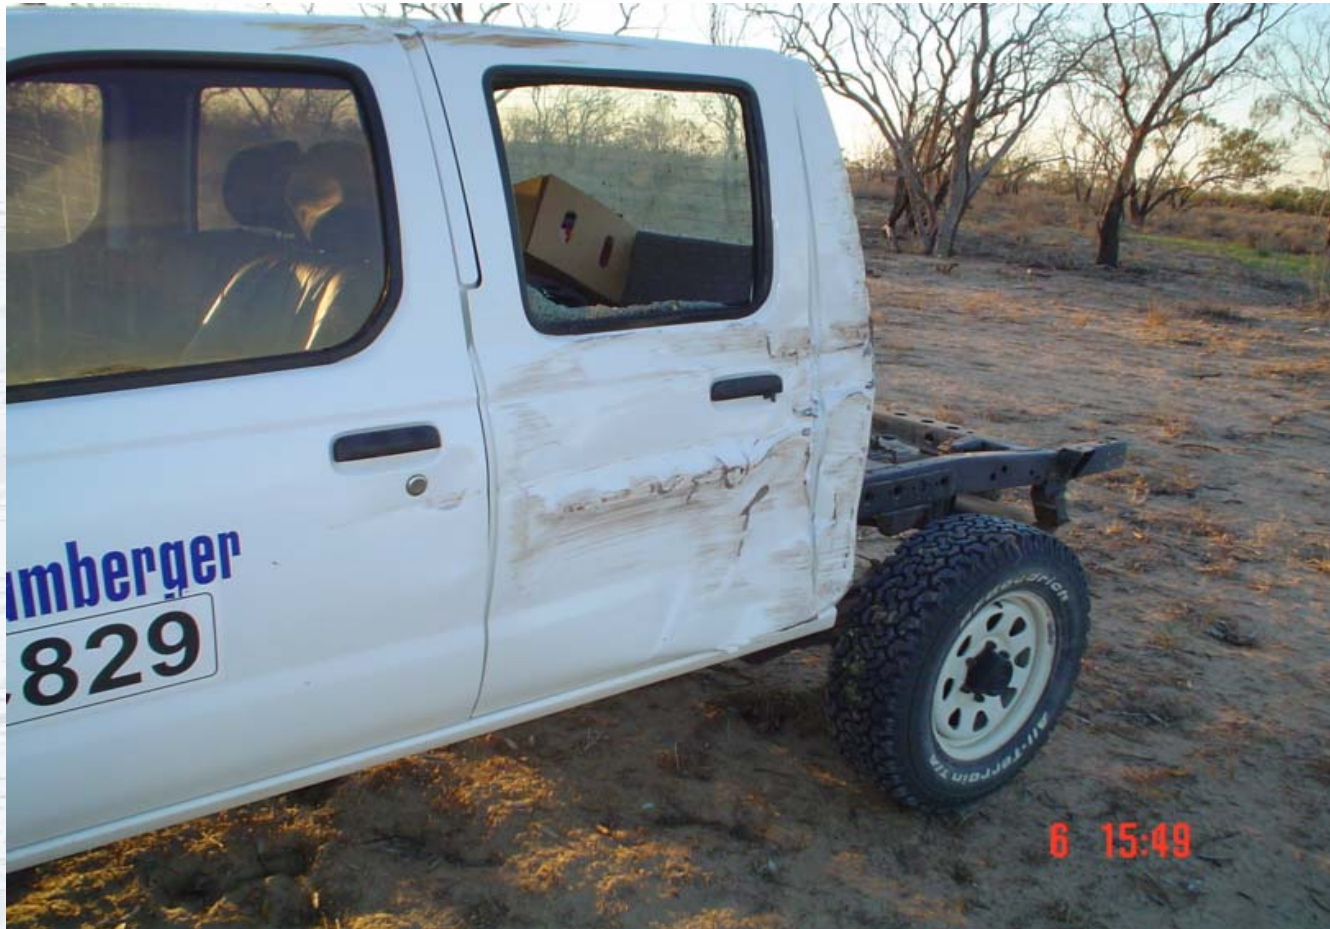
Photograph showing impact damage to rear passenger door

- Personnel driving from Jackson to Moomba completing routine well optimisation checks
- Vehicle was coming around a bend changing direction from South to West
- As vehicle came of the bend traveling West it came into contact with loose sand and caused the vehicle to begin to lose control
- Tyre tracks indicate vehicle path continued right to the edge of the road and then overcorrection occurred
- Overcorrection caused the vehicle to travel off the roadway
- Once the vehicle left the roadway it traveled for another 16 meters at which point the rear passenger compartment struck a tree and sheared off the tray
- The force of impact caused the tray to shear the bolts from the frame and project the tray approximately 4 meters from the impact point

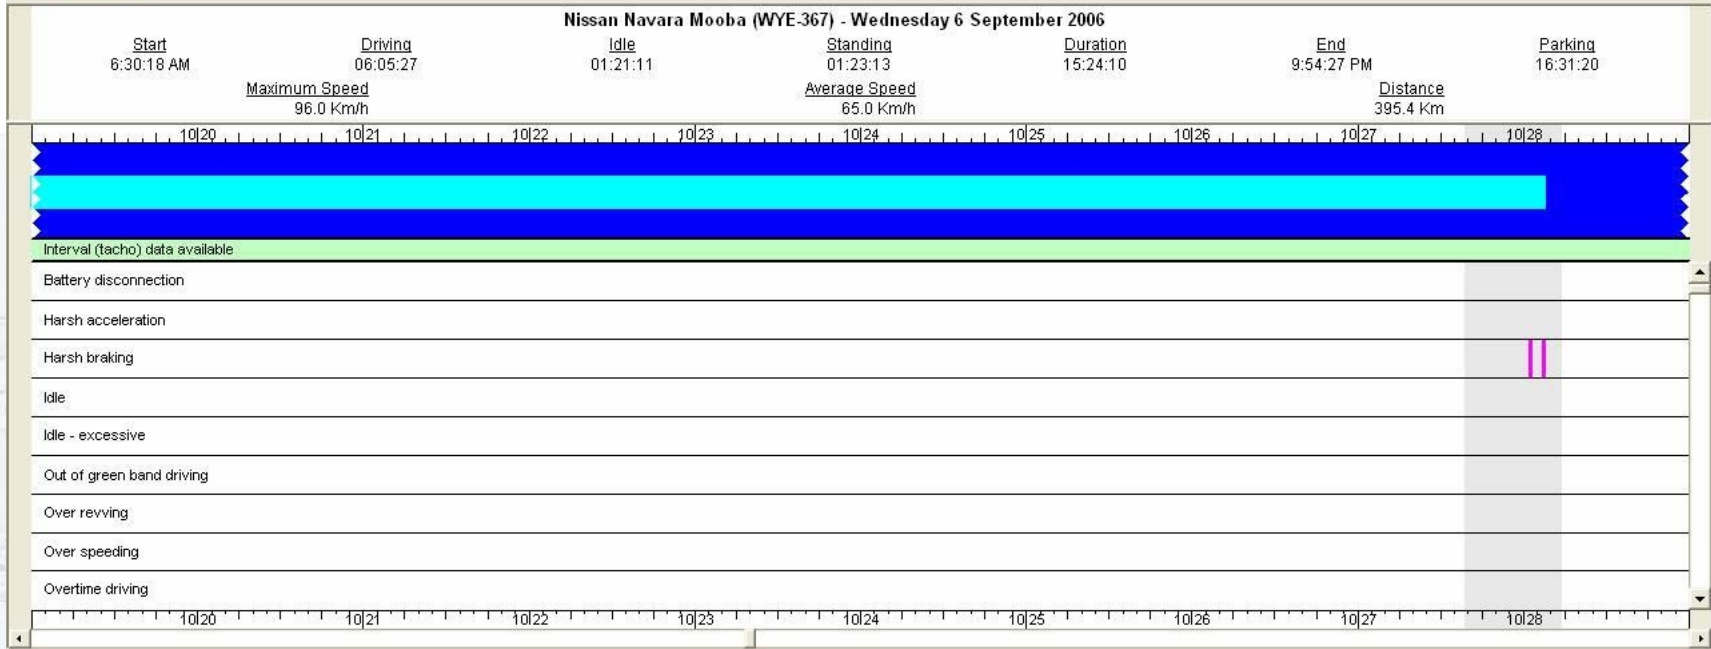
Select Period: from 10:27:39 AM until 10:28:14 AM

10:28:02 Harsh braking start. Odometer reading 83935.4 Km.
 10:28:03 Harsh braking end. Duration of 00:00:01. maximum value of 15.0 Km/h/s. Odometer reading 83935.5 Km.
 10:28:07 Harsh braking start. Odometer reading 83935.5 Km.
 10:28:08 Harsh braking end. Duration of 00:00:01. maximum value of 12.0 Km/h/s. Odometer reading 83935.5 Km.
 10:28:08 Sub Trip end. Driving time 00:17:12. Sub Trip distance 19.3 Km, with ending Odometer 83935.5 Km.
 Maximum speed 95.0 Km/h. Average speed 67.3 Km/h.
 No Over speeding.
 Maximum engine revs 2800. RPM. No Over revving. Maximum deceleration 15.0 Km/h/s. Maximum acceleration 7.0 Km/h/s. No Idle. No Idle - excessive.

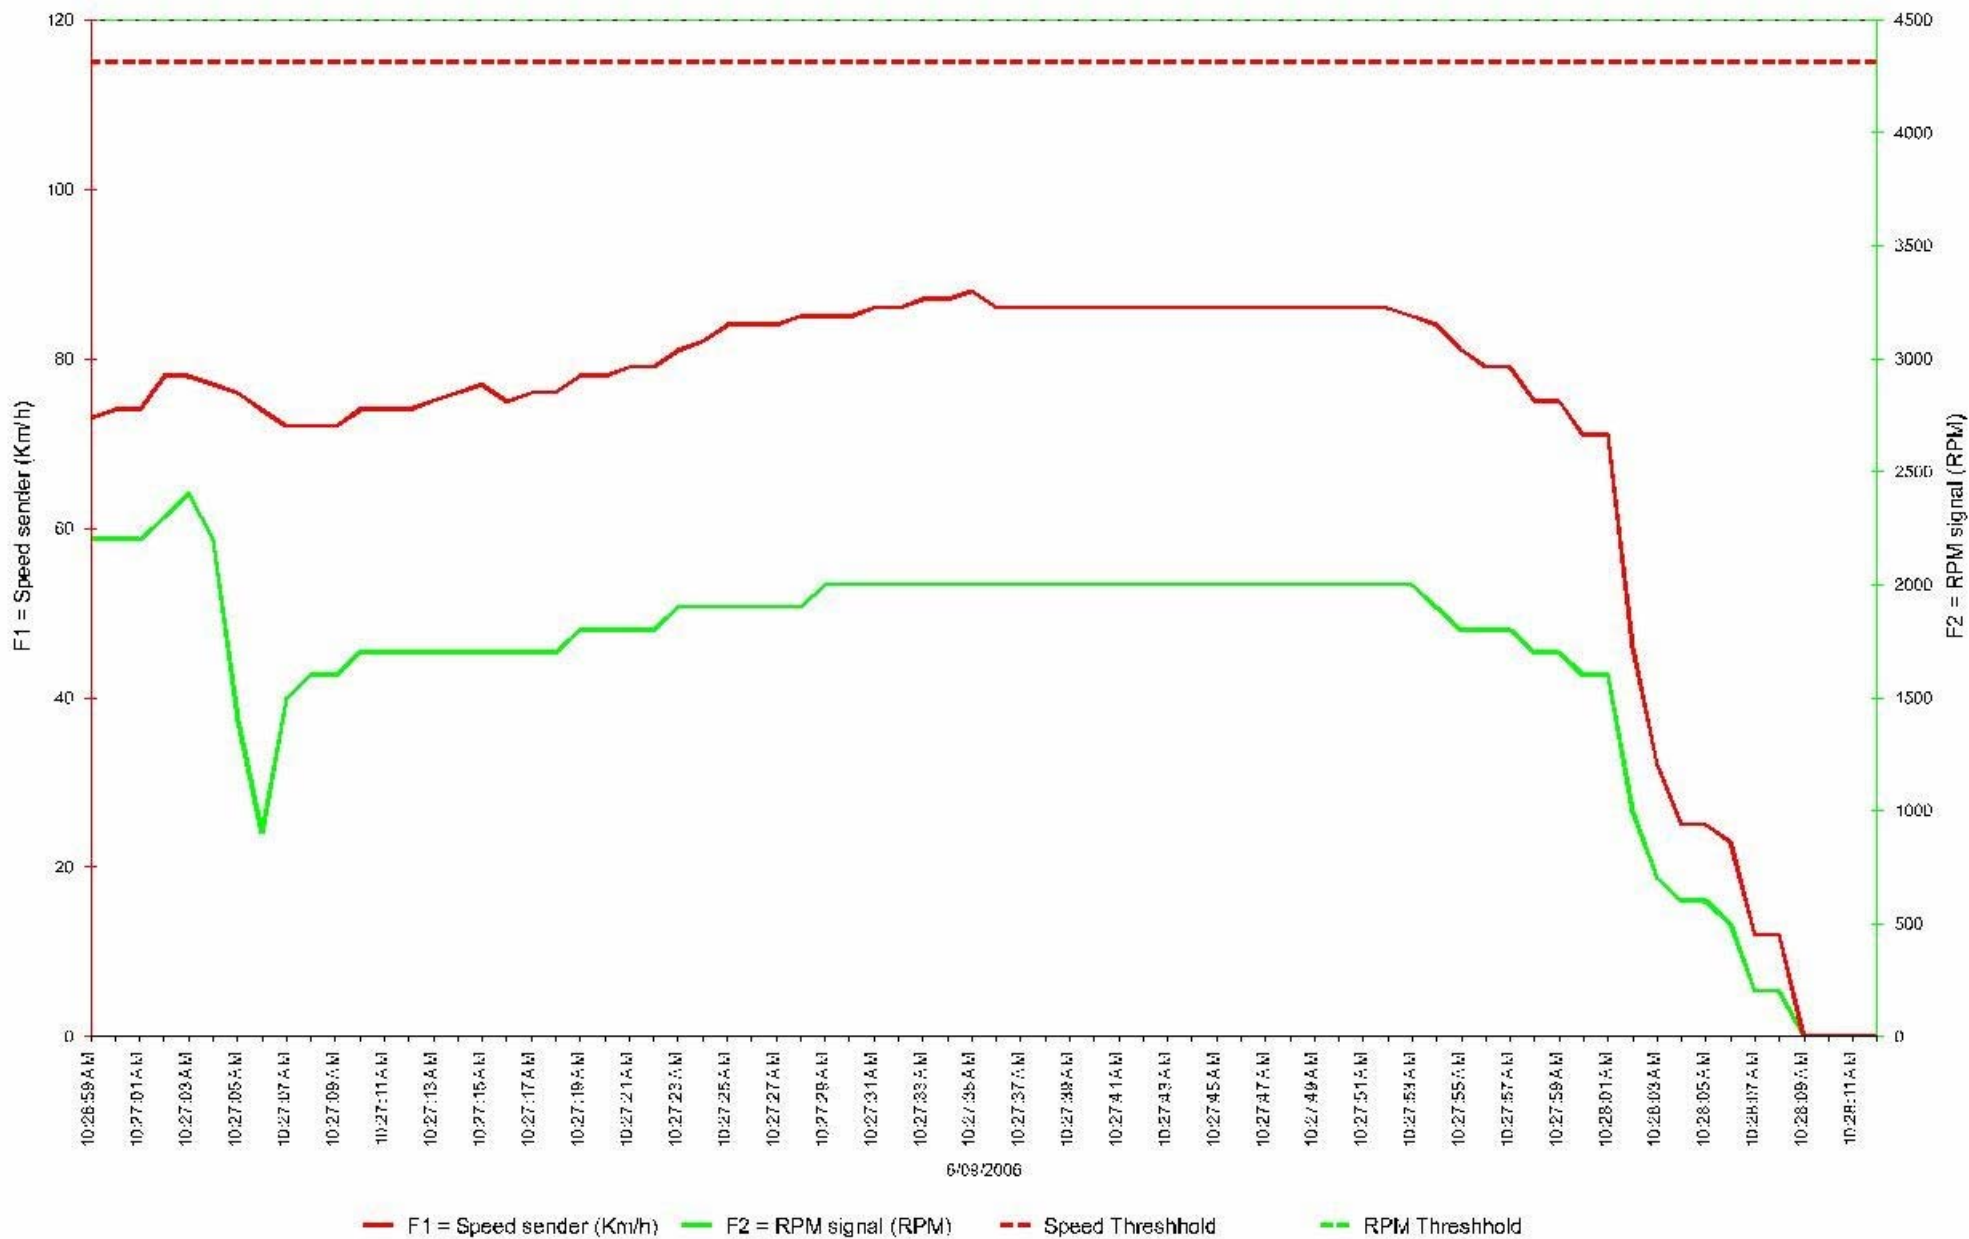
Interval (tacho) Data
Nissan Navara Mooba (WYE-367)
For the period 6/09/2006 10:26:59 to 6/09/2006 10:28:12

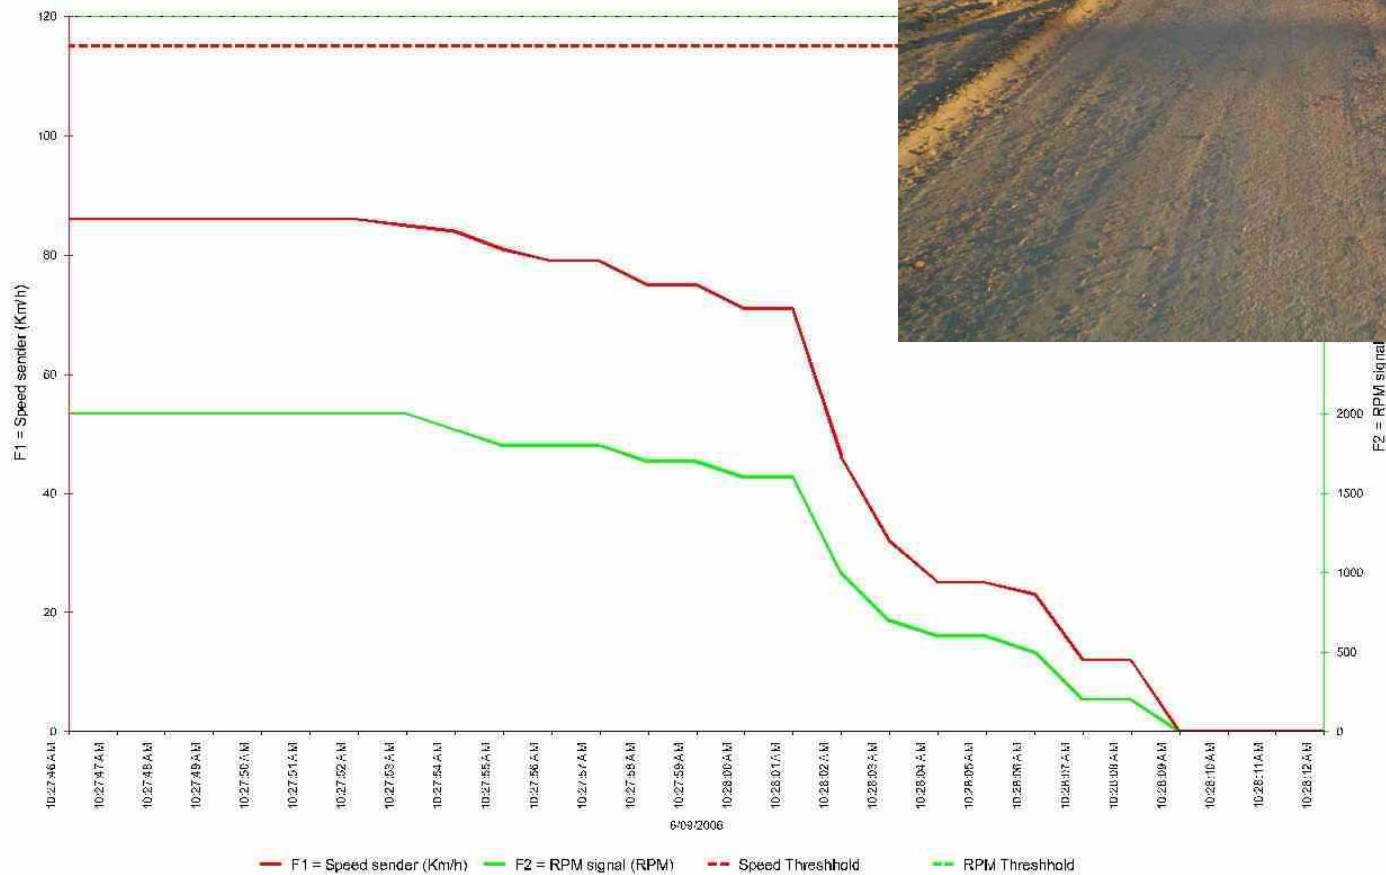
Interval (tacho) Data
 Nissan Navara Mooba (WYE-367)
 For the period 6/09/2006 10:27:46 to 6/09/2006 10:28:12
