Drillsafe – Perth – 7th March 2007

Dropped Blocks – Rig #3 – 04/04/2006

Ben Prain, HS&E Manager, Century Resources.

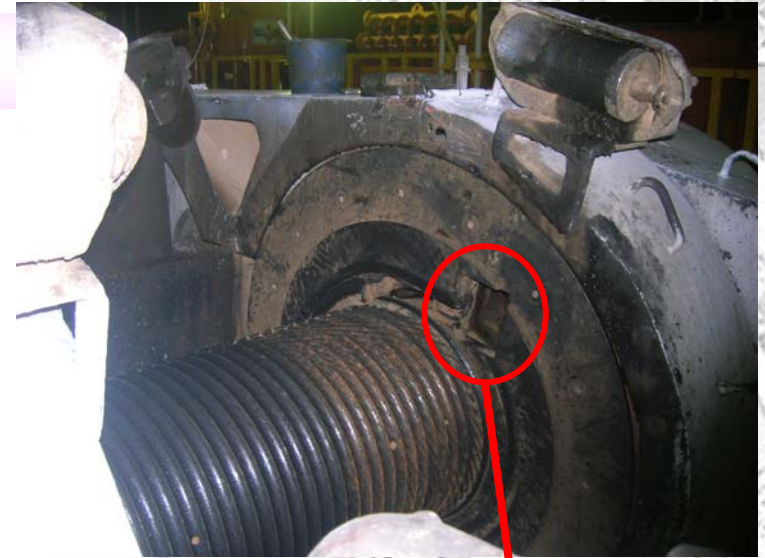
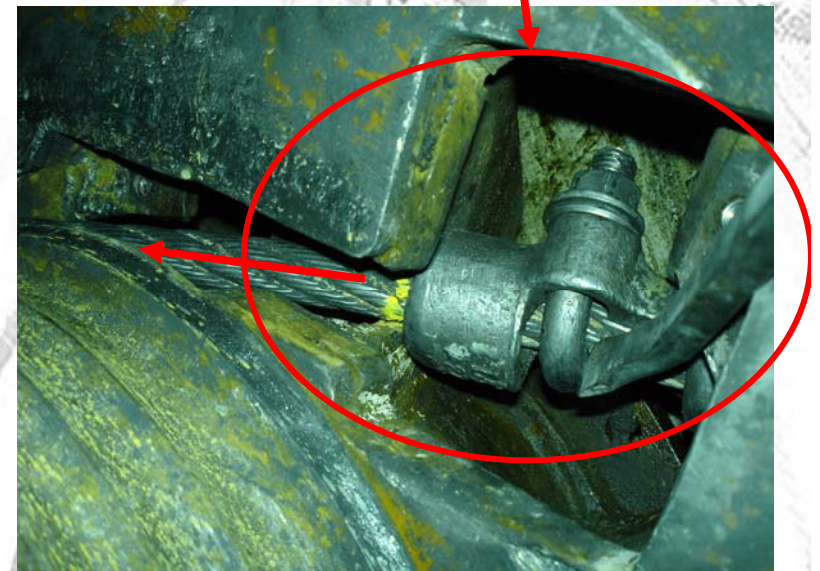
- 7.15pm - 02/04/06: Slip & cut procedure was undertaken and completed by 3 rig personnel – a floorman, driller and night rig supervisor.
- 7.15pm – 04/04/06 (48 hours later): A subsequent event occurred whereby the drill-line cable slipped and pulled out of the drill-line knuckle and retaining slot in the draw works.
