UPDATE SM-07-048-LTA

**Crushed Finger
Injury**

06 November 2007

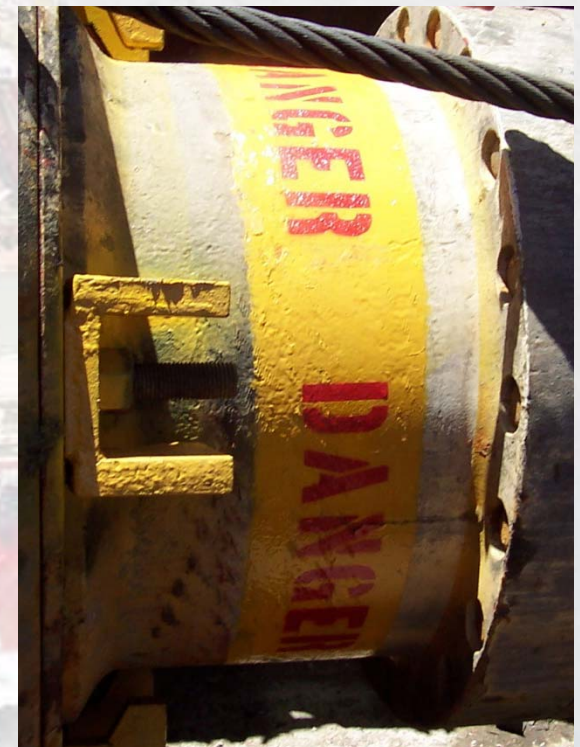
- **Who:** Derrickman
- **What:** Open fracture of the left ring finger
- **When:** 6 November 2007 at 17:55 hrs
- **How:** The Derrickman sustained a serious crush injury to his left hand ring finger during man riding activities to remove the marine riser tensioner cables from the Riser Tensioner Ring (RTR).
- **Why:** During the release of pressure from the Marine Compensators (a process required to ease the tension on the tensioner cables prior to removing the RTR clevis pins), the IP inadvertently placed his left hand ring finger between the load ring retainer brackets and slip joint.
- **NB** Tension on the marine compensator cables raises the RTR thereby creating a pinch point gap when the air pressure released.

- **Review procedure** – completed
- **Review sheave placement** – completed
- **Investigate use of EWP** – ongoing, no practical system identified to date
- **Highlight pinch points** – completed
- **Review MoC procedure** – completed
- **Rollout MoC training** – in progress
- **Management to give clear guidelines on MoC process** – completed
