Stena Clyde

Engine Room Fire
20th October 2007

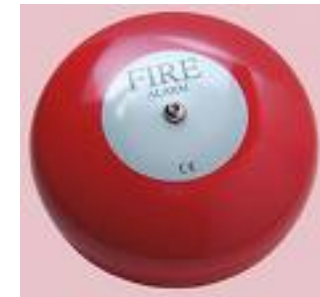
Detail of Area

The initial fire alarm was initiated by an automatic thermal detector in the engine room, which houses 4 engines. The fire was reported as being located between and/or behind engines 2 and 4.
