Near Miss

Dropped 13 3/8 inch Casing

6th November 2008

DrillSafe Forum Presentations - Perth Western Australia – 5th Mar 09

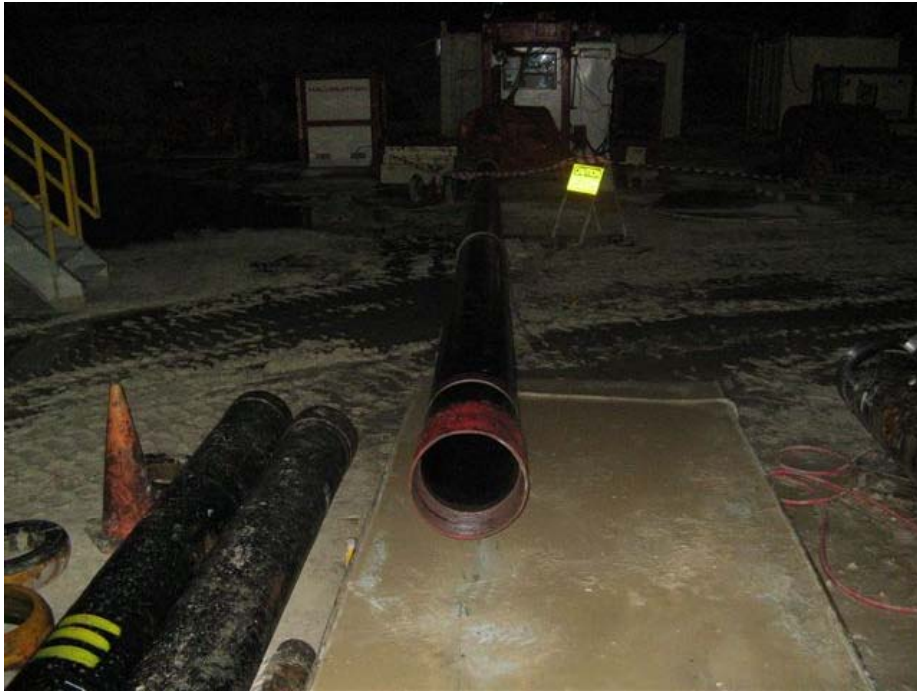
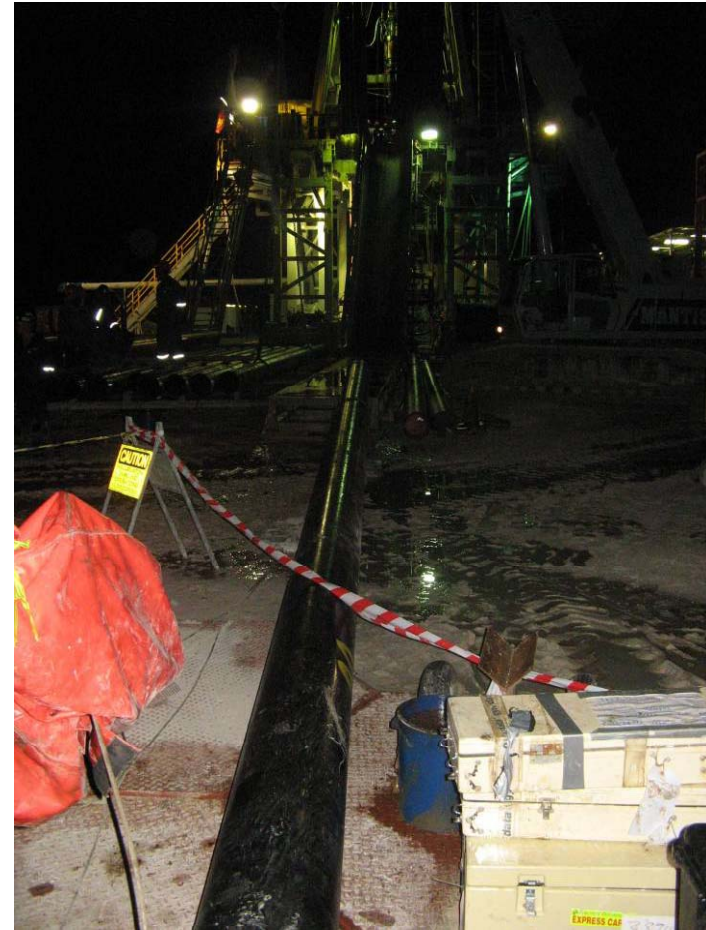
A joint of 13 3/8 inch casing came out of the single joint elevator at floor level and travelled down the vdoor, along the catwalk finally coming to rest against the nearby wire line unit. The incident resulted in slight damage to the wire line unit skid and had potential for a serious injury up to fatality
