DrillSafe

Ferrule

Transocean
Legend
LGD-2000

We recently experienced 2 members of the team needing first aid treatment after contact with wires protruding from the end section of the ferrule. Both cases were fortunate not to escalate into something more severe.

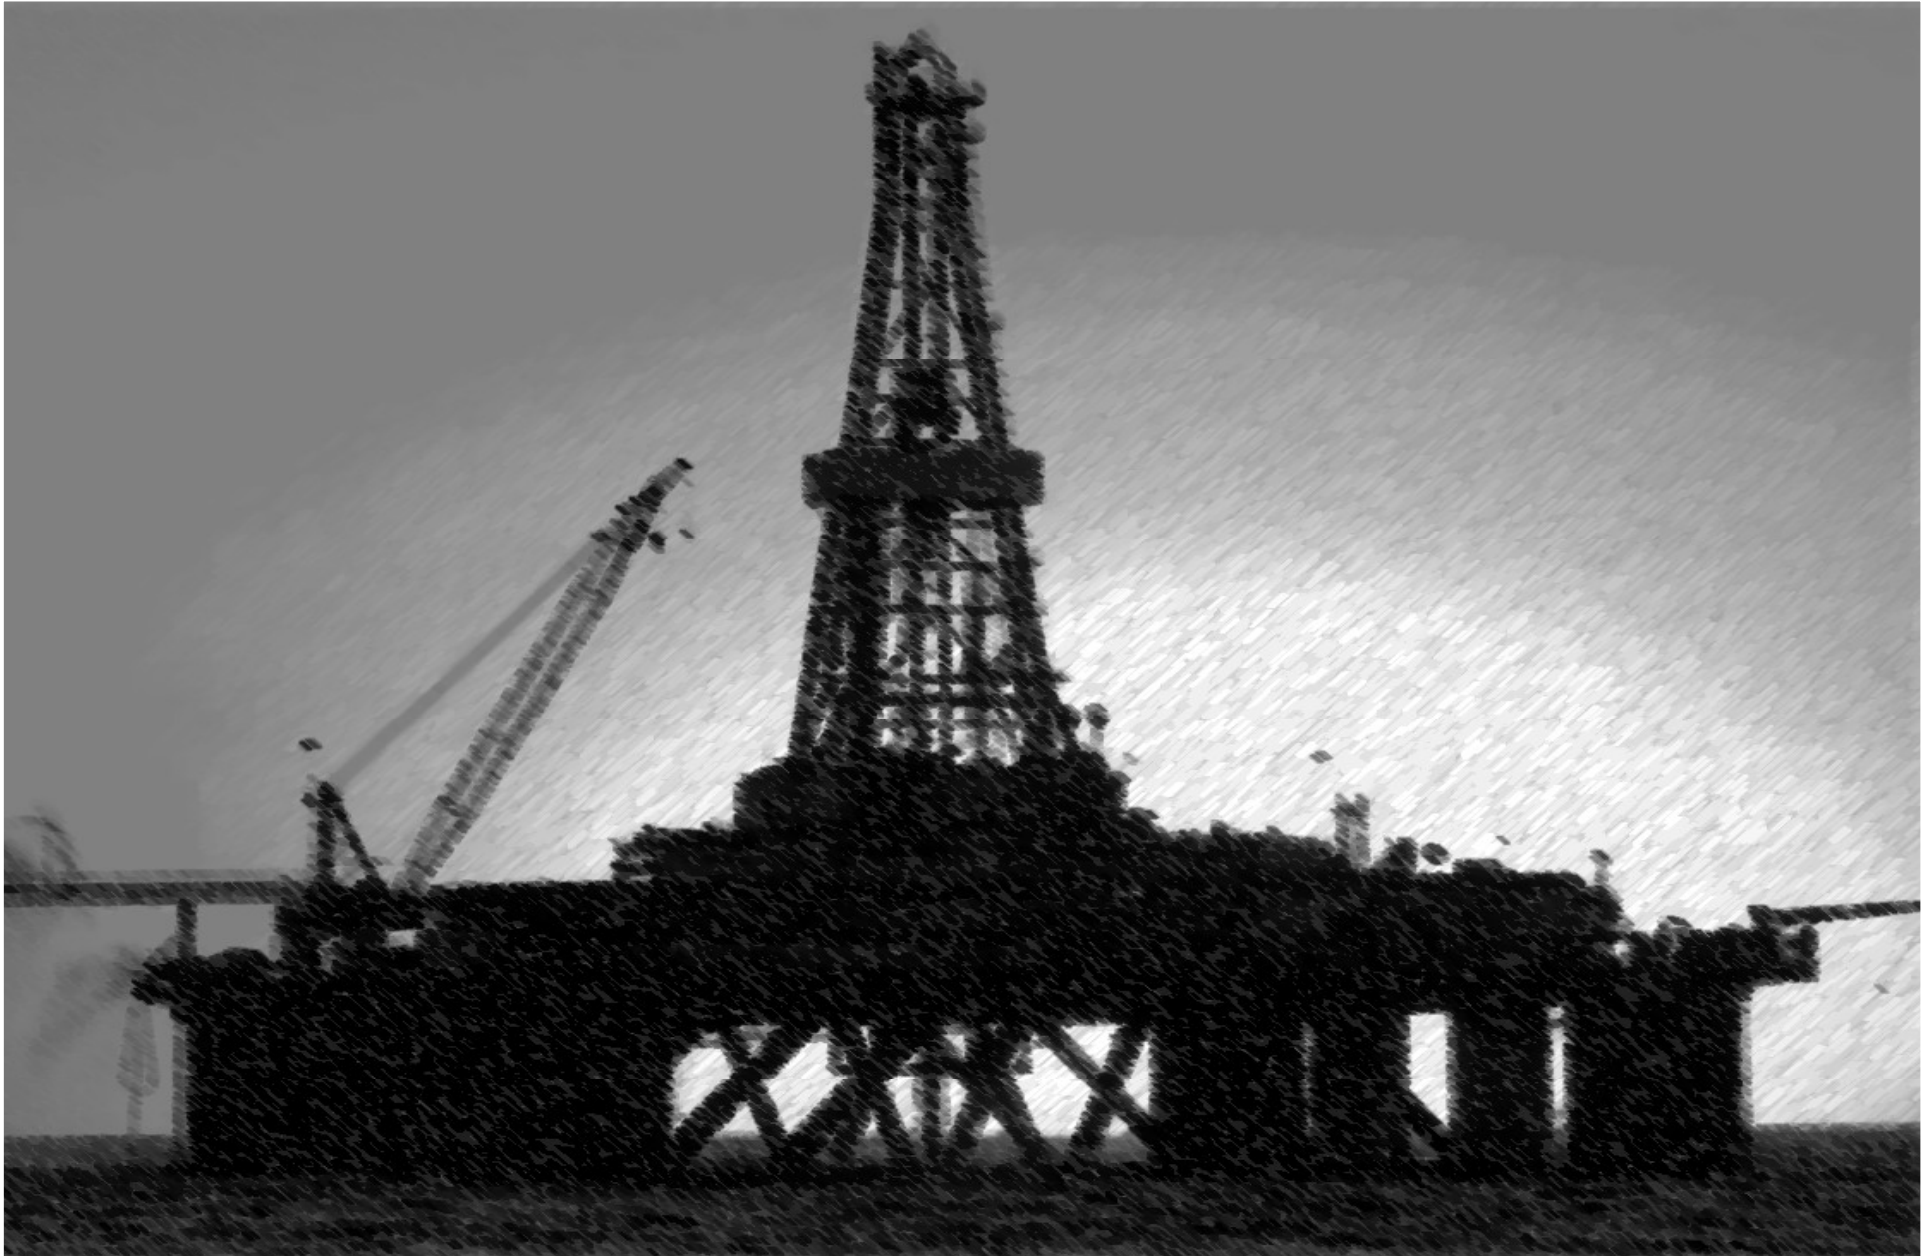
We know we have to remove a single barb from a pennant or sling as it does pose a realistic hazard, yet we accept over 50 at the ferrule end of the sling

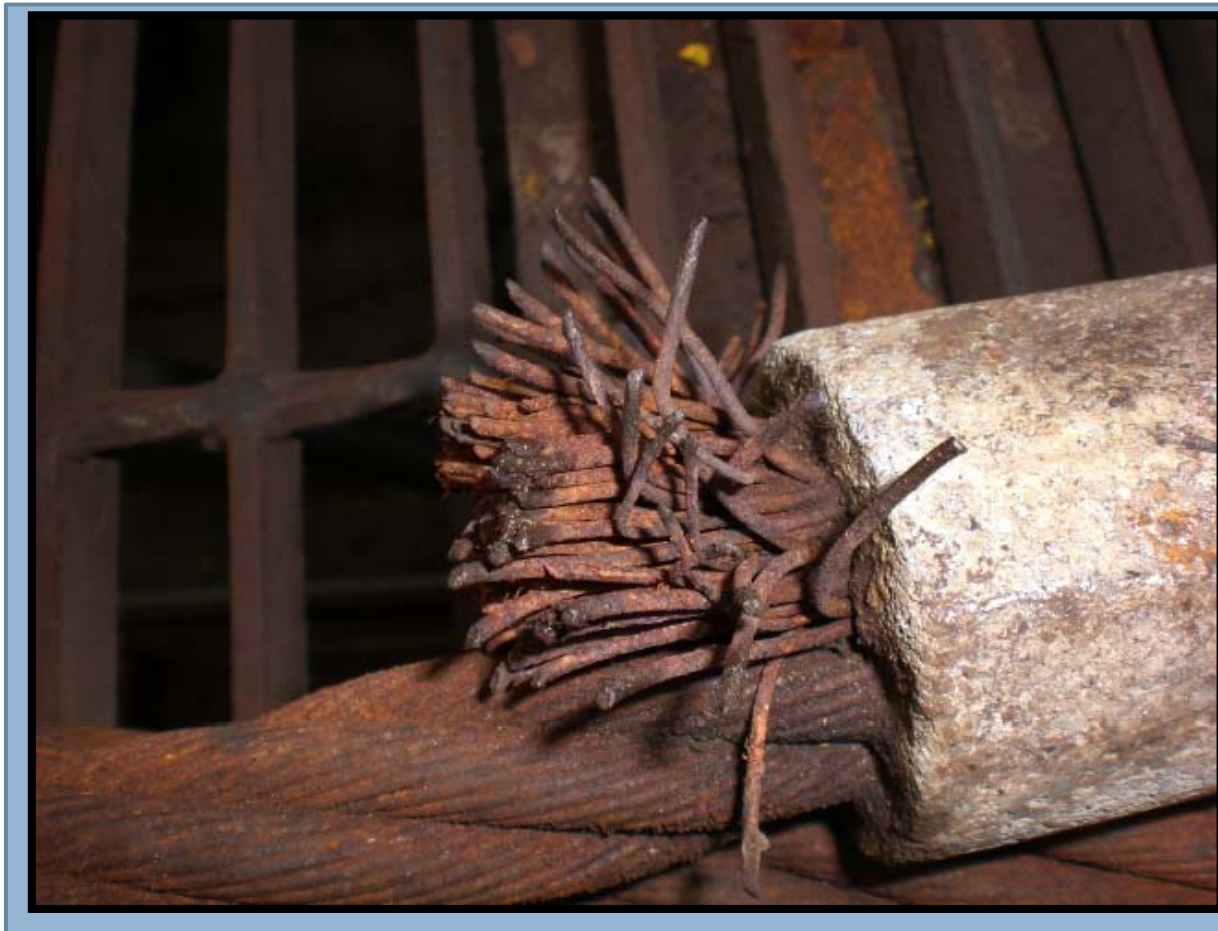
A roustabout was part of the team moving tubulars on the main deck. As he picked up the sling the section protruding from the ferrule made contact with his finger resulting in a puncture wound.

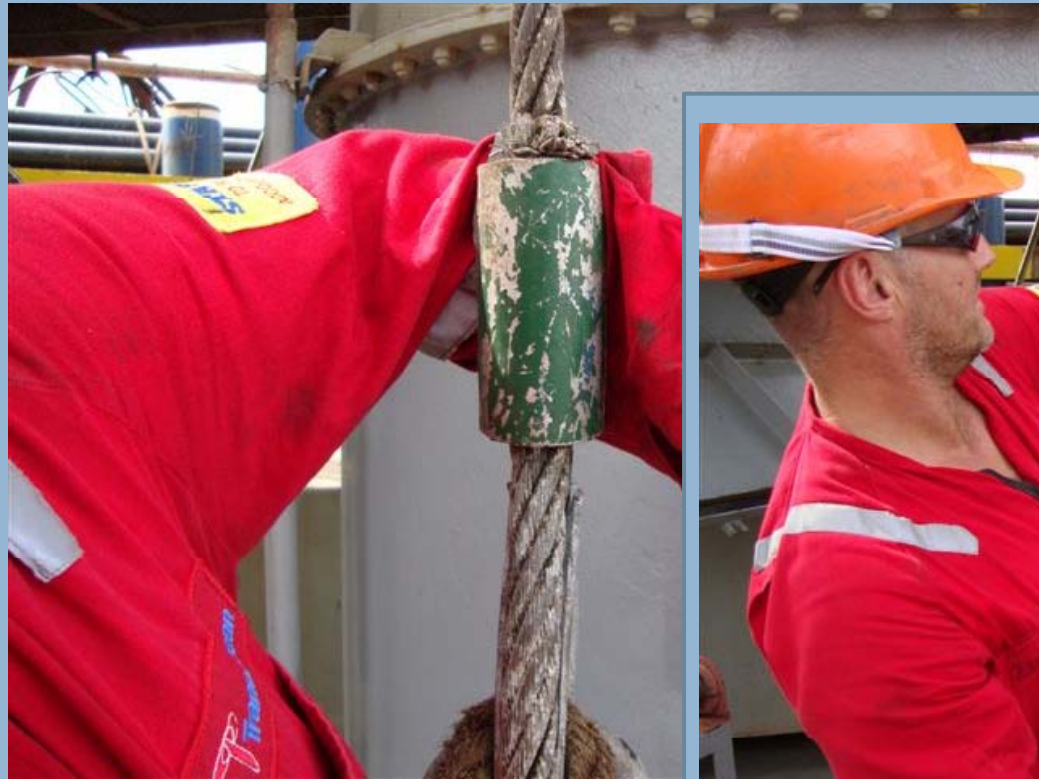
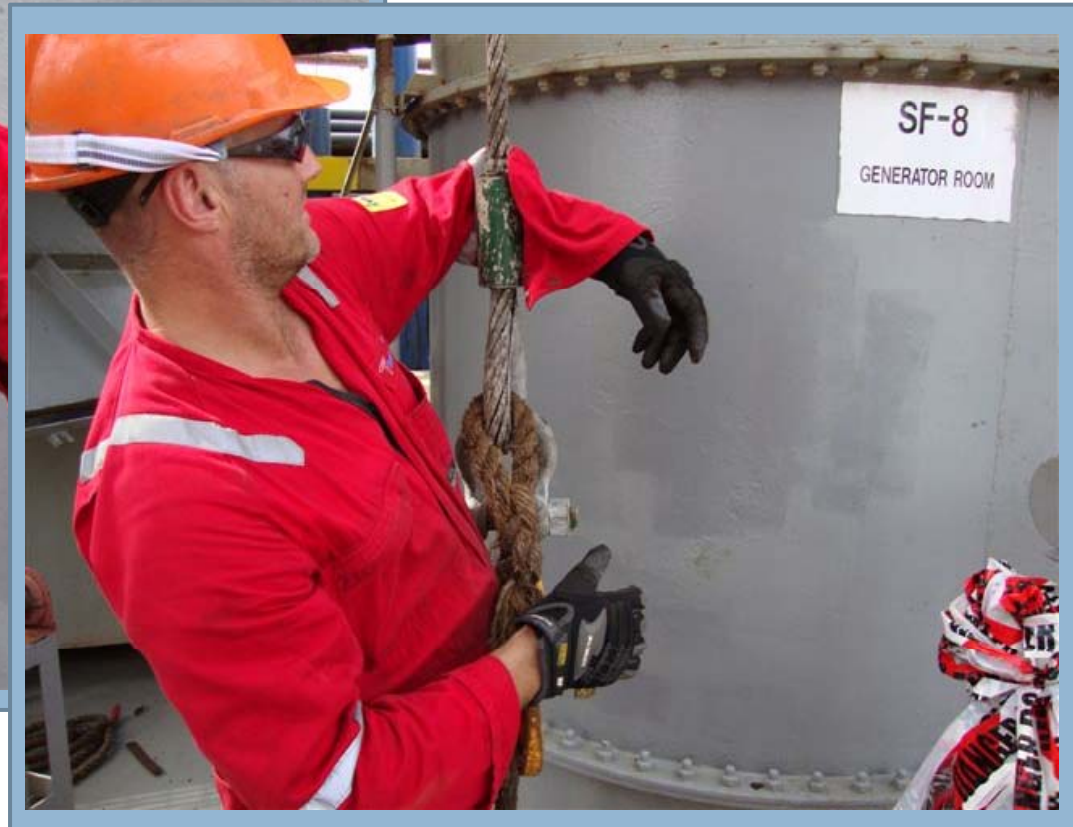
From evidence it is clear that the IP's hand came into contact with the wires that were protruding the ferrule. Despite the IP wearing gloves, they were not of a satisfactory rating for the job; the wires were sharp enough to penetrate his glove and cause the deep cuts.

The condition of the wires protruding the ferrule created a clear hazard to personnel. Following discussions with operators it has been noted this condition is common.

It is recommended that all operators inspect their lifting equipment for similar type of deficiencies.

In the long term these types of terminations require to be re-assessed, consideration should be given to terminations that do not create such hazards.

- A recommended solution is to utilize crane pendants for offloading / back loading supply vessels which are fitted with a Flemish or 'Super Loop' type of termination (pictured). The sleeve has a tapered top which encompasses the wire ends.
- It is suggested that they would only be required on crane pendants and not normal wire slings. It is further recommended that Companies ensure that operatives wear the most suitable glove for the task.
